Satellite-based Damage Assessment

Sectoral Analysis: Cultural Heritage

Sudan

CE20231504SDN

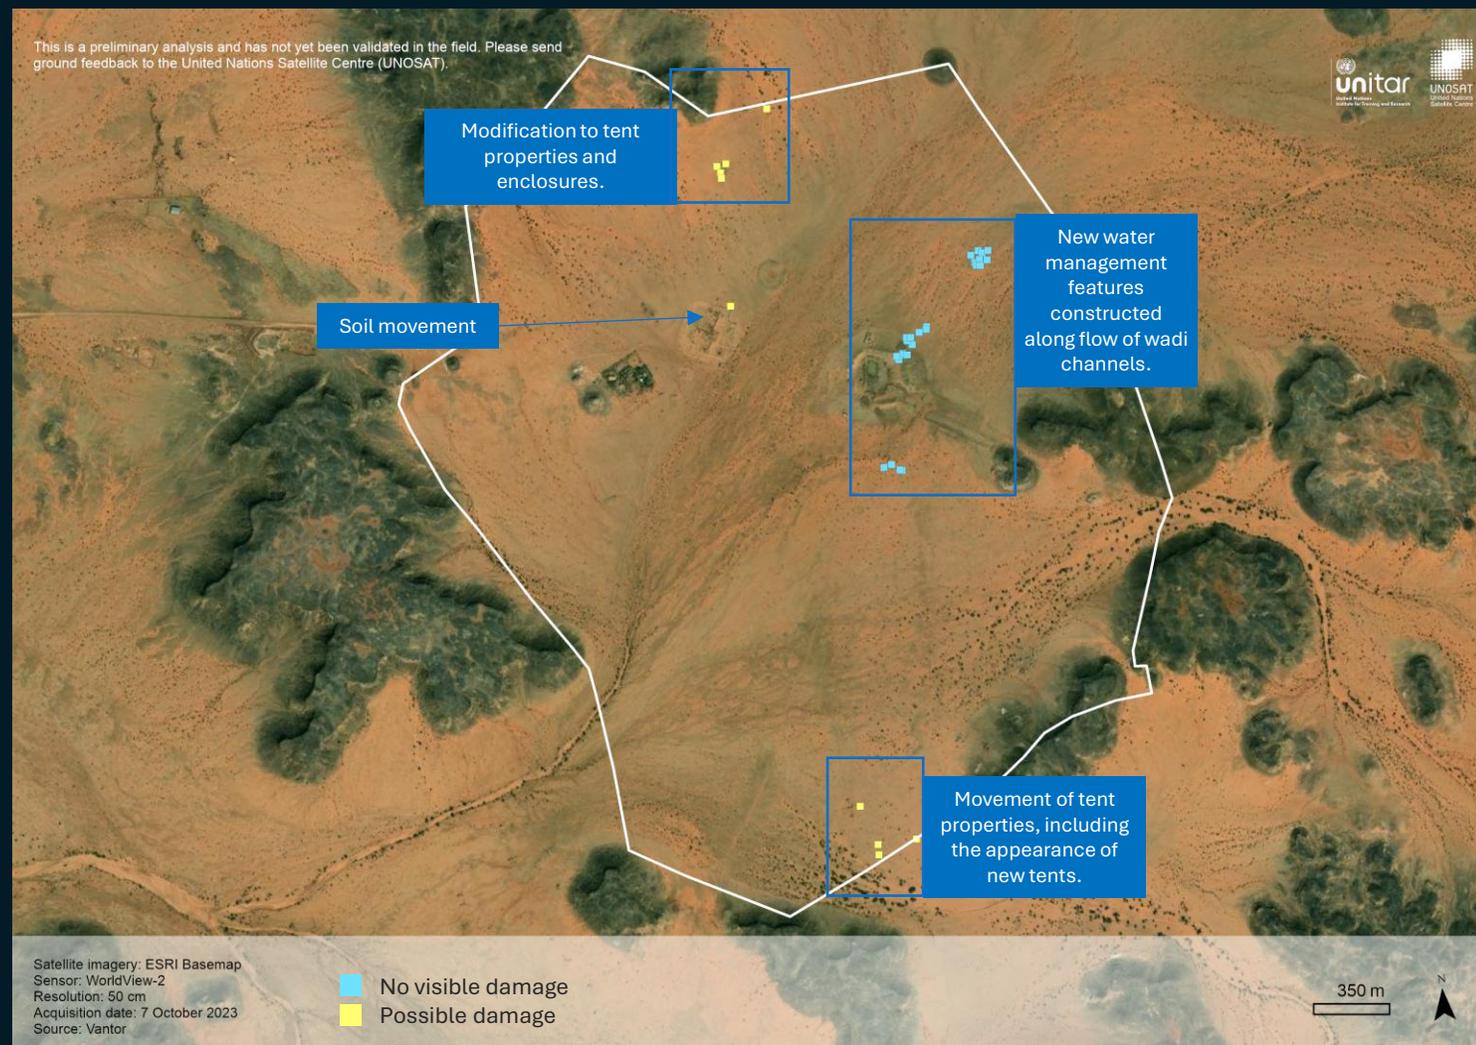
This page illustrates damage observed from a very-high resolution image captured by a WorldView-2 satellite on the 7 October 2023.

Within the analysed area, 35 locations showed changes with 25 locations of no visible damage and 10 locations with possible damage.

Several areas with changes observed as no visible damage were identified due to new water management features constructed along the flow of wadi channels.

Possible damage locations were due to the movements and modification of structures, tents and enclosures. As well as one location where soil movement could indicate possible damage.

These activities may disturb or impact any shallow archaeological layers.

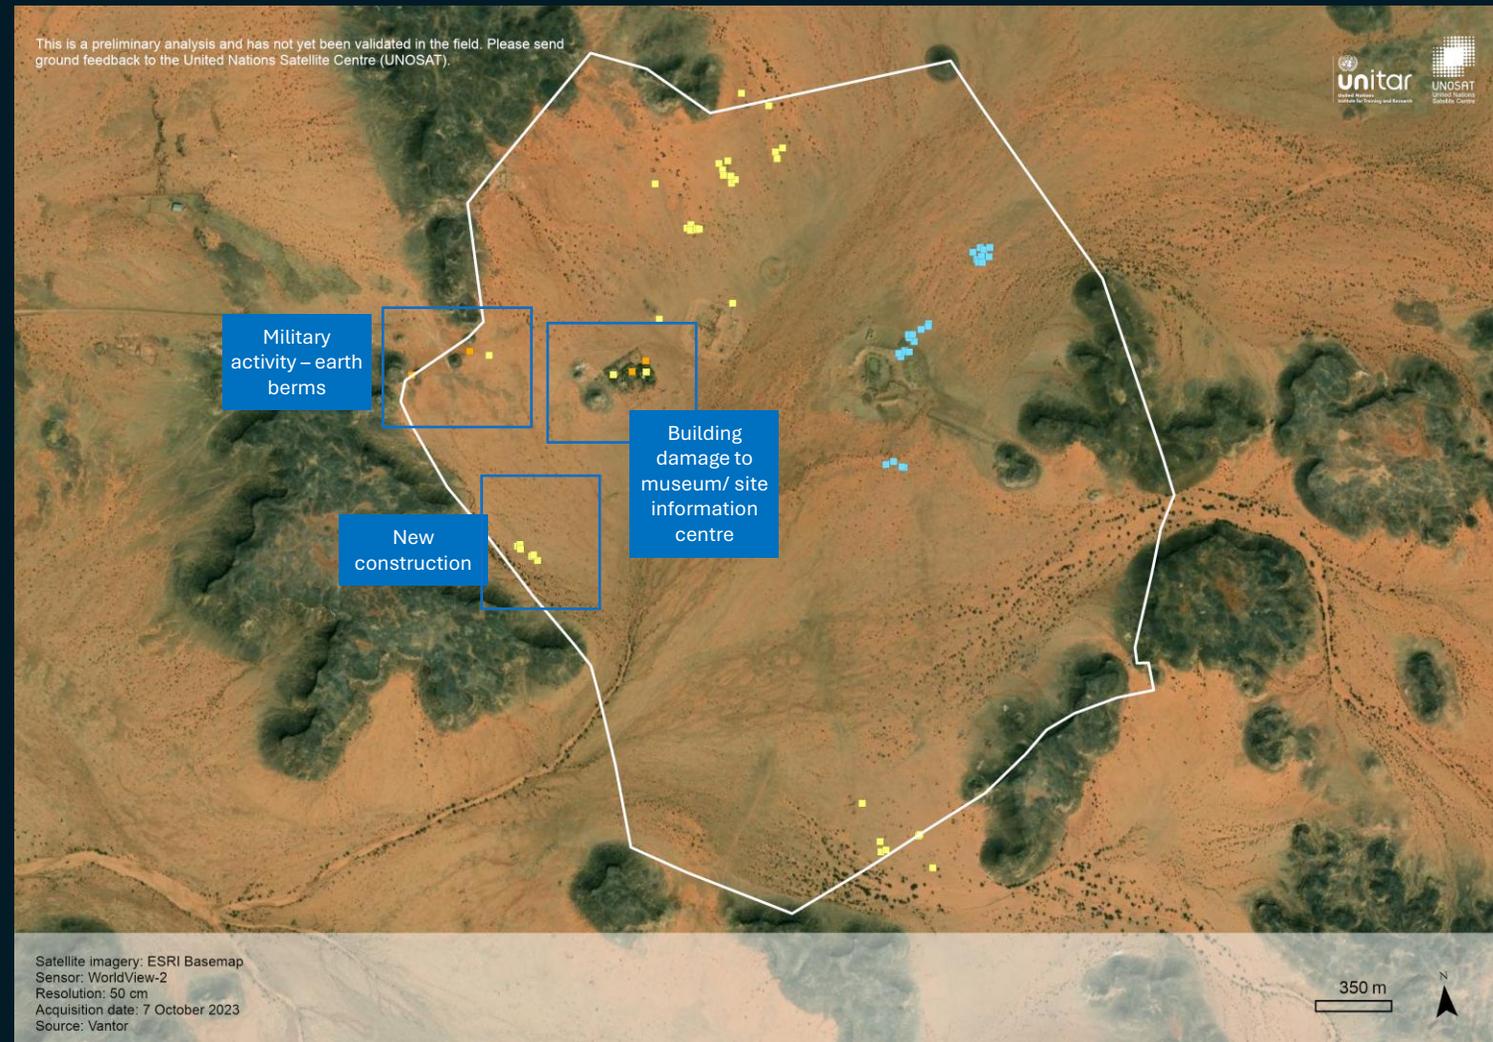
2. Musawwarat es-Sufra - Archaeological Sites of the Island of Meroë

This page illustrates damage observed from a very-high resolution image captured by a WorldView-3 satellite on the 25 June 2025. Within the analysed area, 66 locations showed changes, an increase of 31 locations since the last assessment.

- 25 no visible damage
- 37 possible damage

The increase of possible damage locations include possible damage to the main buildings/ museum on site; as well as new construction of habitation areas. Such activities may disturb or impact any shallow archaeological layers.

- 4 moderate damage

New areas with moderate damage are due to military activity detected within the site boundary with large earth movements present on the western side of the site – including what looks to be a large berm, possibly acting as a roadblock. This berm was first spotted on imagery captured on the 26 September 2024, which also shows possible military vehicles operating around the roadblock, the vehicles have moved by late 2024.

The observed military activity is in line with online reports, suggesting that fighting could have been happening within this area ([Dabanga Sudan, 2024](#))

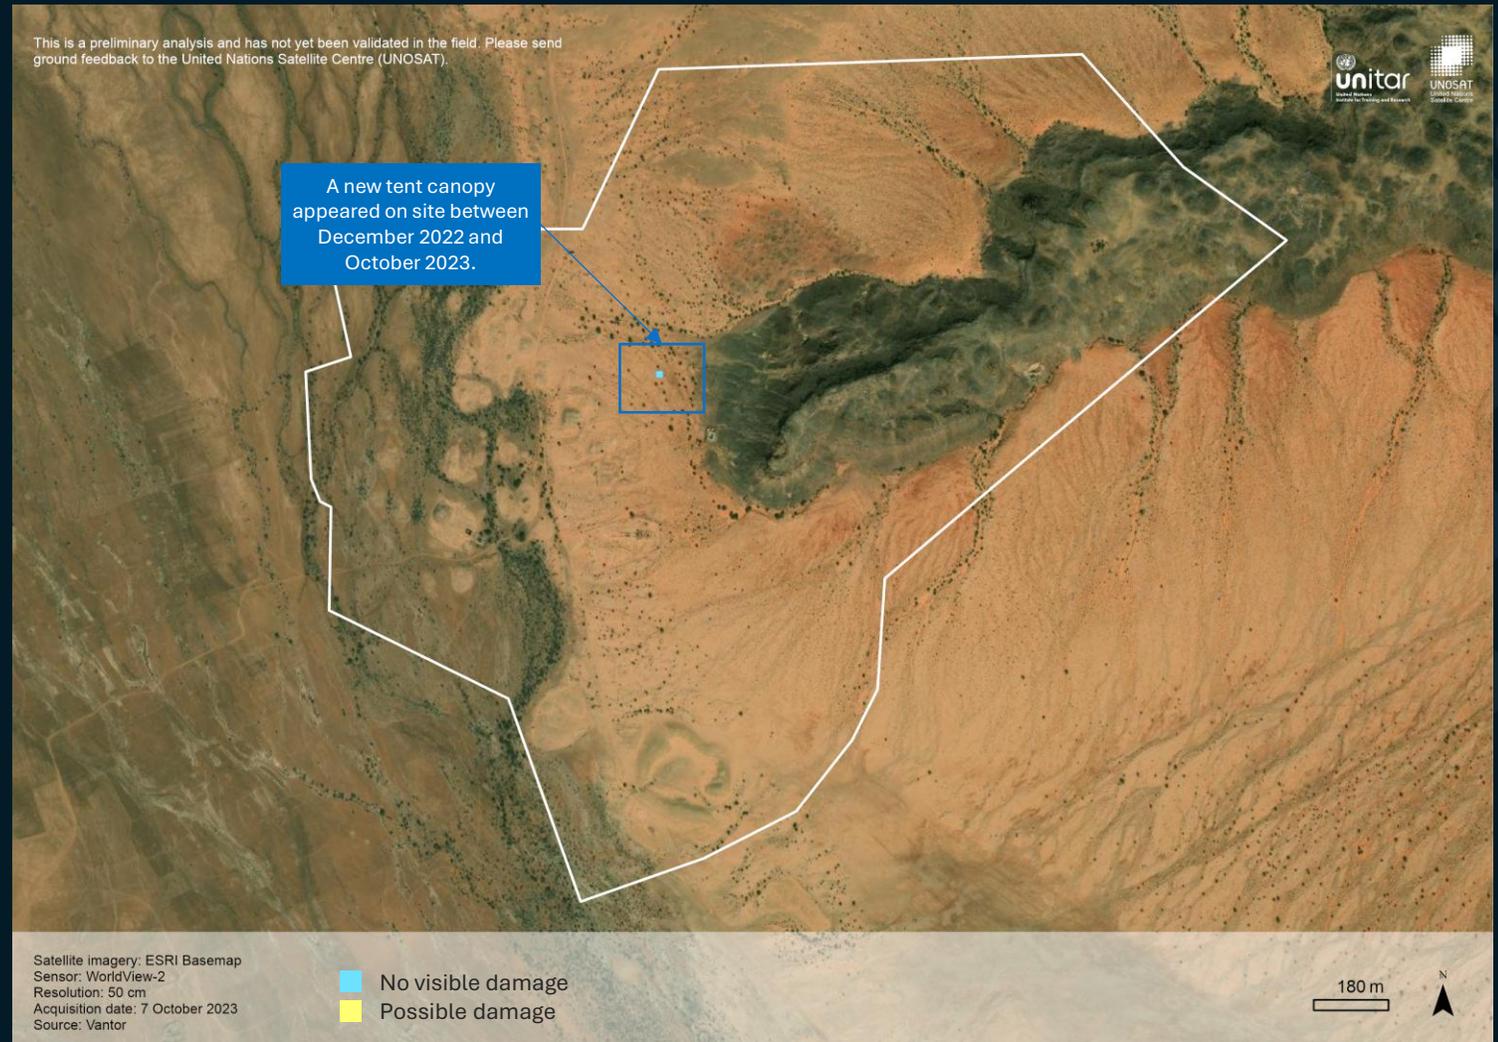
3. Naqa - Archaeological Sites of the Island of Meroë

This page illustrates damage observed from a very-high resolution image captured by a WorldView-2 satellite on the 7 October 2023.

Within the analysed area, one location showed changes of no visible damage. This was due to a new tent canopy appearing on the site between December 2022 and October 2023.

No other change or damage was visible on the site.

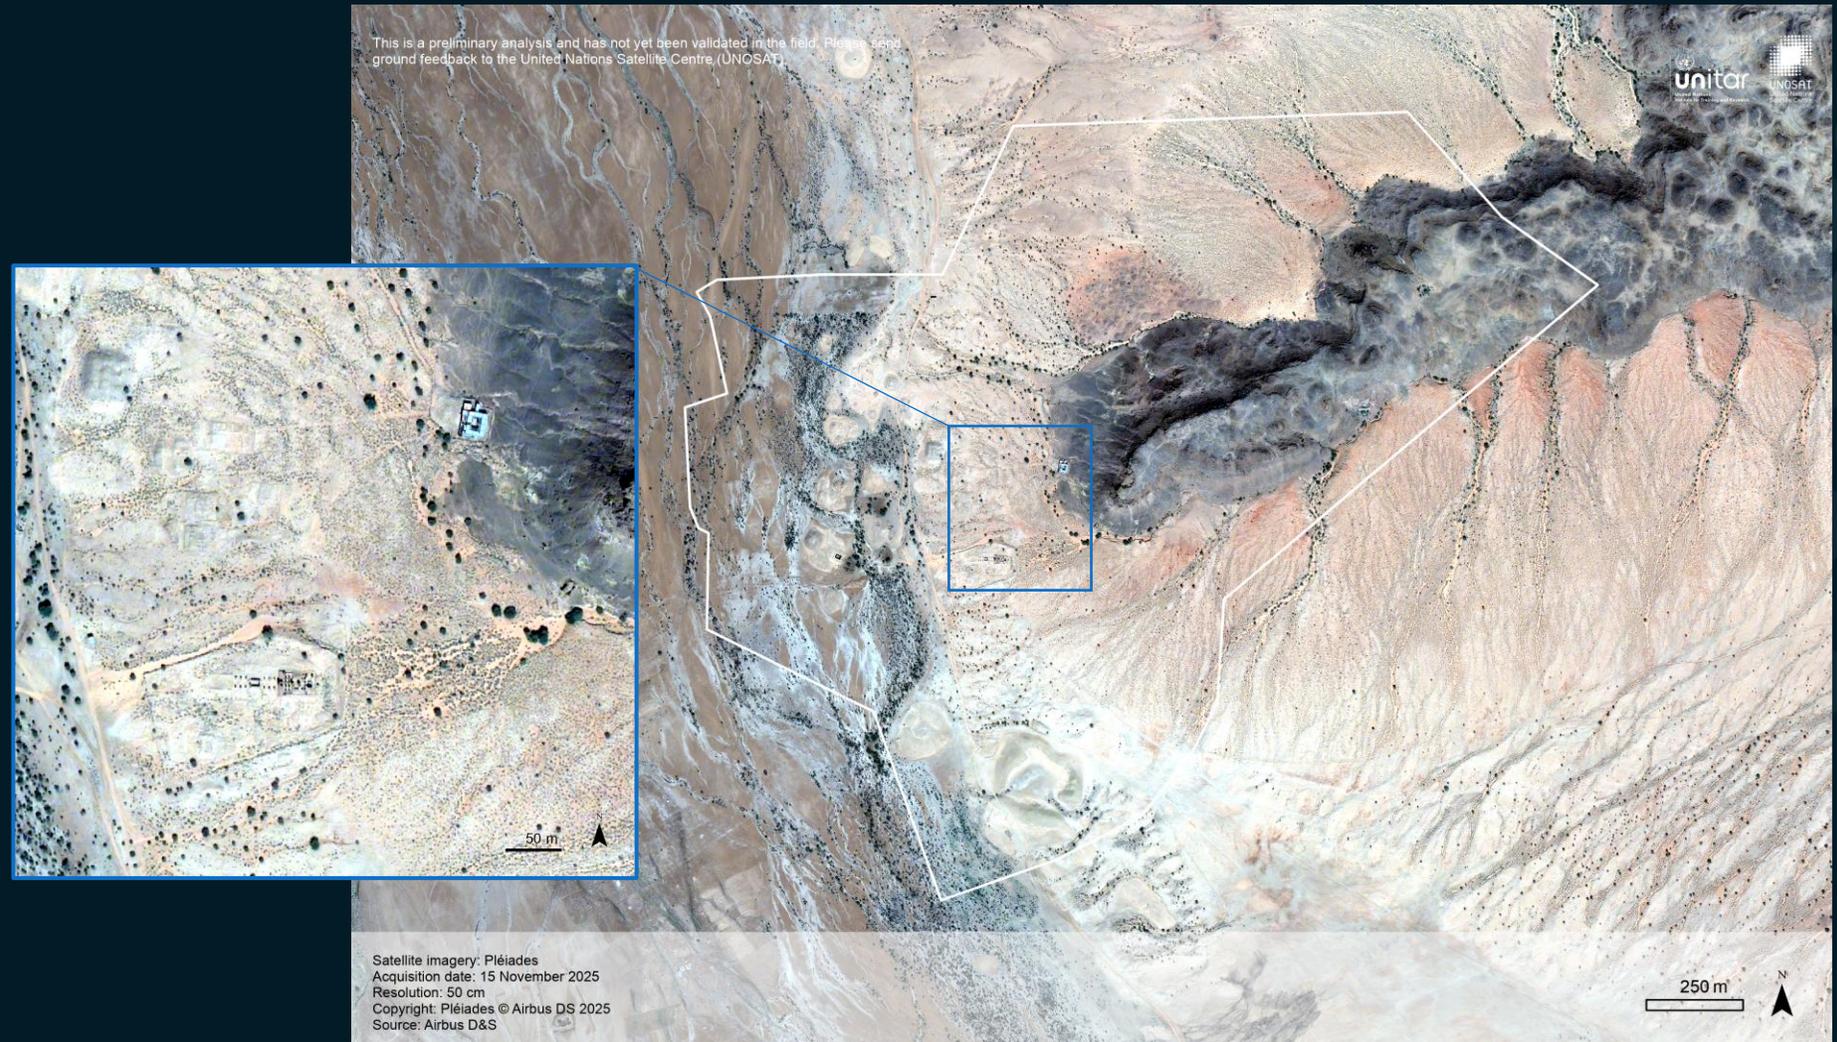
3. Naqa - Archaeological Sites of the Island of Meroë

This page illustrates damage observed from a very-high resolution image captured by a Pléiades satellite on the 15 November 2024.

Within the analysed area, no visible damage has been detected and no direct evidence of military presence was detected on the site.

Possible indirect evidence of military activity was observed approx. 2-3km south of Naqa. This was present in the form of earth movements and heavy vehicle tracks. The markings first appeared on imagery from October 2023 and have expanded by November 2024.

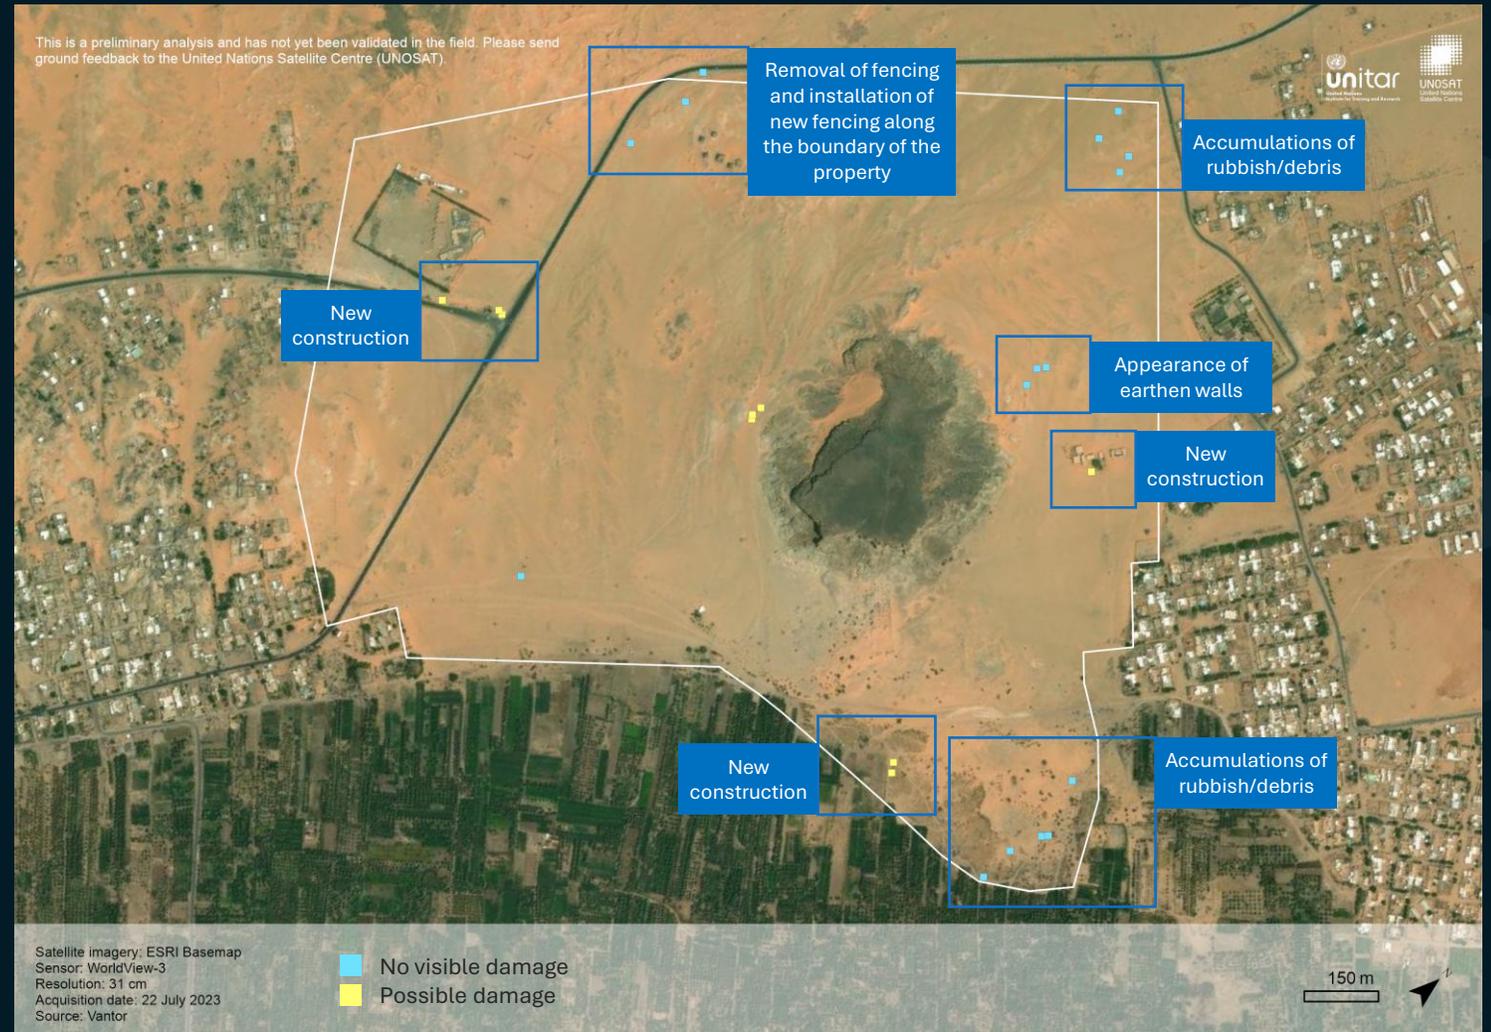
This page illustrates damage observed from a very-high resolution image captured by a WorldView-3 satellite on the 12 July 2024.

Within the analysed area, 19 locations showed changes with no visible damage, while 9 locations exhibited indications of possible damage.

Several areas with no visible damage displayed accumulations of rubbish or debris. Additionally, the site fence has been removed and new fencing along the property boundary looks to be installed.

Instances of possible damage were identified where new structures or fences had been constructed on the site, as such activities may disturb or impact any shallow archaeological layers.

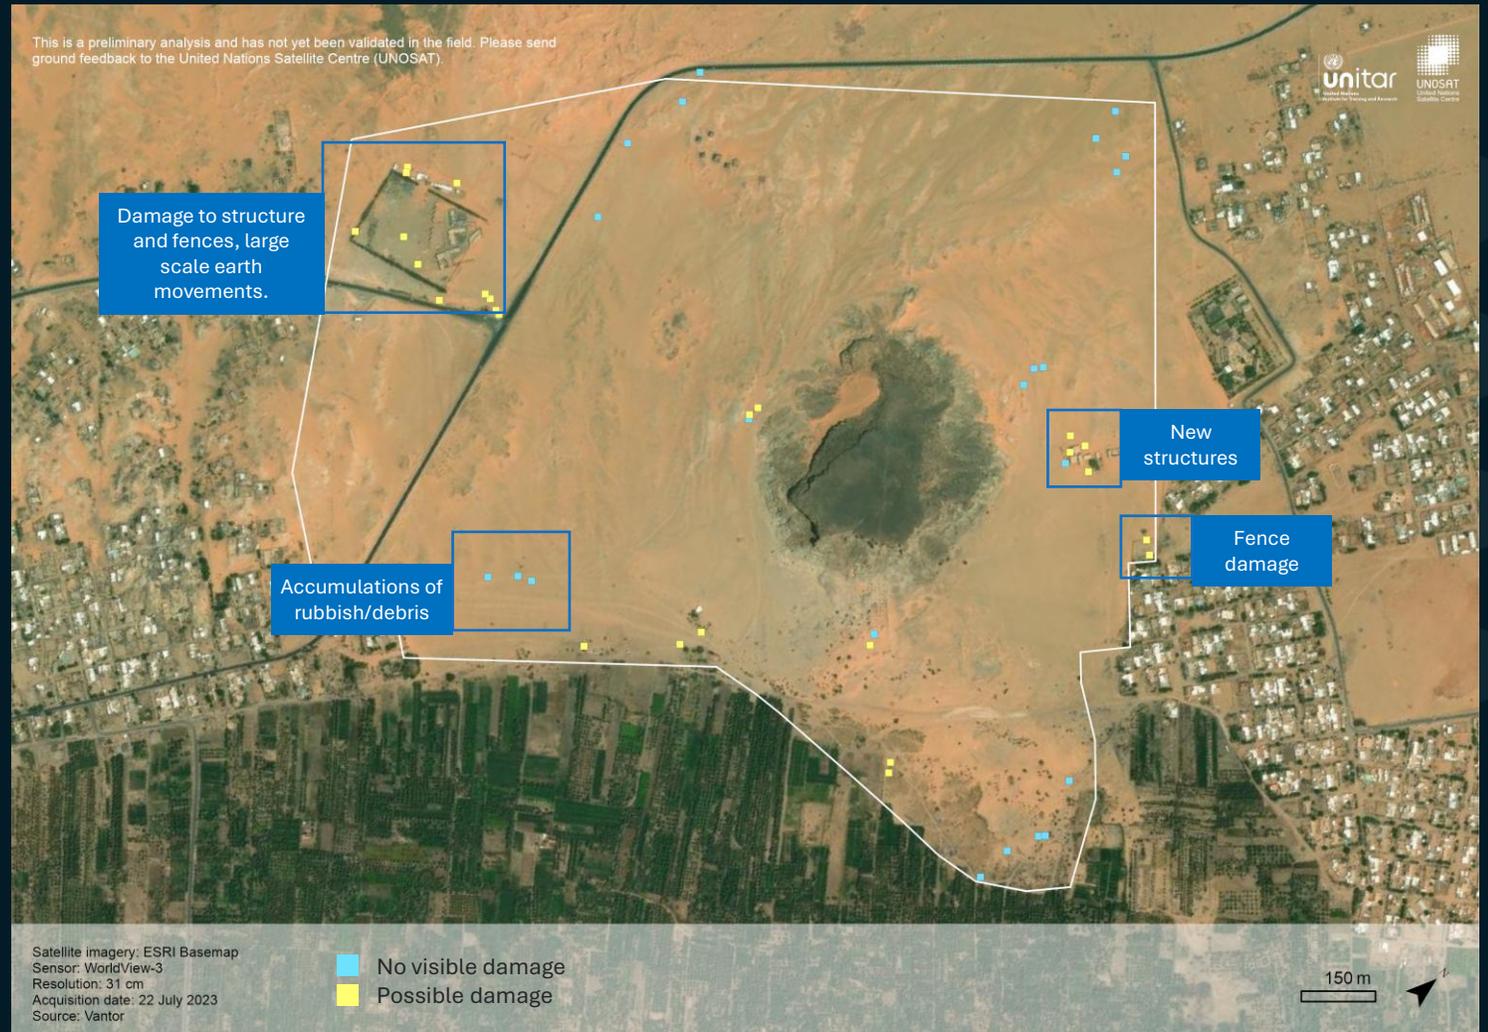
1. Gebel Barkal - Gebel Barkal and the Sites of the Napatan Region

This page illustrates damage observed from a very-high resolution image captured by a WorldView-3 satellite on the 3 March 2025.

Since the last assessment, there has been an increase in possible damage locations, with 22 no visible damage and 25 possible damage points.

Several areas with no visible damage displayed accumulations of rubbish or debris, in both the same and different locations to the previous assessment.

Instances of possible damage were identified where new structures or fences had been constructed or removed/damaged on the site, as such activities may disturb or impact any shallow archaeological layers.

There were several instances of possible damage to fences, as well as observed earth movement within the site.

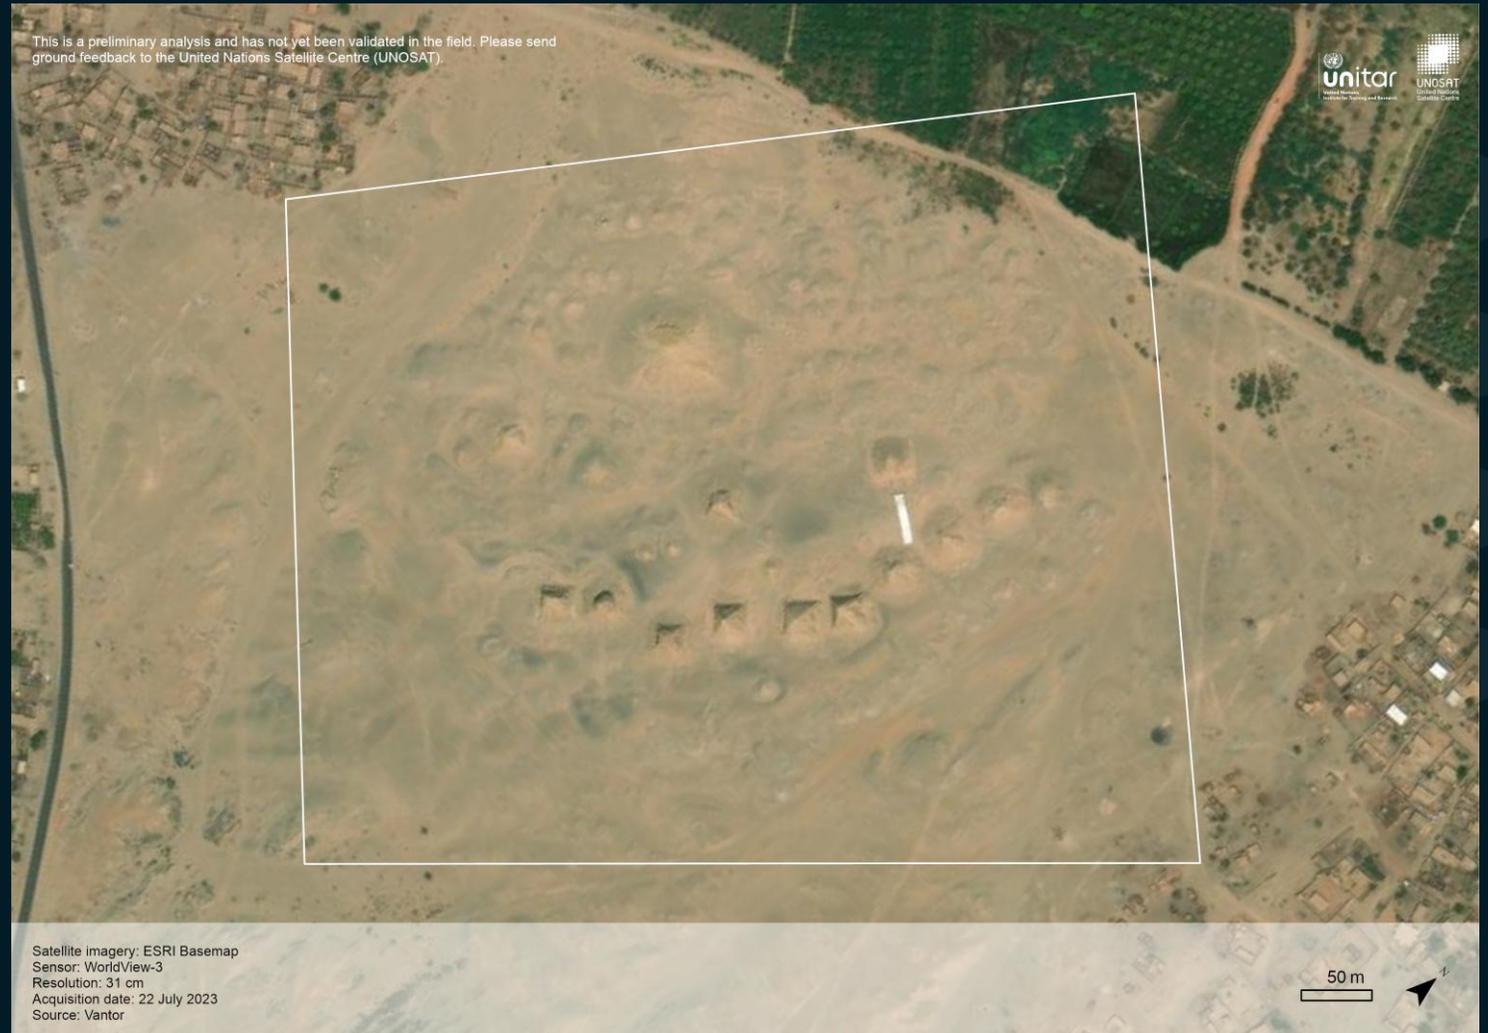
2. Nuri - Gebel Barkal and the Sites of the Napatan Region

This page illustrates damage observed from a very-high resolution image captured by a WorldView-3 satellite on the 12 July 2024.

Within the analysed area there was no visible damage observed.

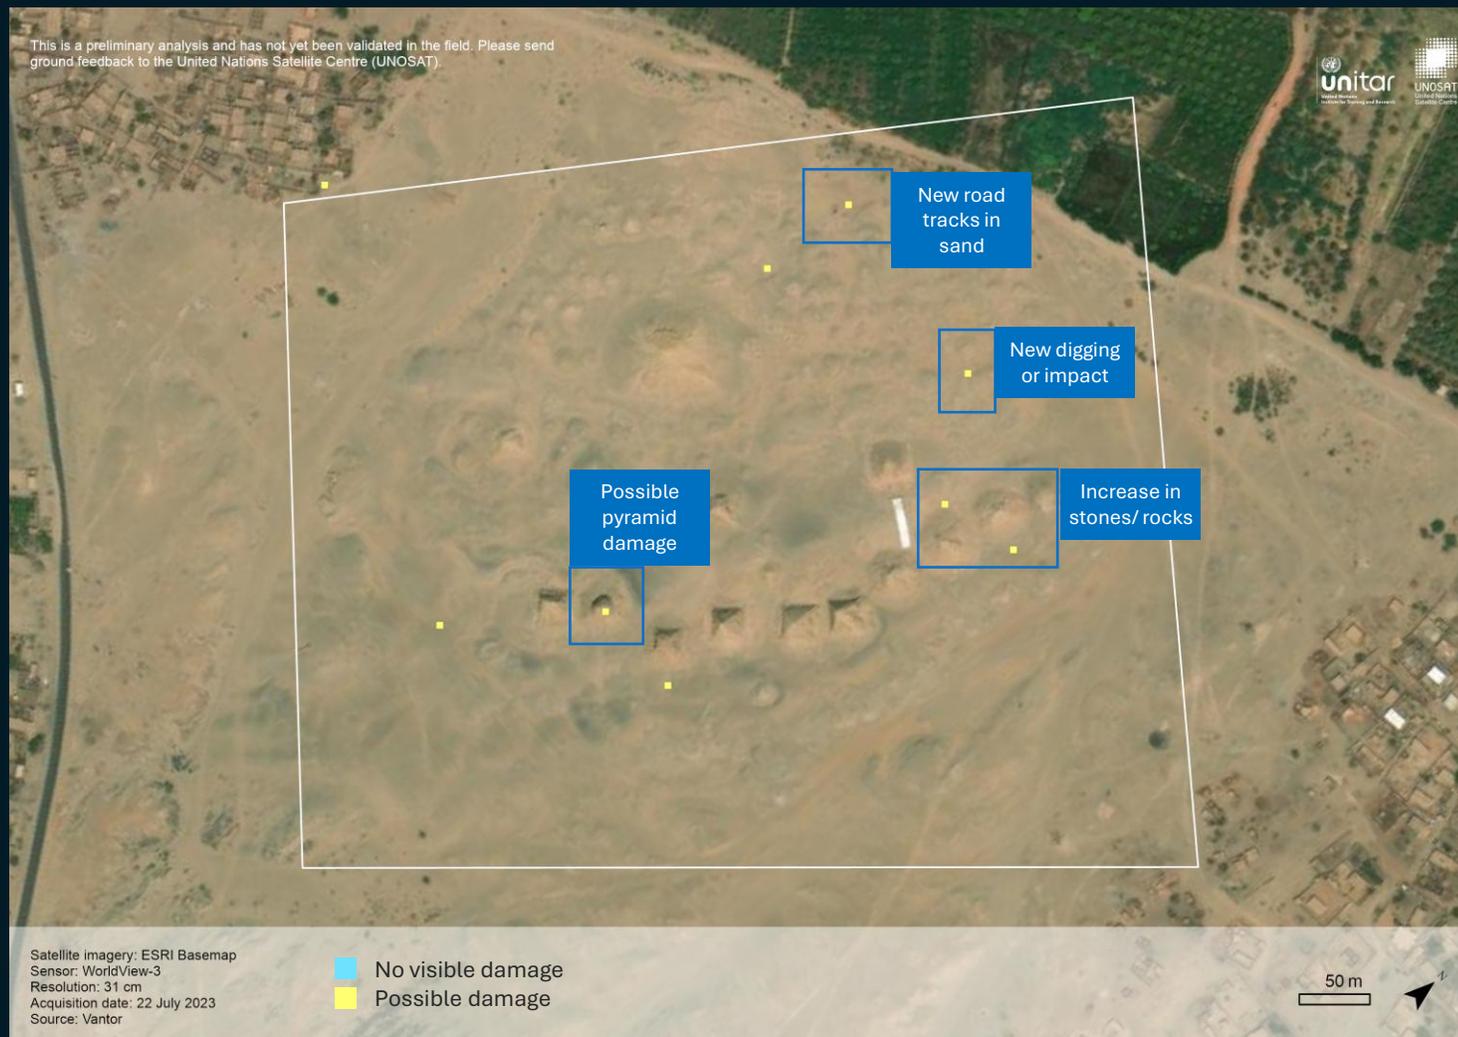
2. Nuri - Gebel Barkal and the Sites of the Napatan Region

The possible damage to a pyramid detected, as marked on the map, may be due to erosion or weather-related events.

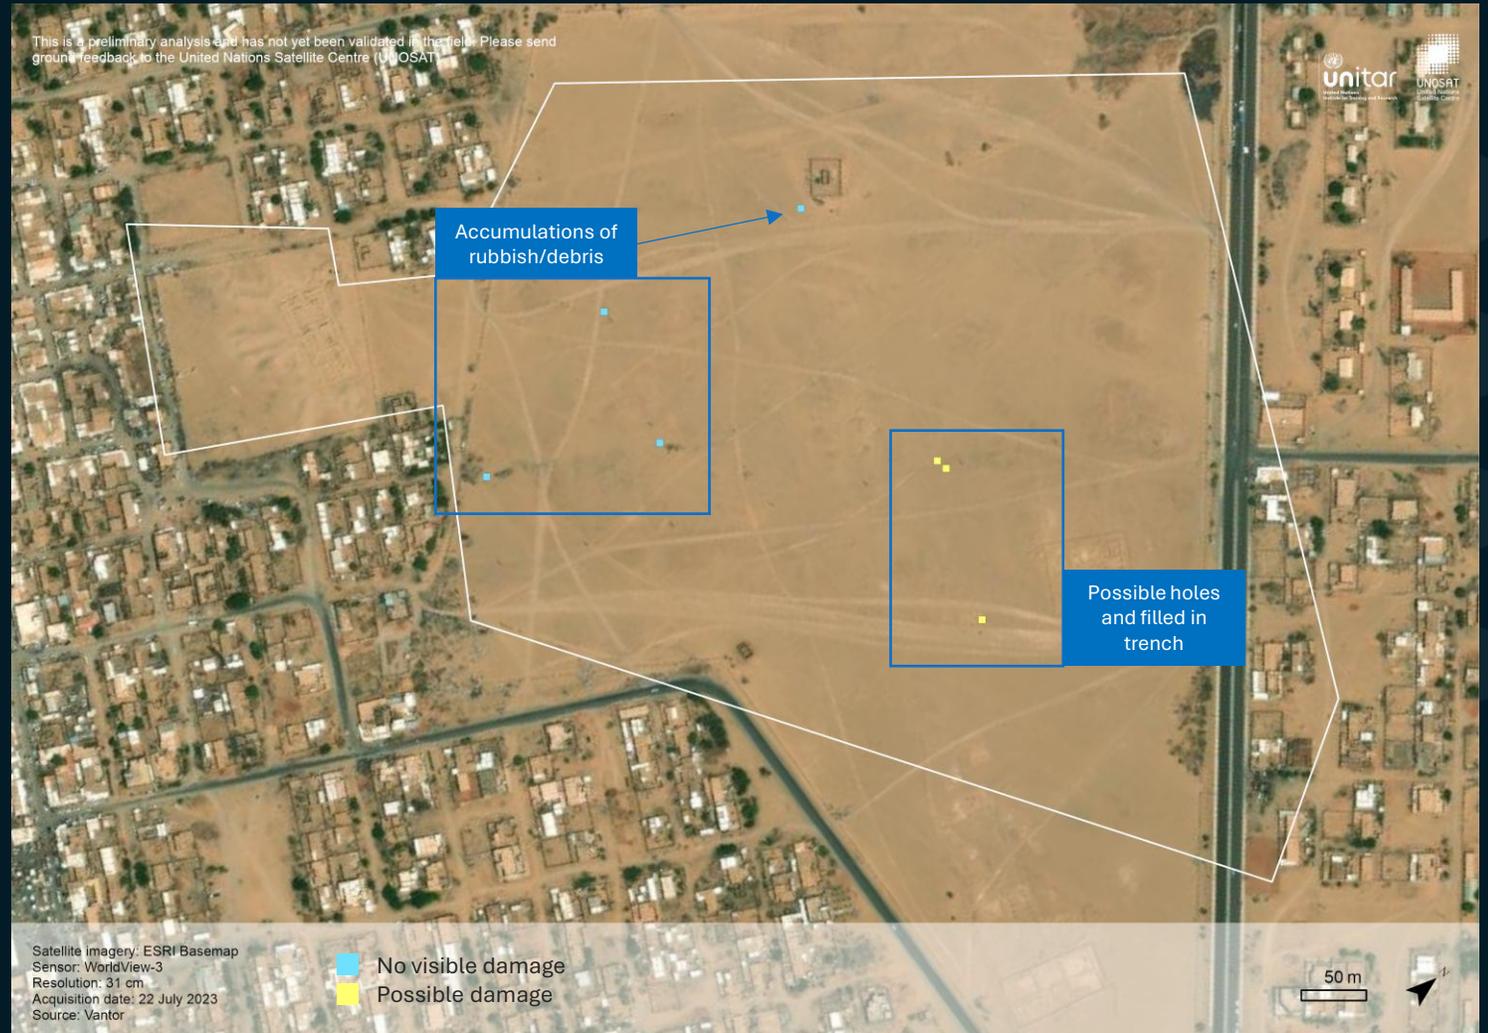
3. Sanam - Gebel Barkal and the Sites of the Napatan Region

Instances of possible damage were identified with possible holes and a filled in trench observed in the earth, as such activities may disturb or impact archaeological layers.

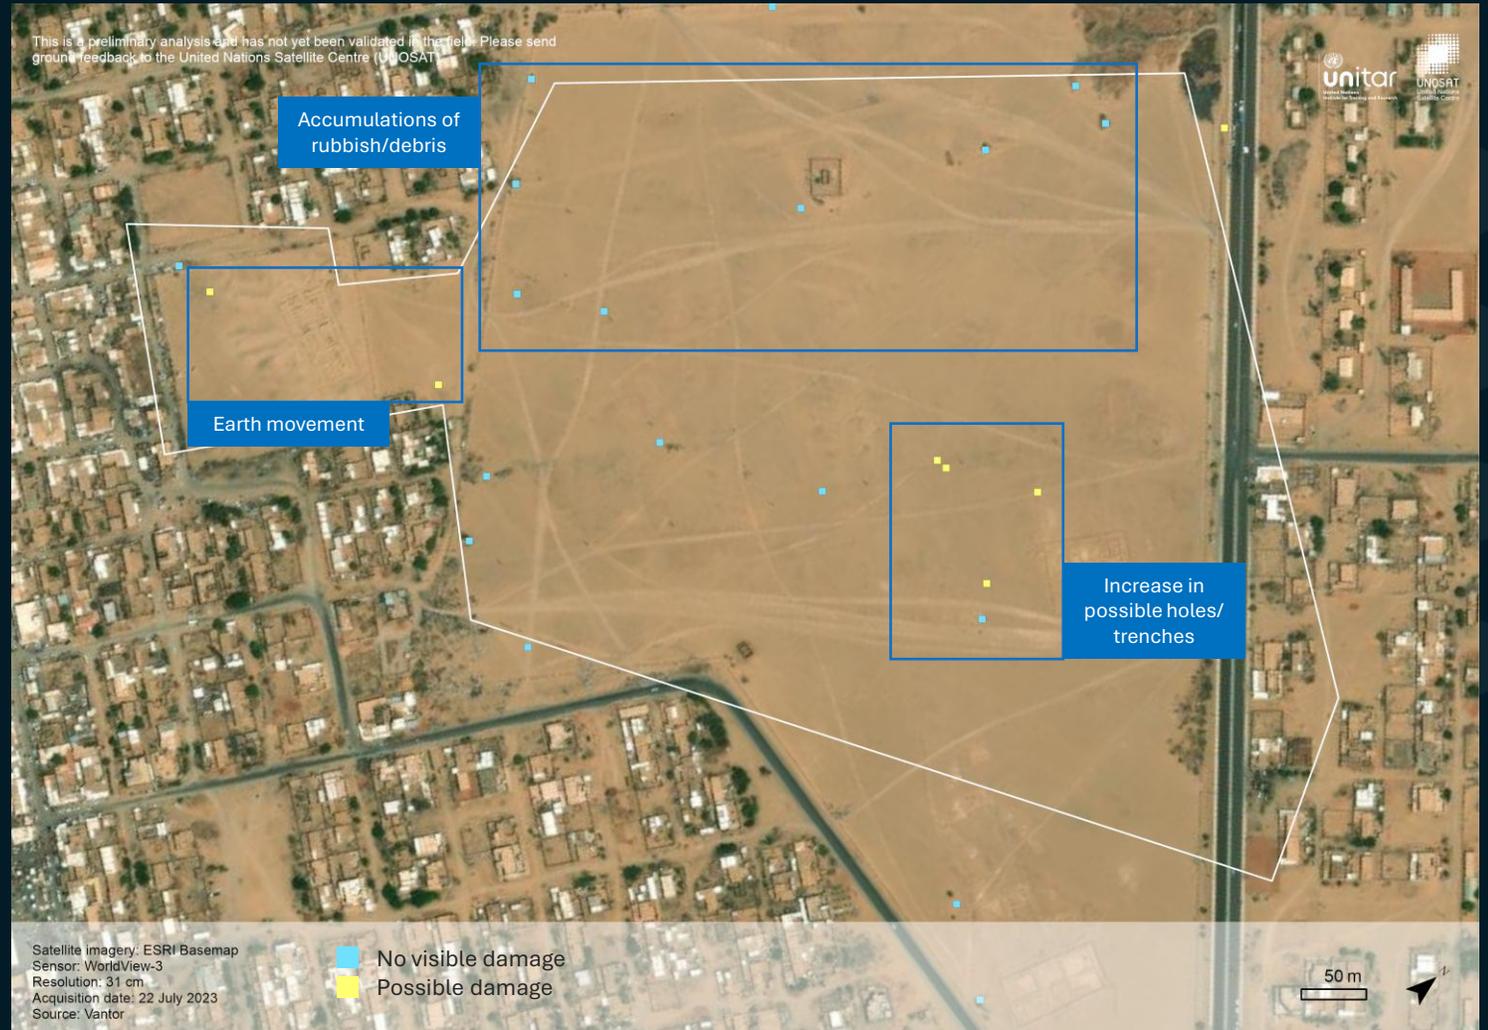
3. Sanam - Gebel Barkal and the Sites of the Napatan Region

Instances of possible damage were identified with earth movements, including an increase of new possible holes, as such activities may disturb or impact any shallow archaeological layers.

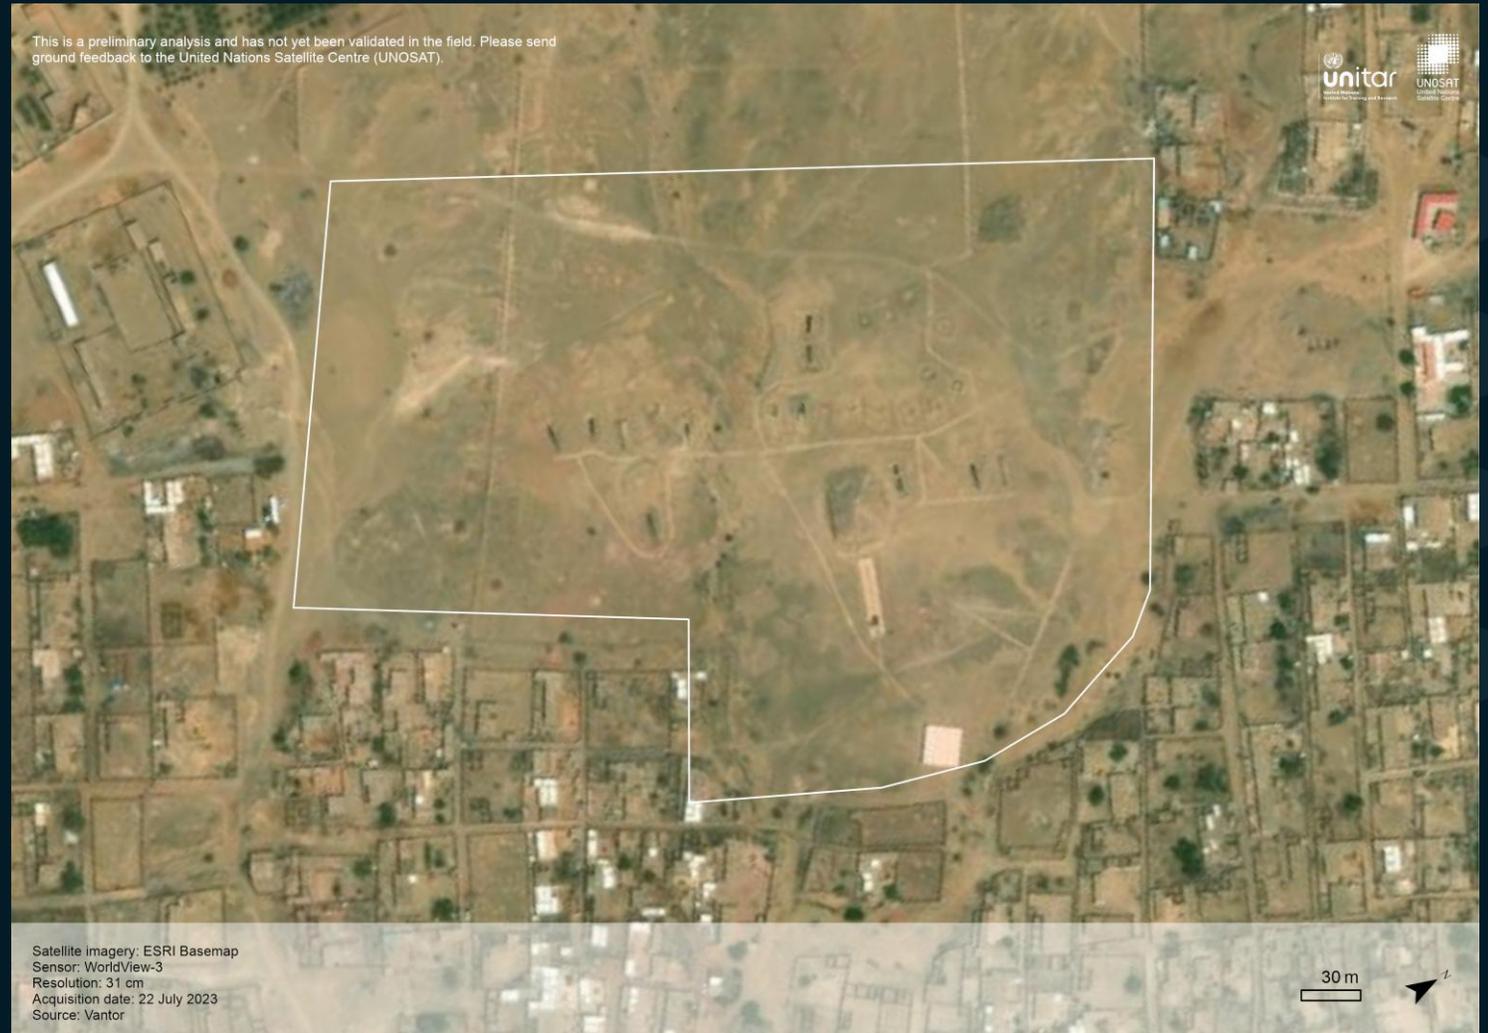
4. El-Kurru- Gebel Barkal and the Sites of the Napatan Region

Since the last assessment, there has been an increase of one possible damage point.

Instances of possible damage were identified as new fence construction, as such activities may disturb or impact any shallow archaeological layers.

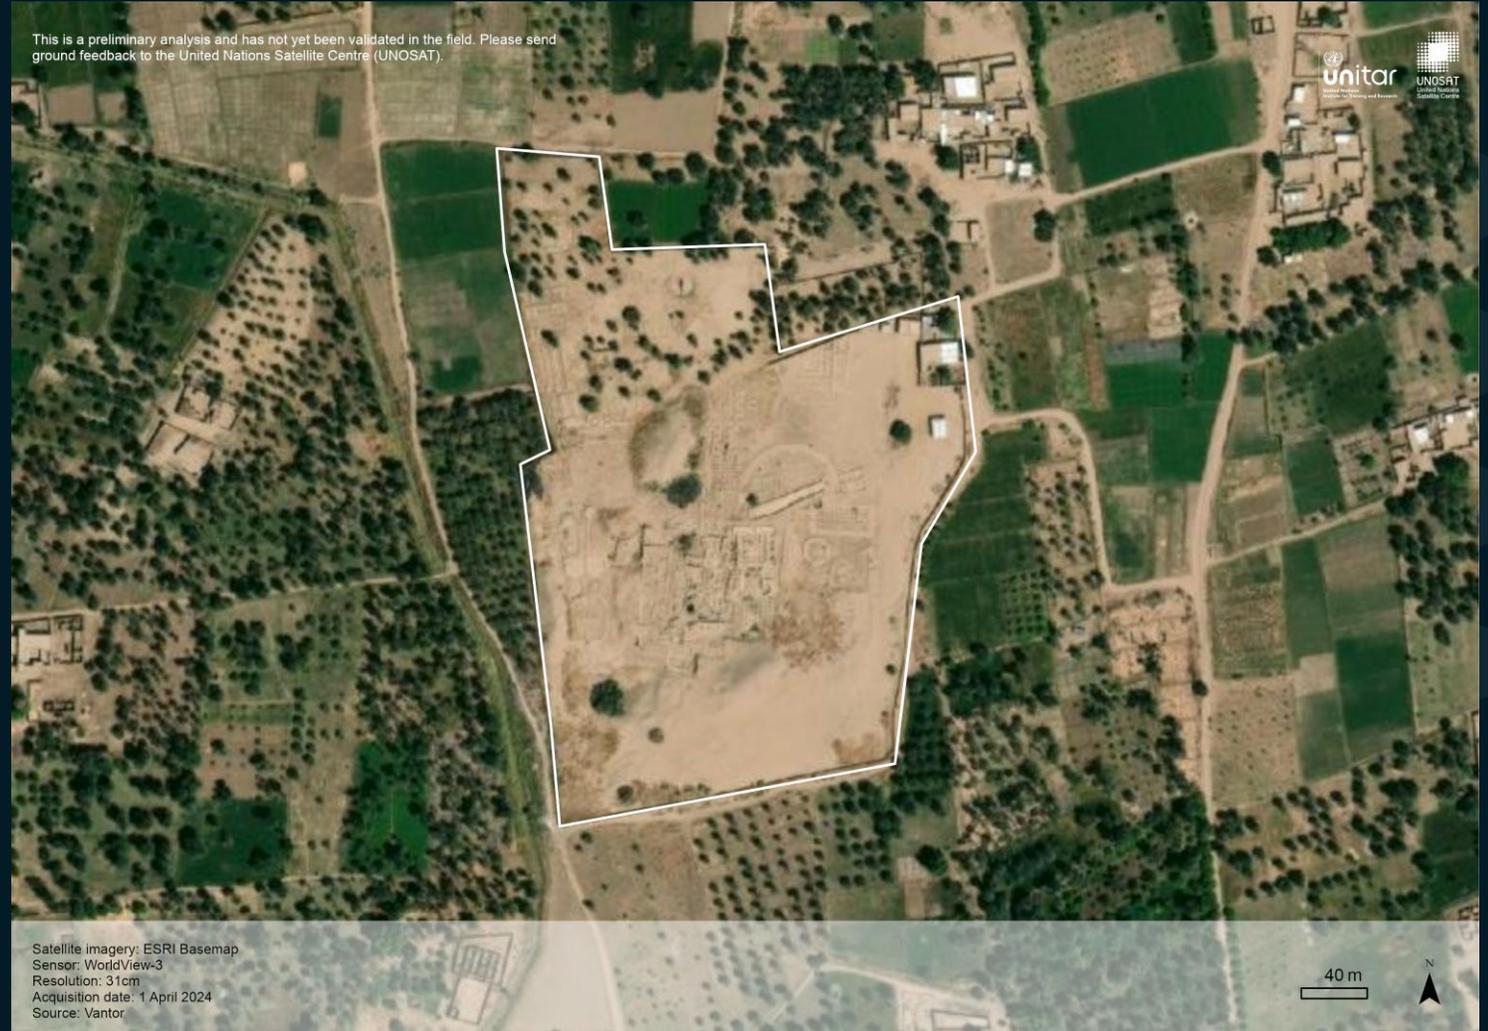
2. Kerma - The Monuments of the Kingdom of Kerma and Dokki Geil

This map illustrates the results of a damage assessment conducted using a very-high resolution image captured by a WorldView-3 satellite on the 13 November 2025.

Within the analysed area there was no visible damage observed to the site and no military activity observed within the direct vicinity of the site.

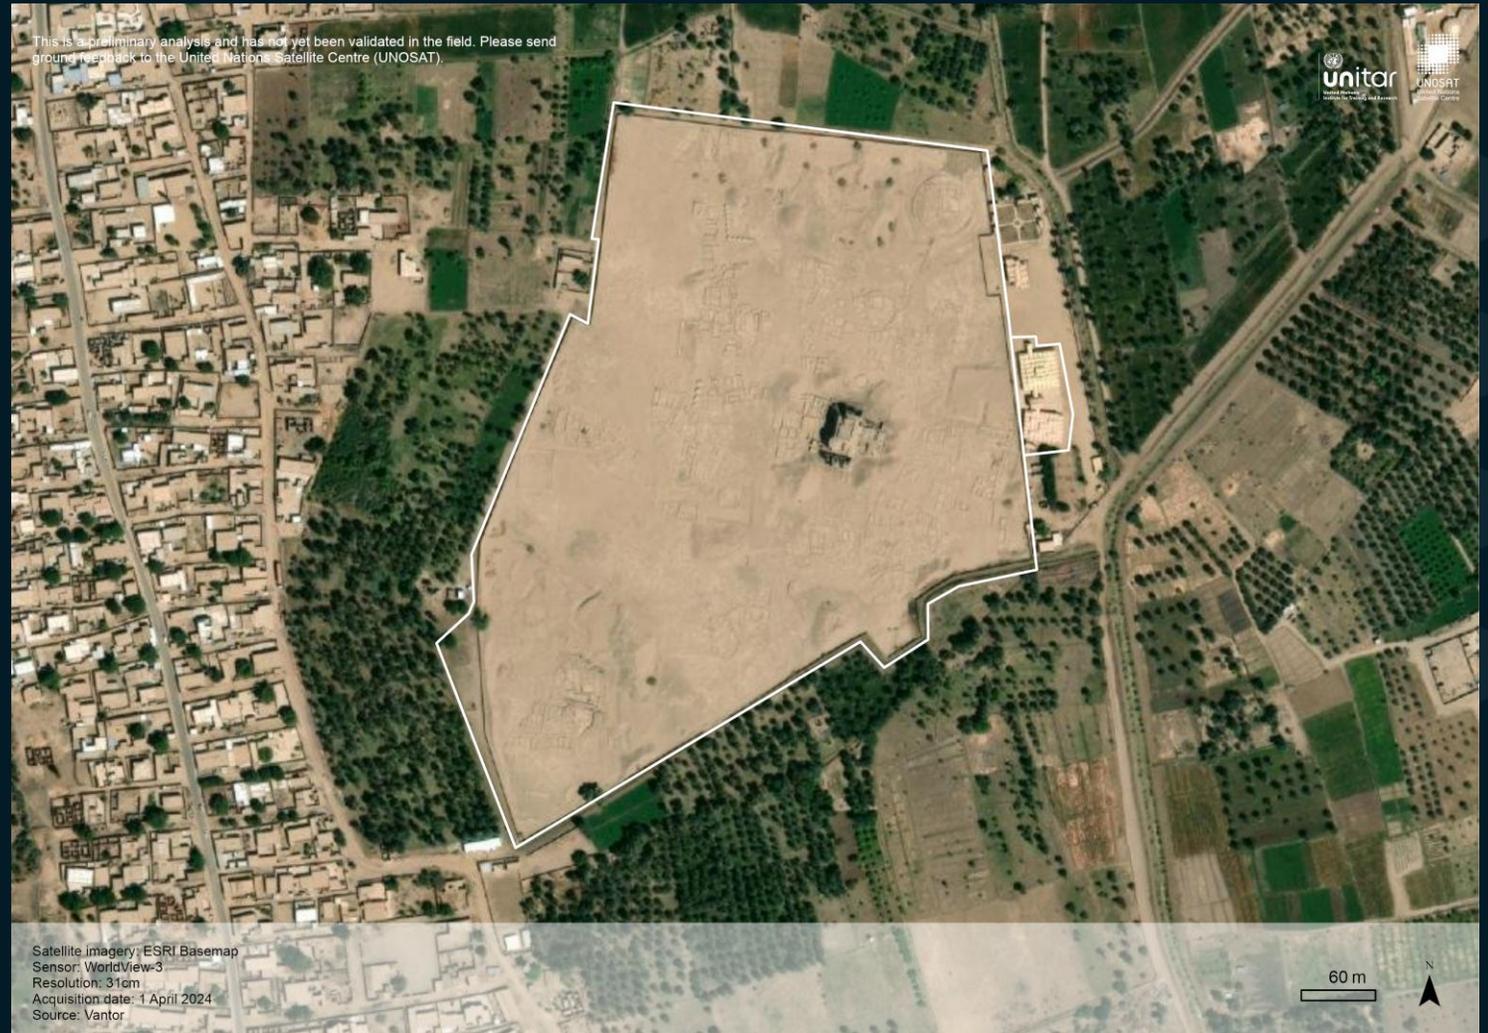
This page illustrates the results of a damage assessment conducted using a very-high resolution image captured by a WorldView-3 satellite on the 13 November 2025.

Within the analysed area there was no visible damage observed to the site and no military activity observed within the direct vicinity of the site.
