Satellite-based Damage Assessment

Sectoral Analysis: Cultural Heritage

Sudan

CE20231504SDN

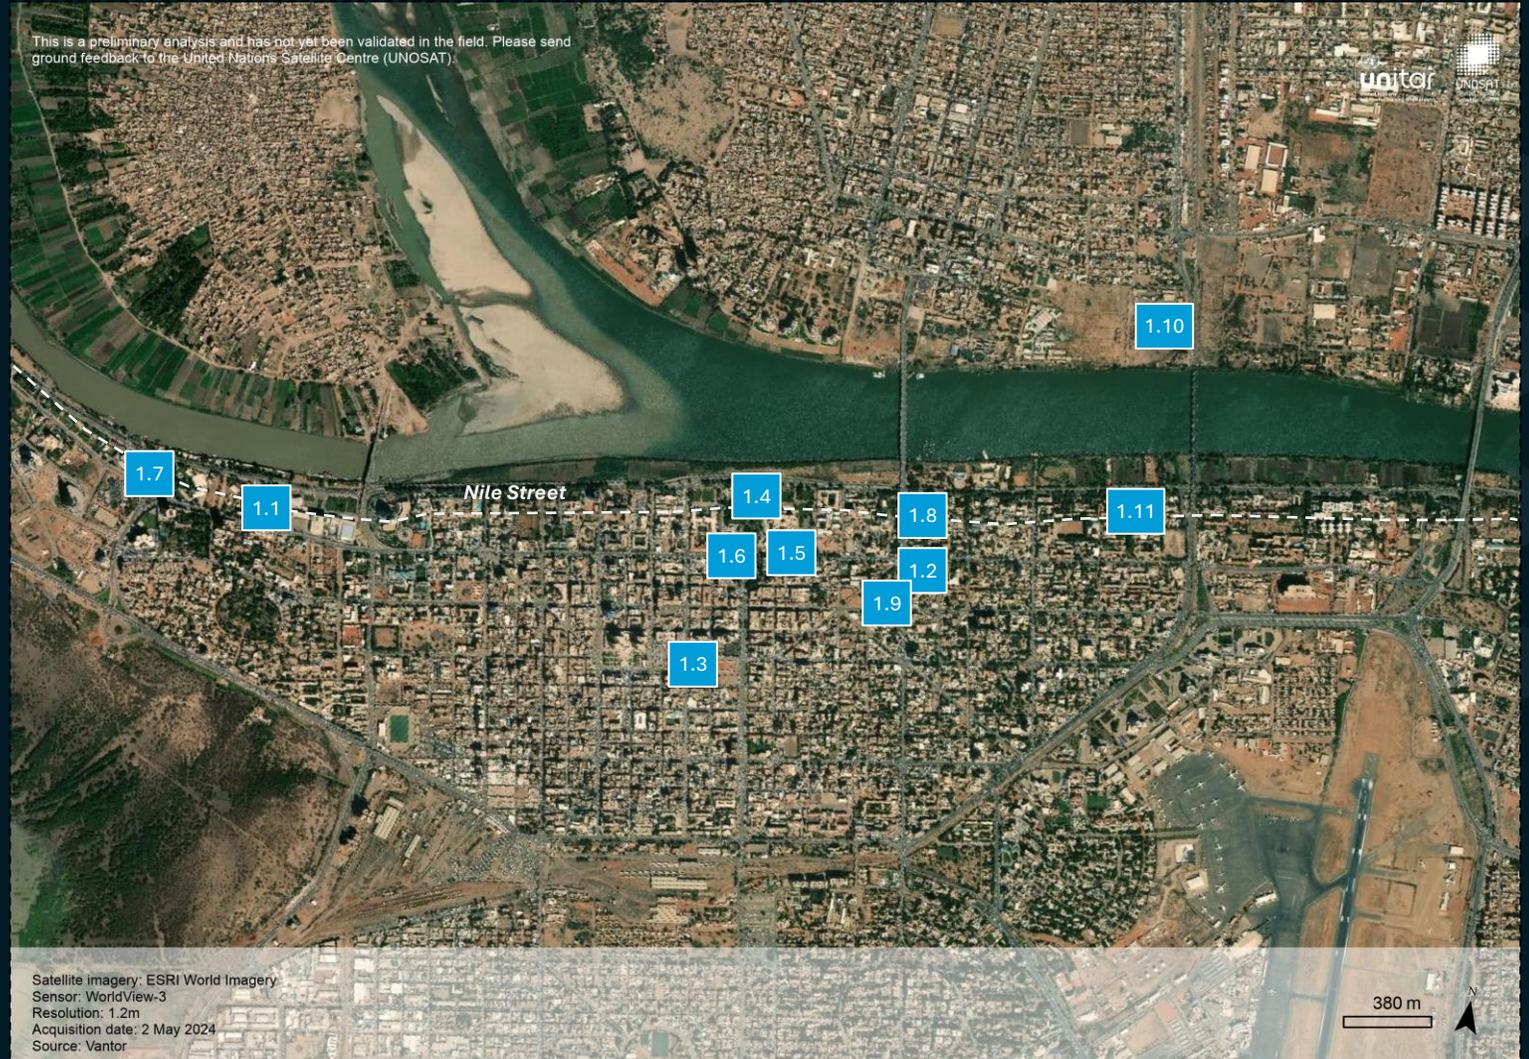
1.1 Sudan National Museum

This page illustrates damage observed from a very-high resolution image captured by a WorldView-2 satellite on the 12 November 2025. It shows damage to several museum buildings; debris is present outside the main museum building. Several buildings surrounding the museum have also been damaged or destroyed.

In addition, the museum grounds, such as gardens and trees look to have sustained damage.

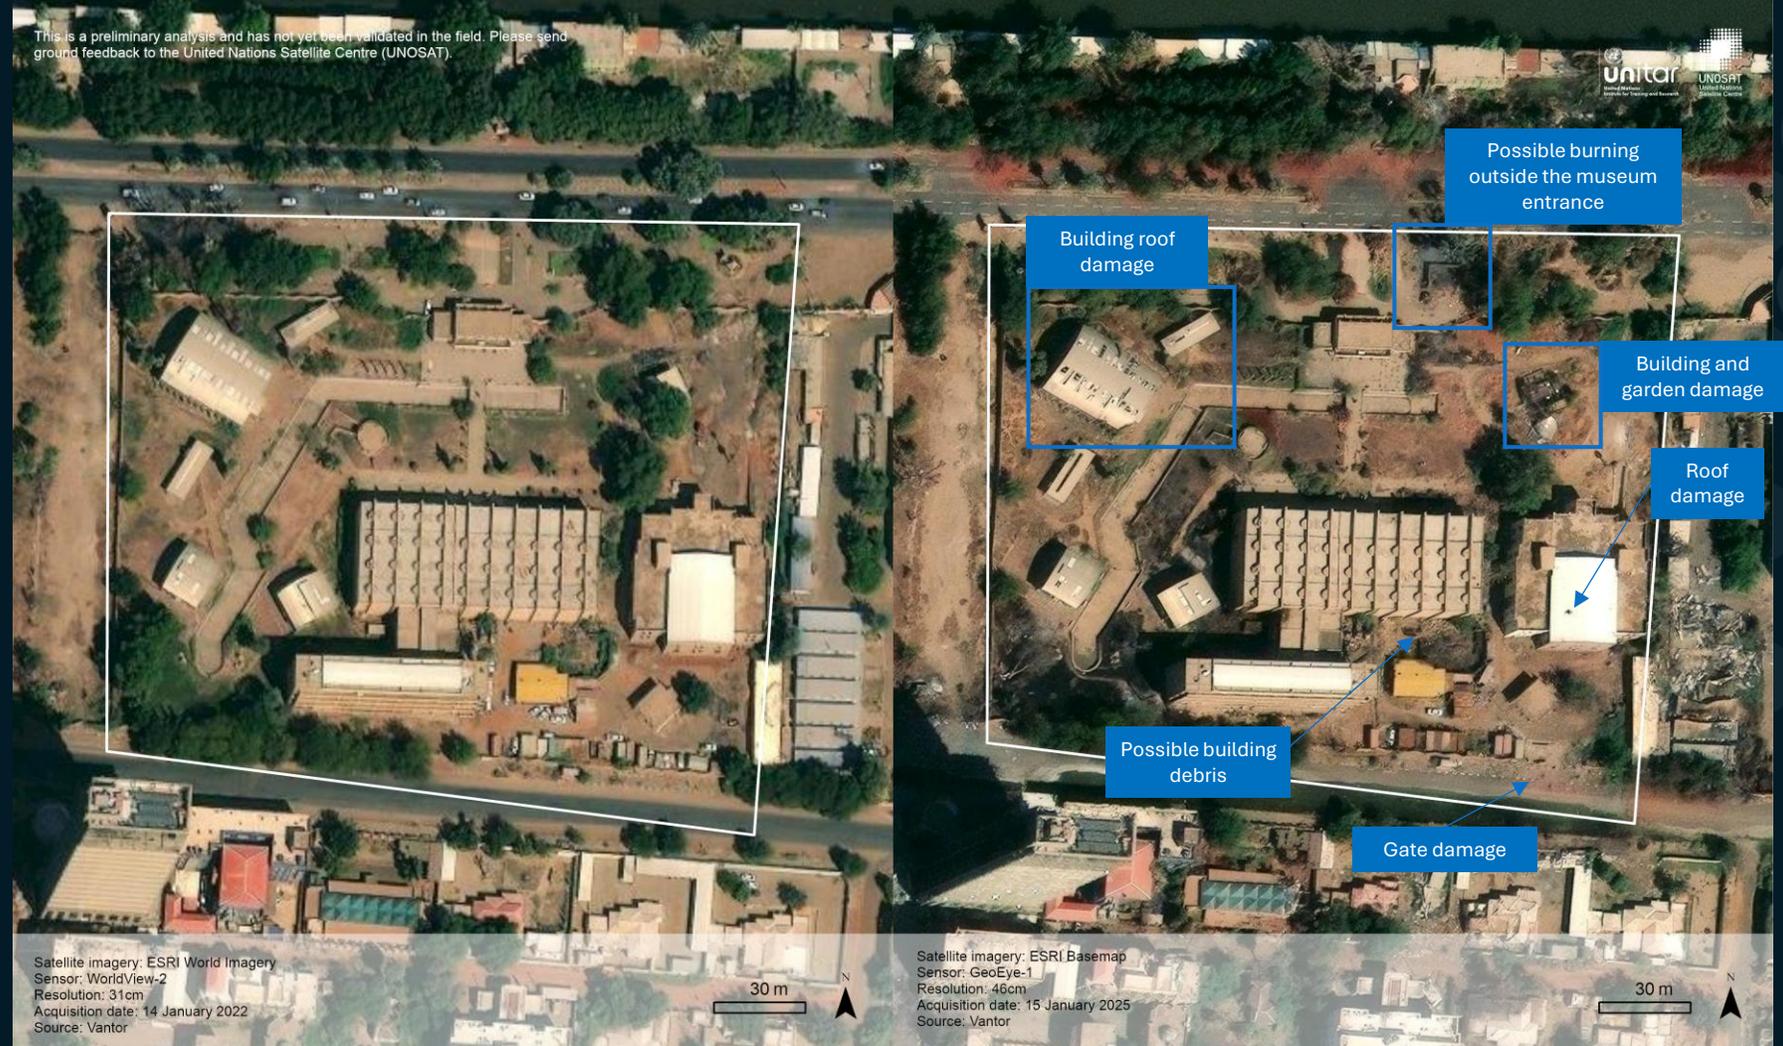
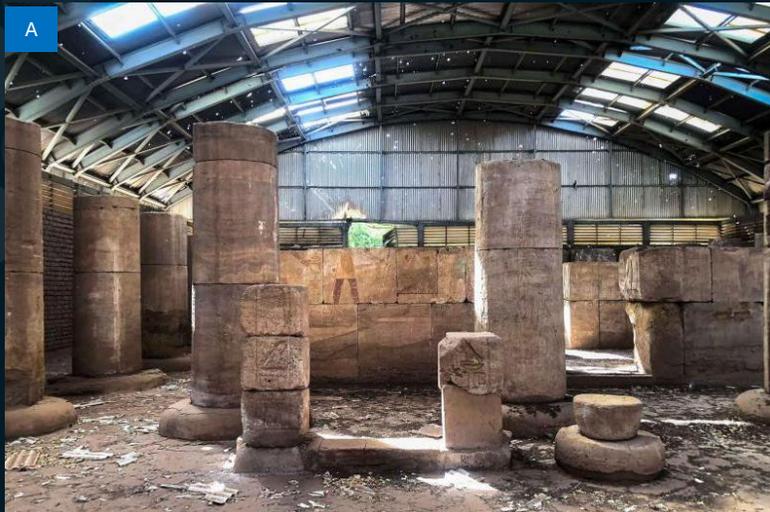
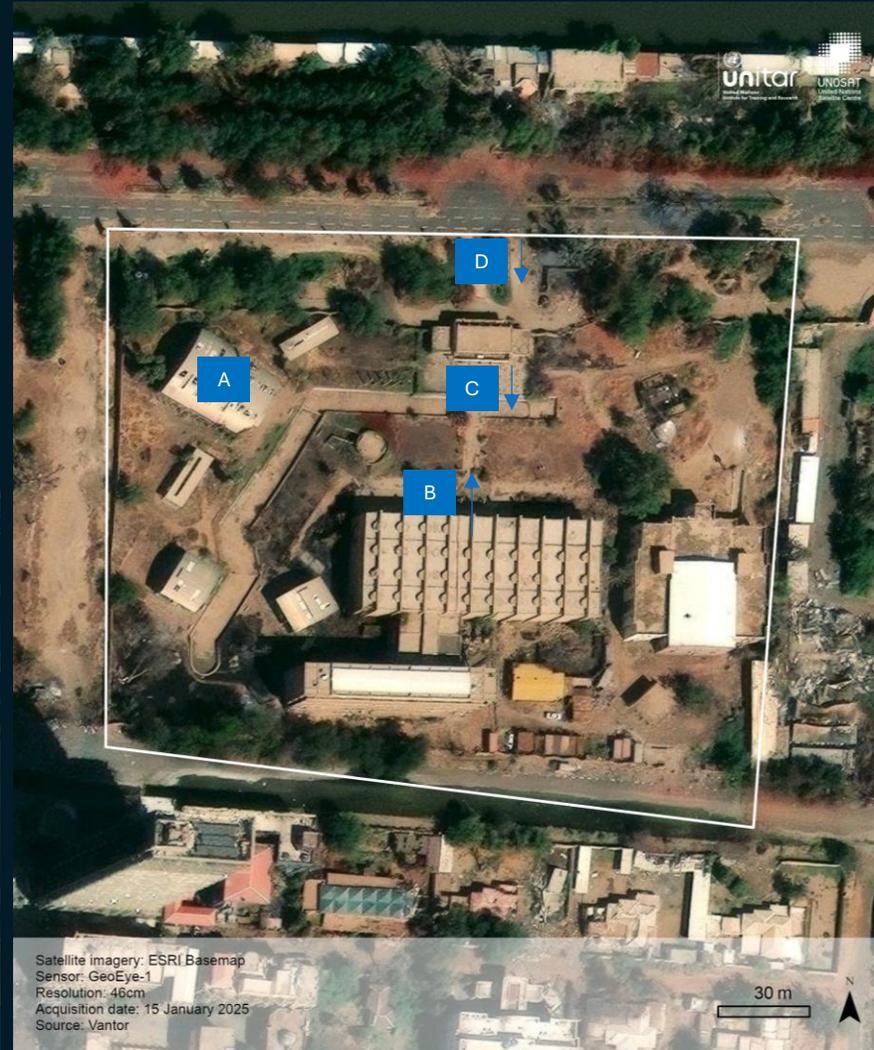
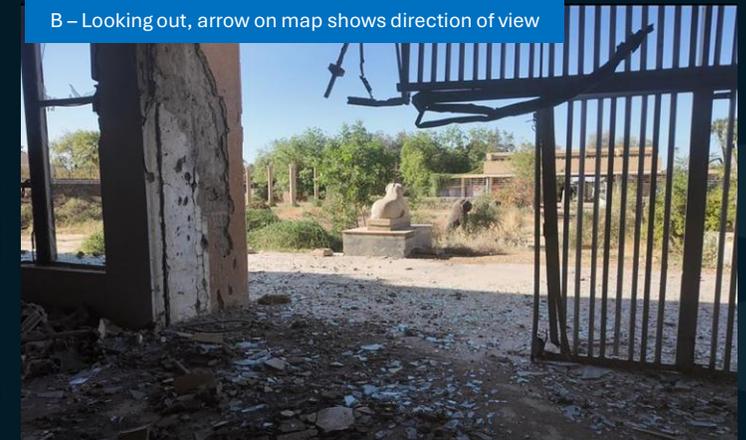
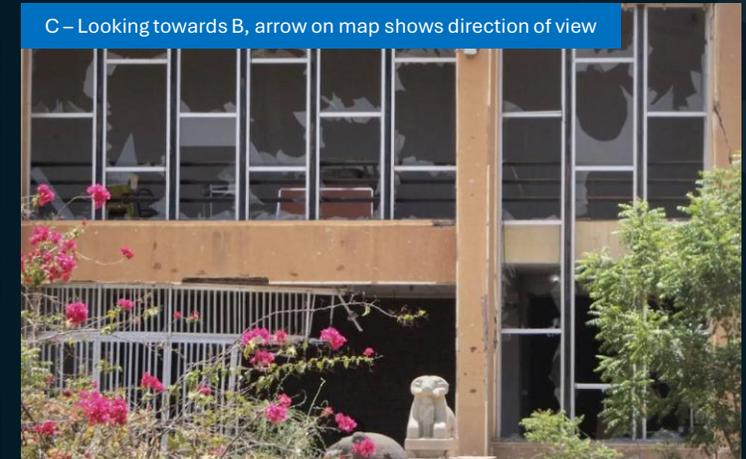
1.1 Sudan National Museum – Ground Images, 1

Ground photos help to identify and verify damage that has been identified through satellite imagery.

Photos taken by NCAM show damage from both outside and inside the Museum. Where possible UNOSAT has marked the likely locations of the photos on the satellite image.

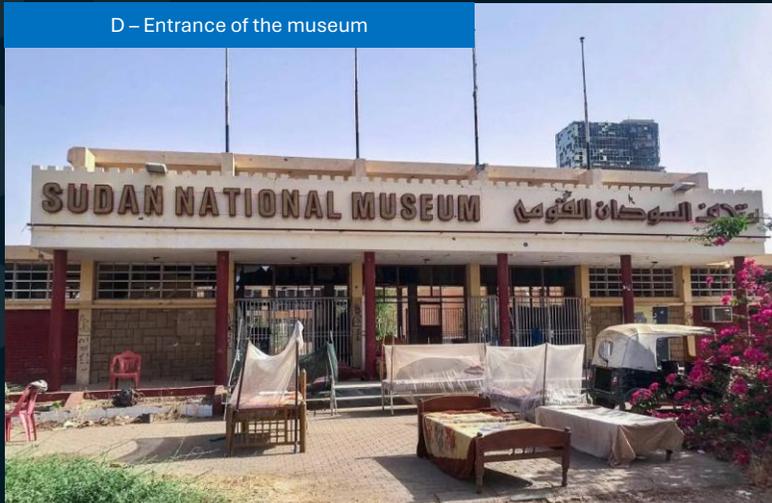
D – Entrance of the museum

Photos taken by NCAM show damage from both outside and inside the Museum. Where possible UNOSAT has marked the likely locations of the photos on the satellite image.

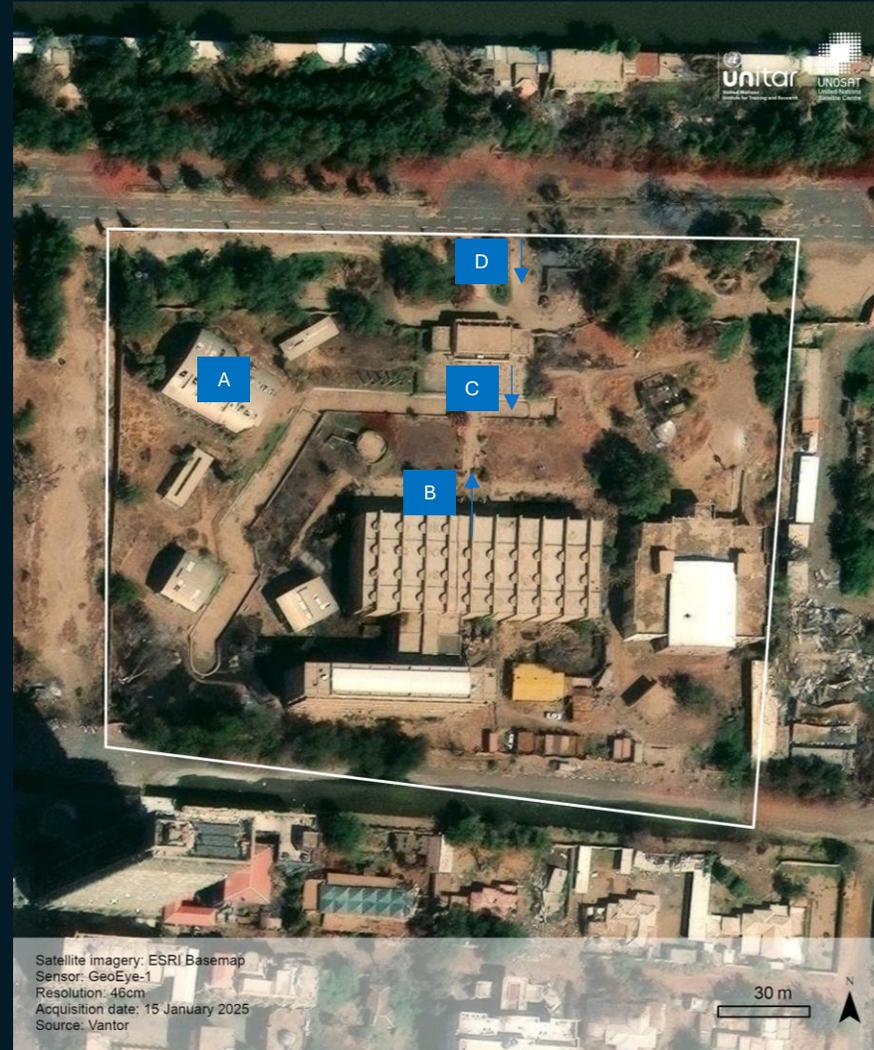
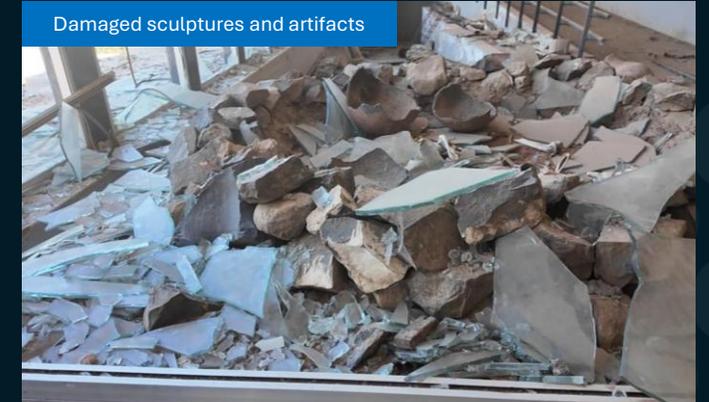
Damaged sculptures and artifacts

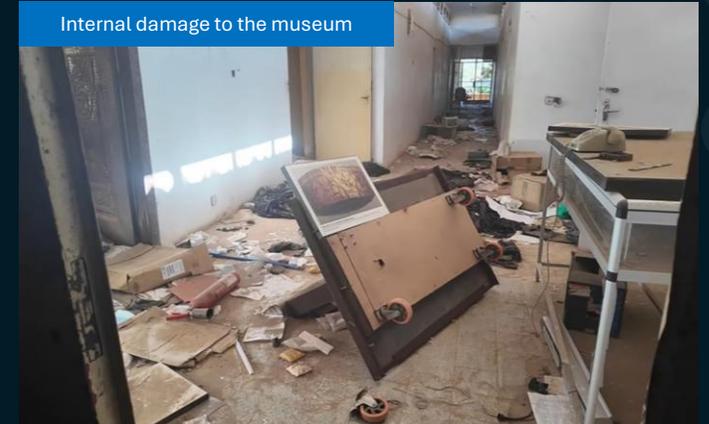
Internal damage to the museum

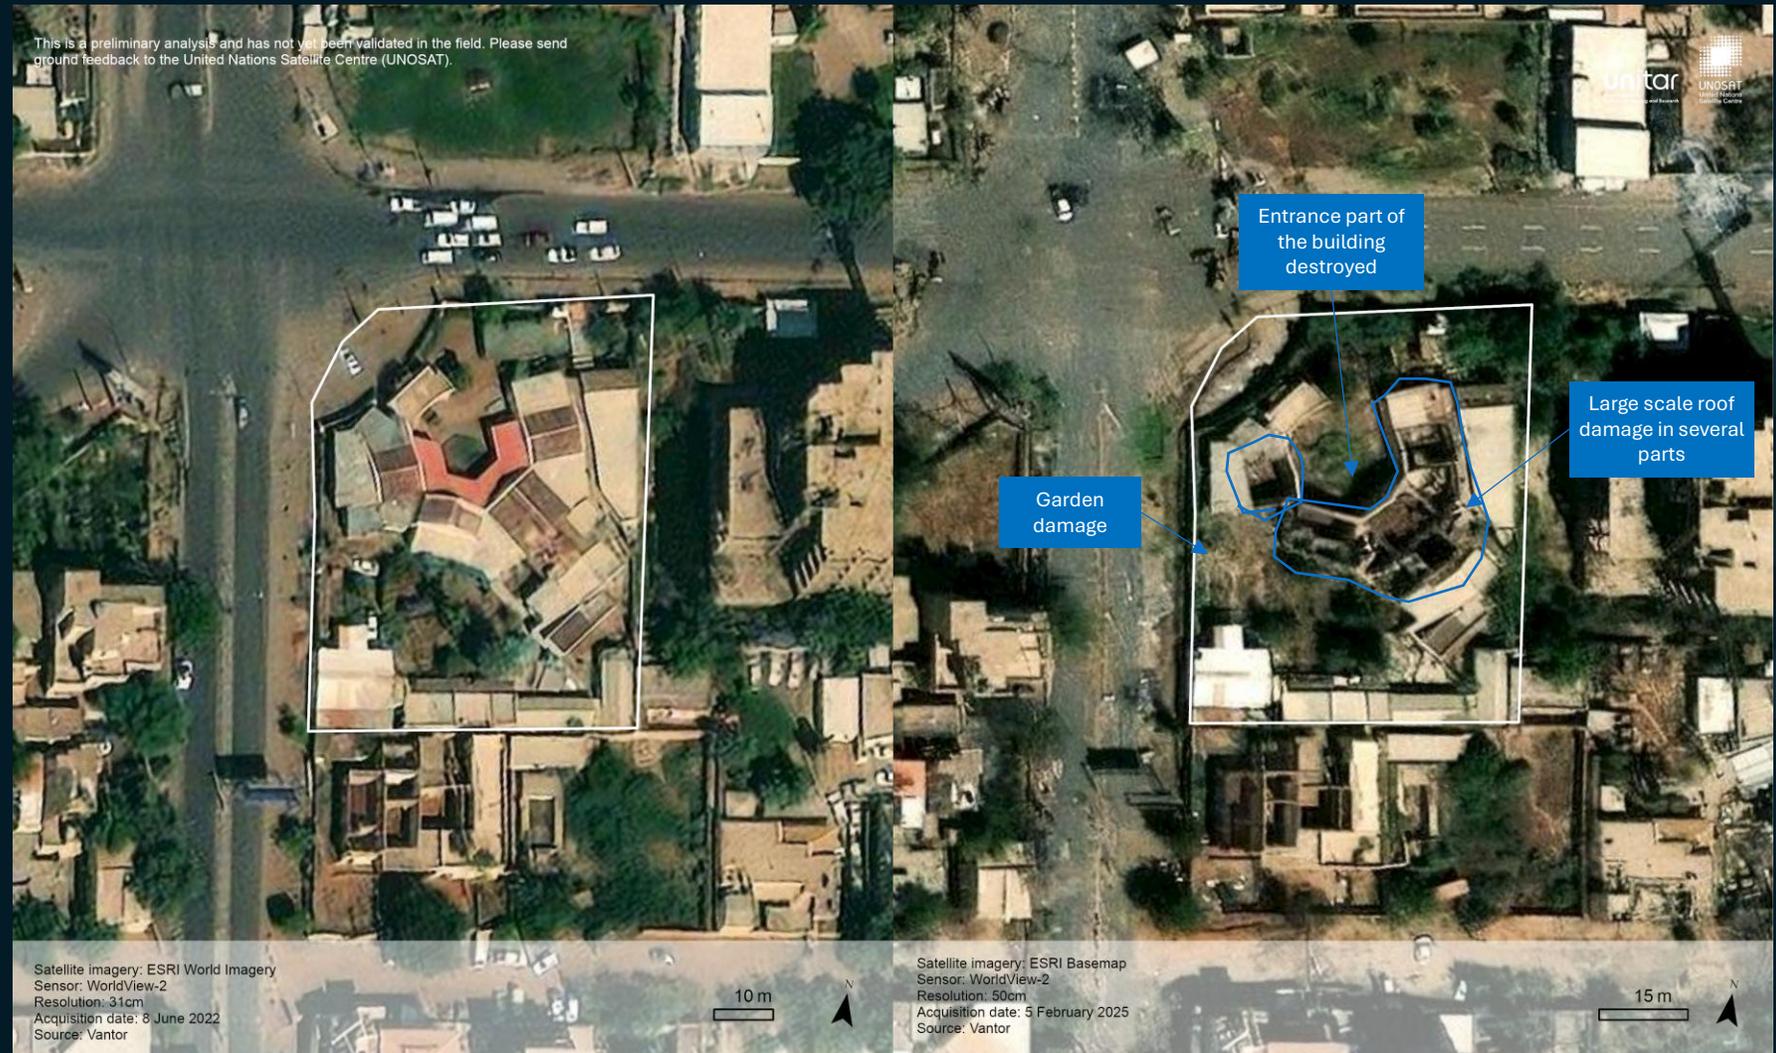
This page illustrates damage observed from a very-high resolution image captured by a WorldView-2 satellite on the 12 November 2025. It shows moderate damage to the museums roof and structure. In addition, the museums entrance and gardens also look to be damaged.

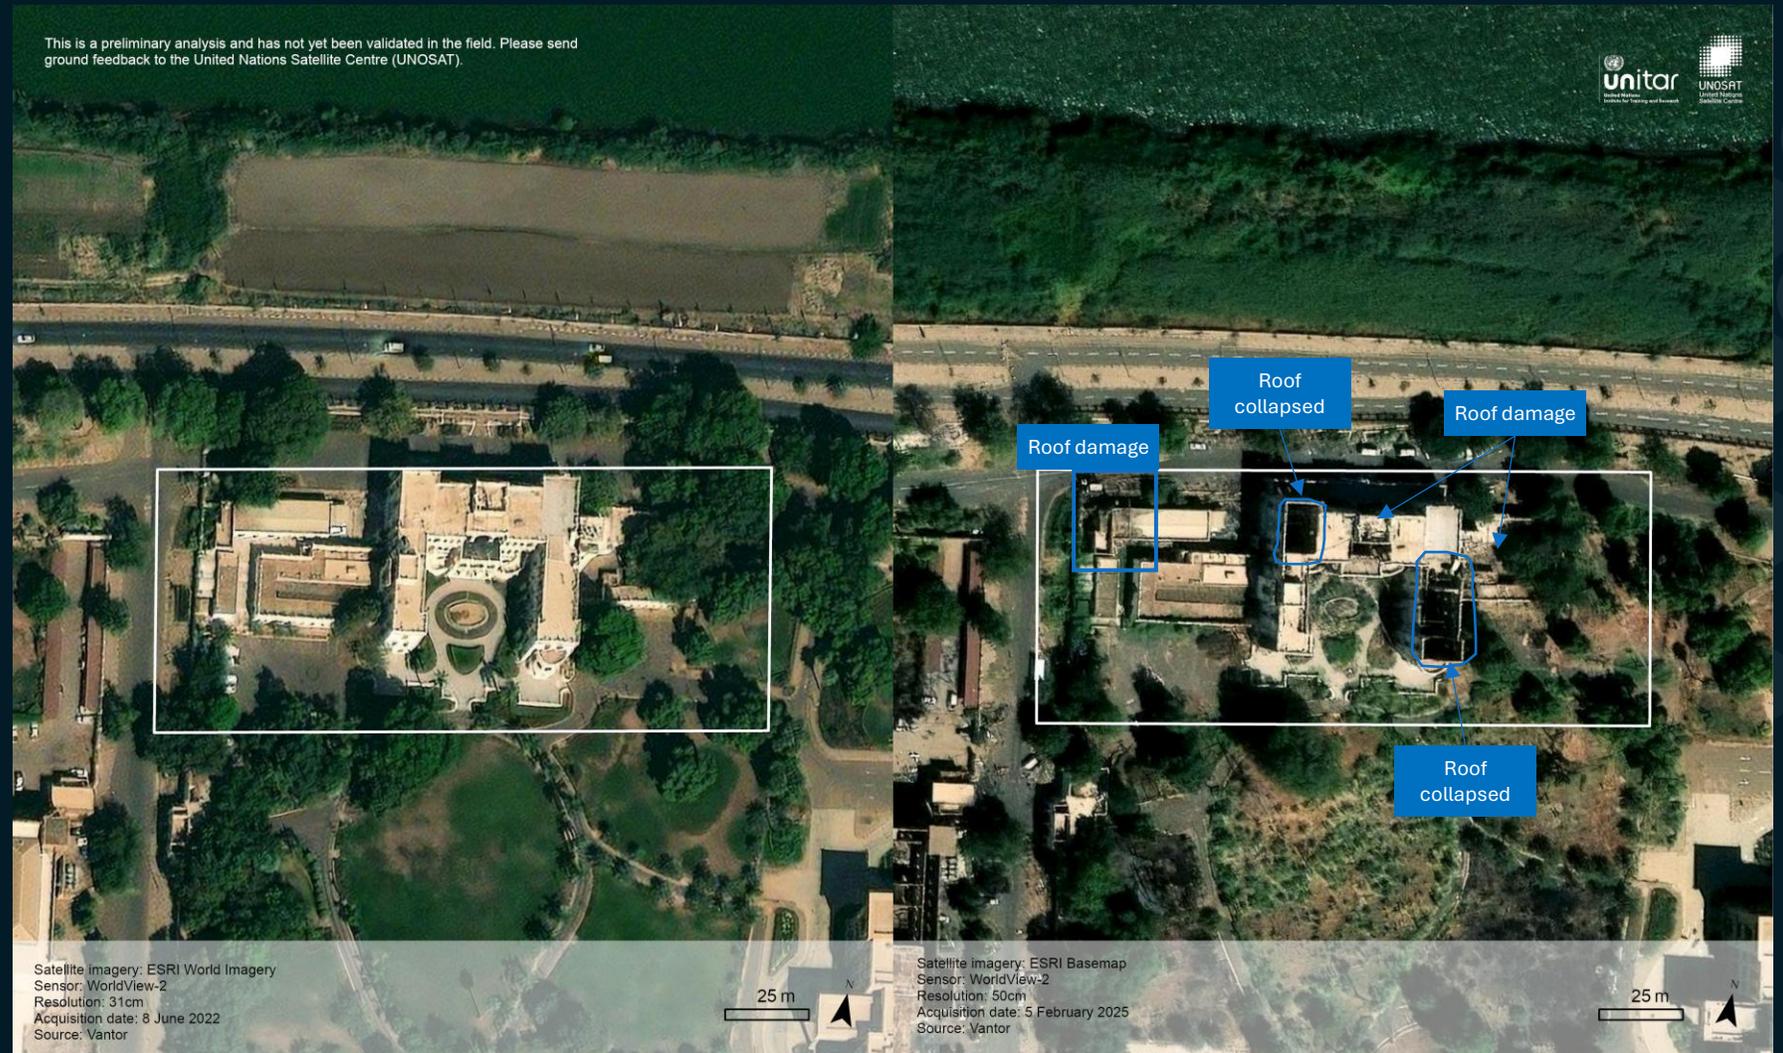
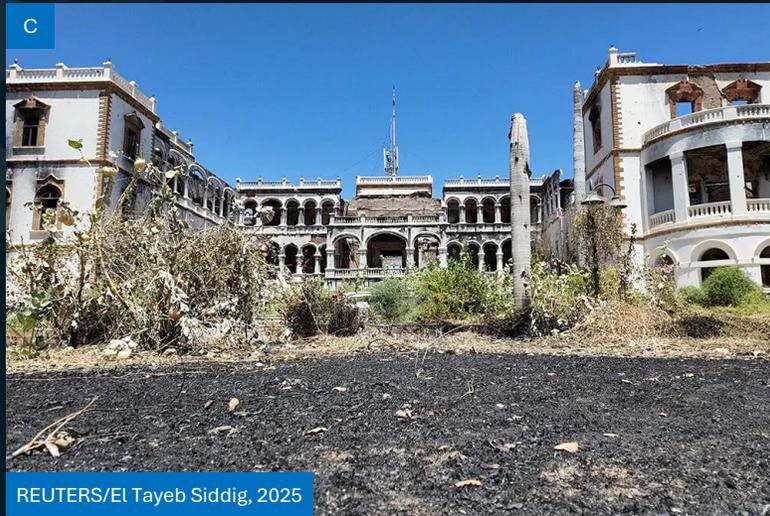
1.4 Khartoum Republican Palace (Presidential Palace)

Ground photos help to identify and verify damage that has been identified through satellite imagery.

Photos taken by several sources show damage to the front of the palace, on several facades and windows/ arches. In addition, the palace gardens and courtyard is also damaged. Where possible, UNOSAT has marked the likely locations of the photos on the satellite image.

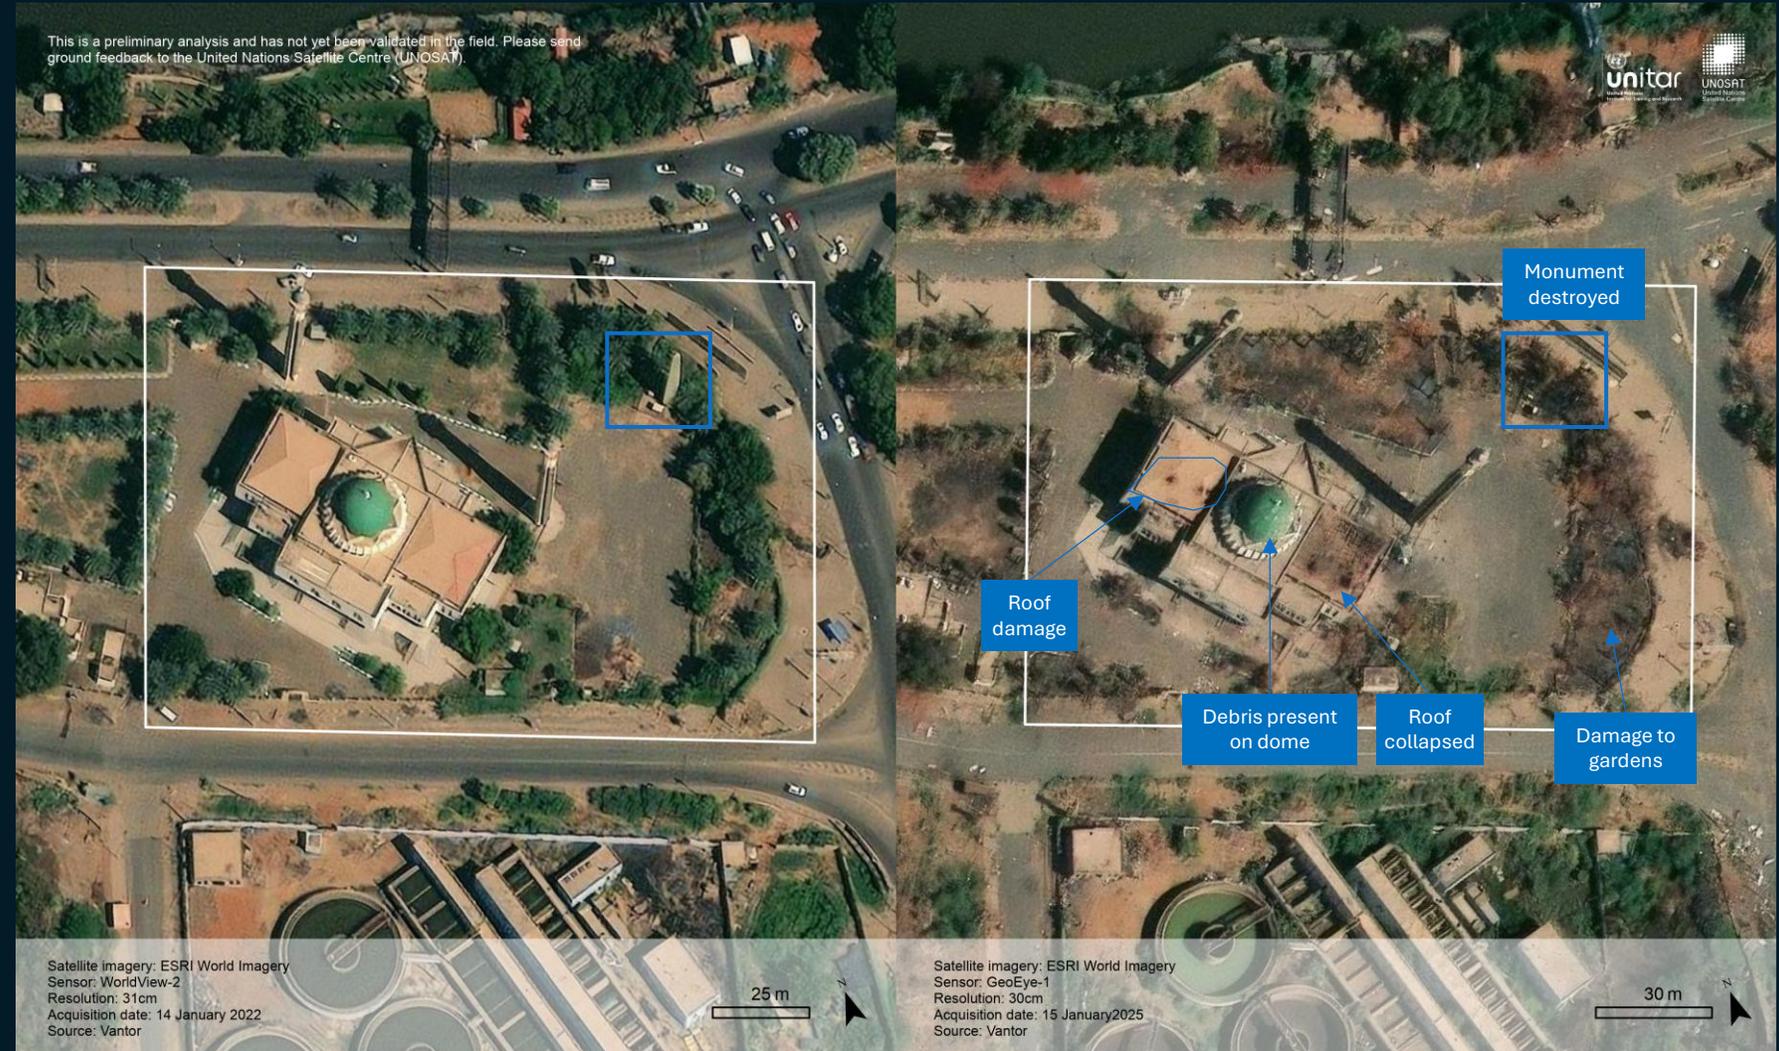
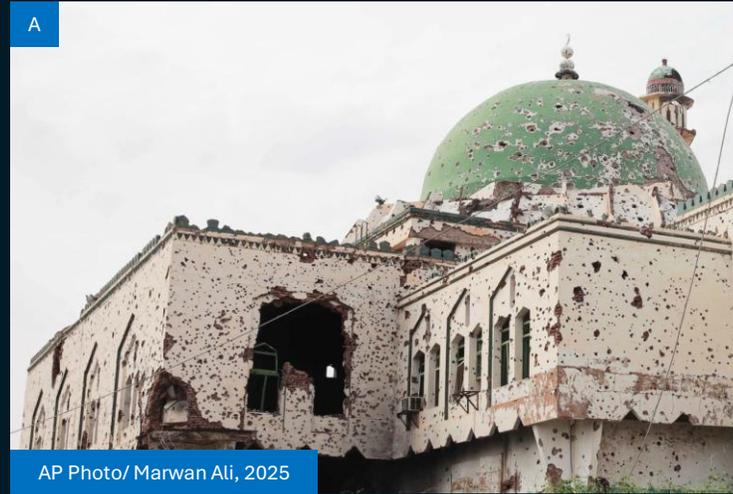
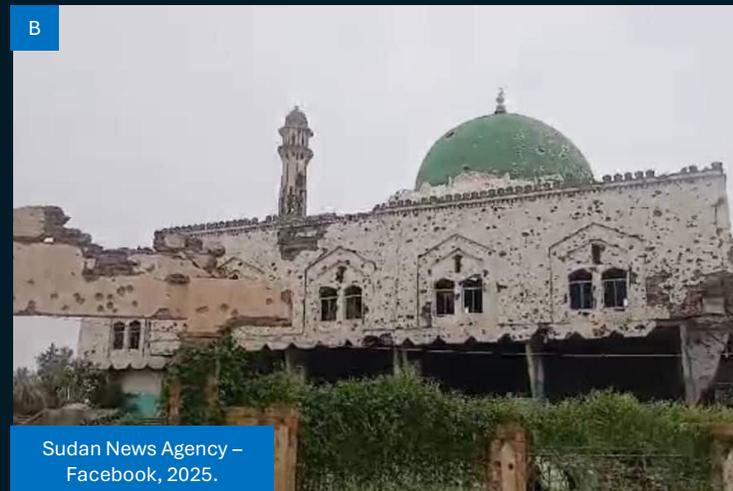
1.7 Al-Shaheed Mosque – Ground Photos

Photos obtained online show damage to the mosque's façade and minaret from several sides.

Social media posts from the [Sudan News Agency](#), in August 2025, state that the Governor of Khartoum has announced that they will start rehabilitation on the mosque.

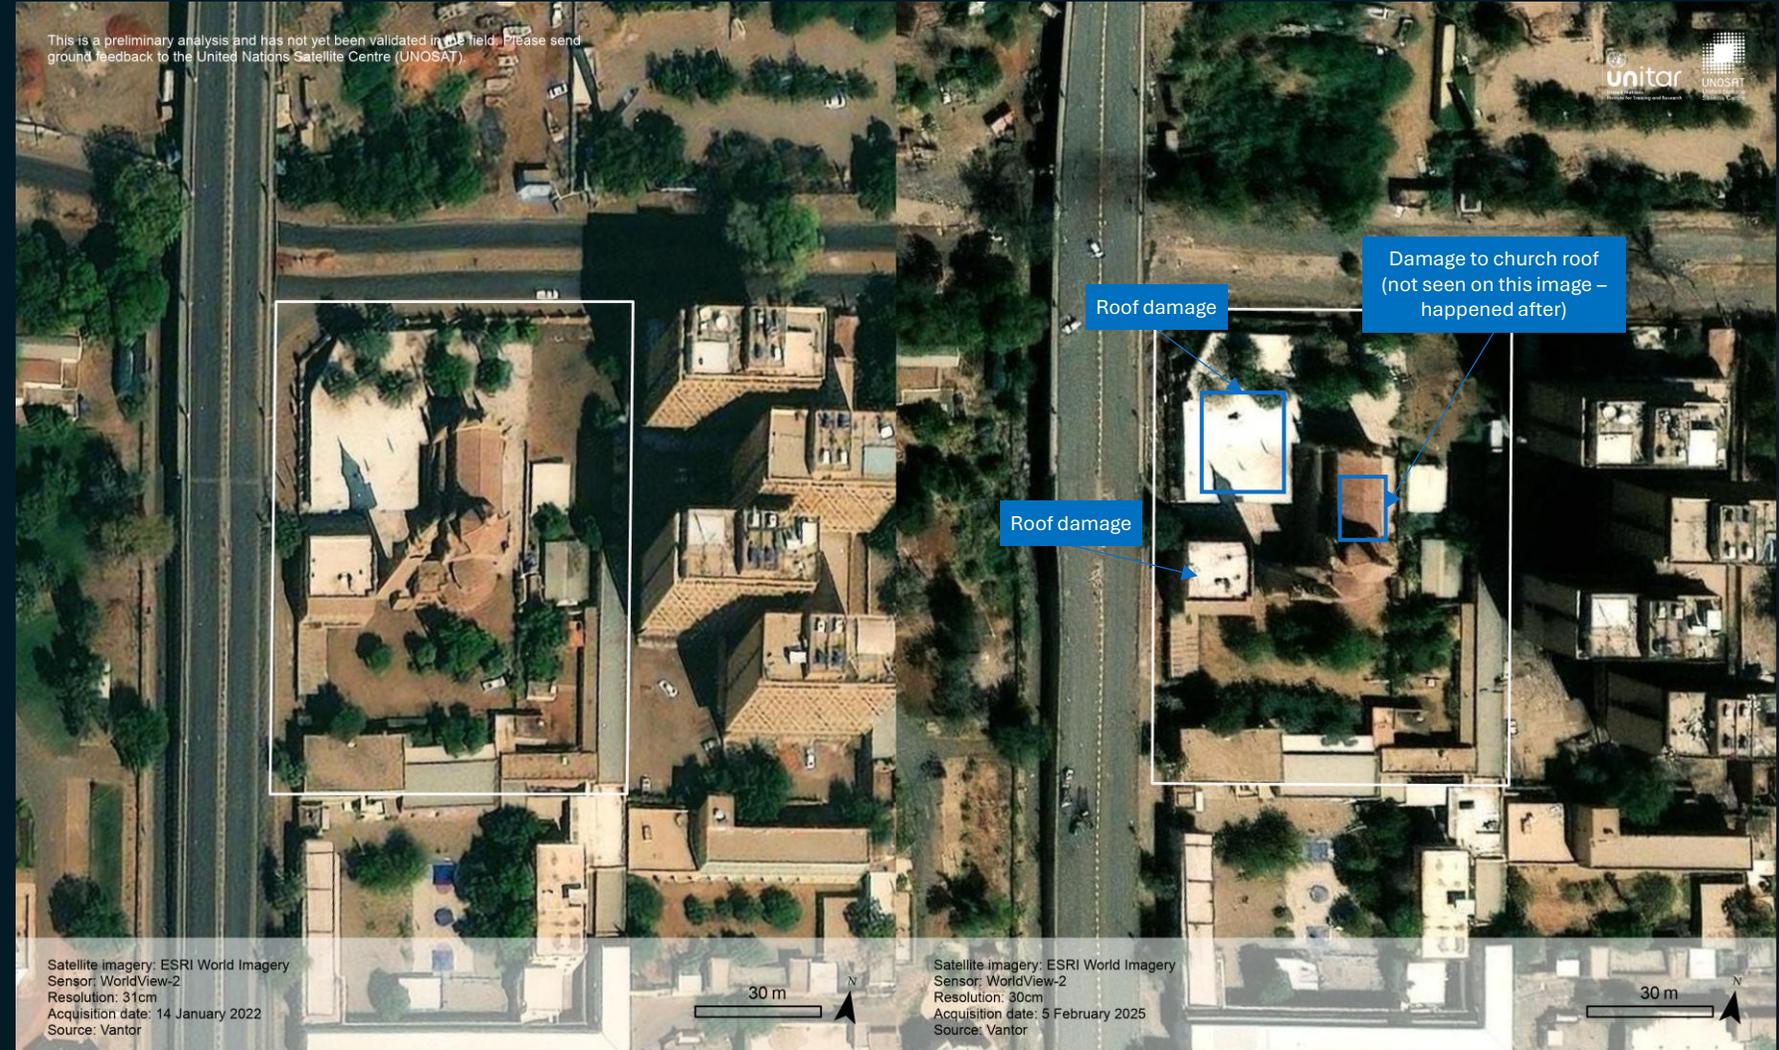
This page illustrates damage observed from a very-high resolution image captured by a WorldView-2 satellite on the 12 November 2025. It shows moderate damage to St Matthew's Cathedral, with roof damage in several locations. Including on the main cathedral area.

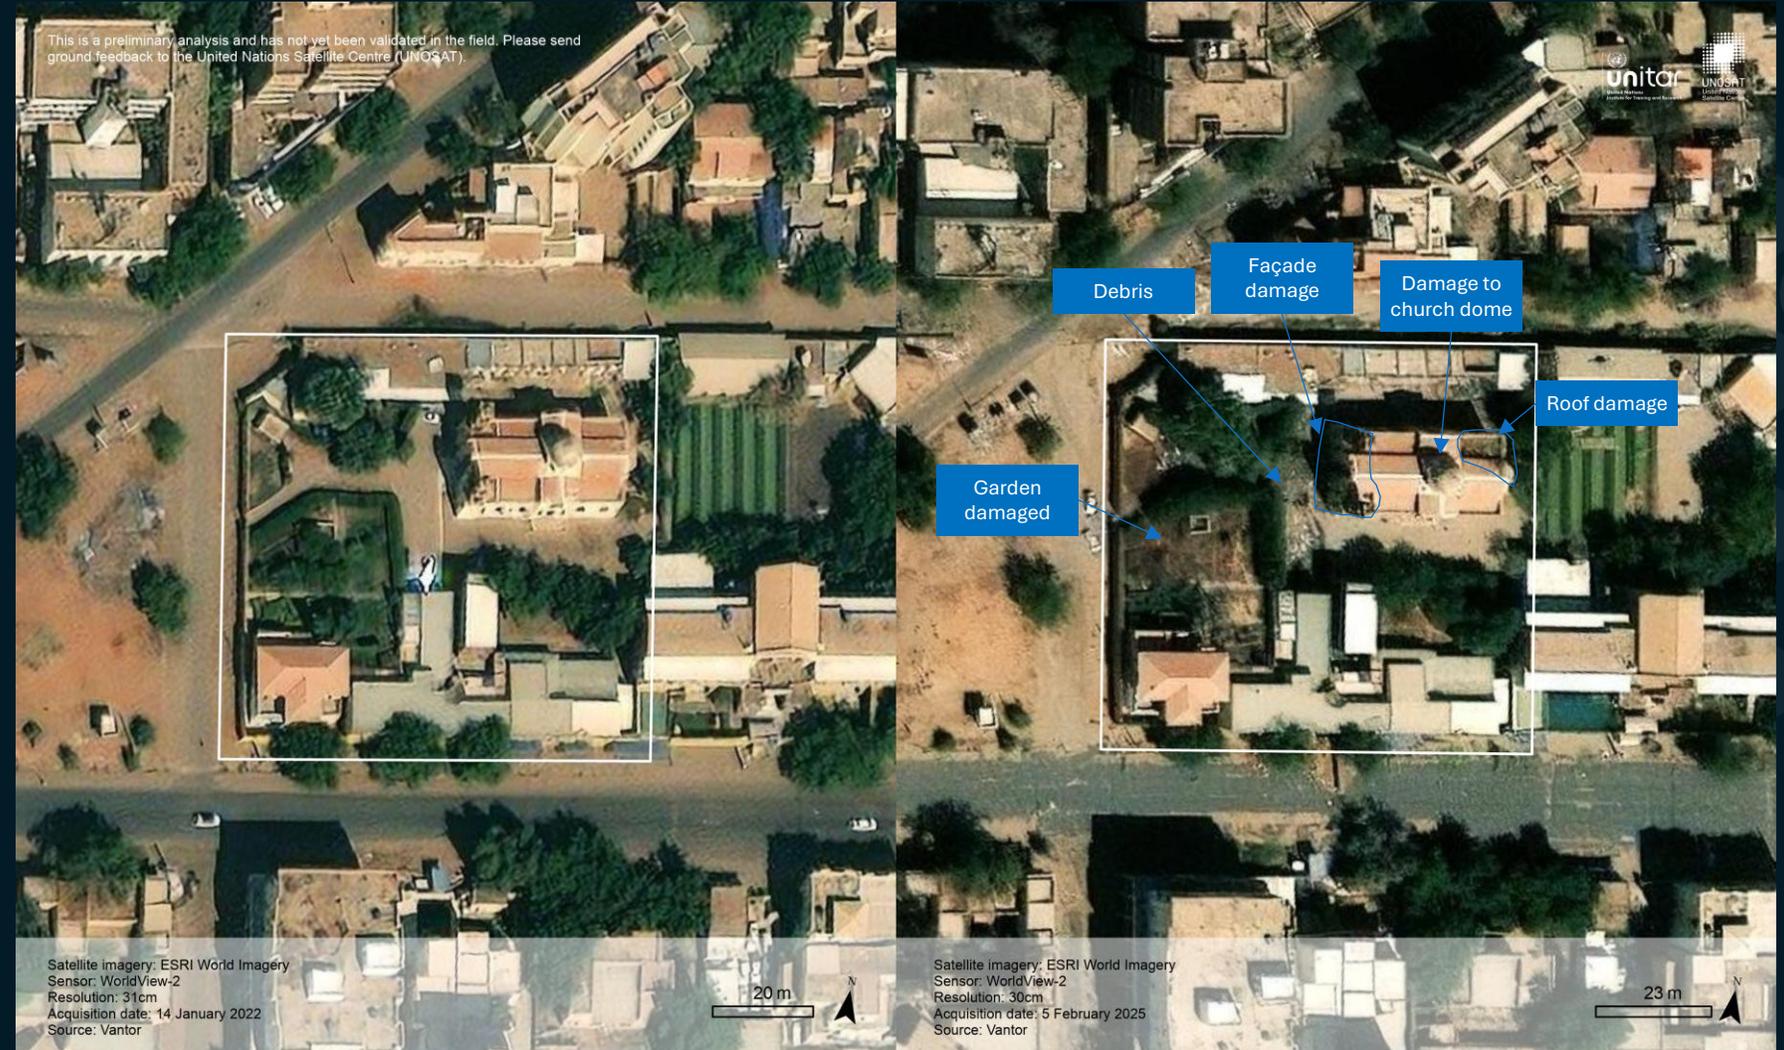
It shows moderate damage to the church, with façade damage and roof damage in several locations. The garden in the complex has also been damaged and debris is present beside the church.

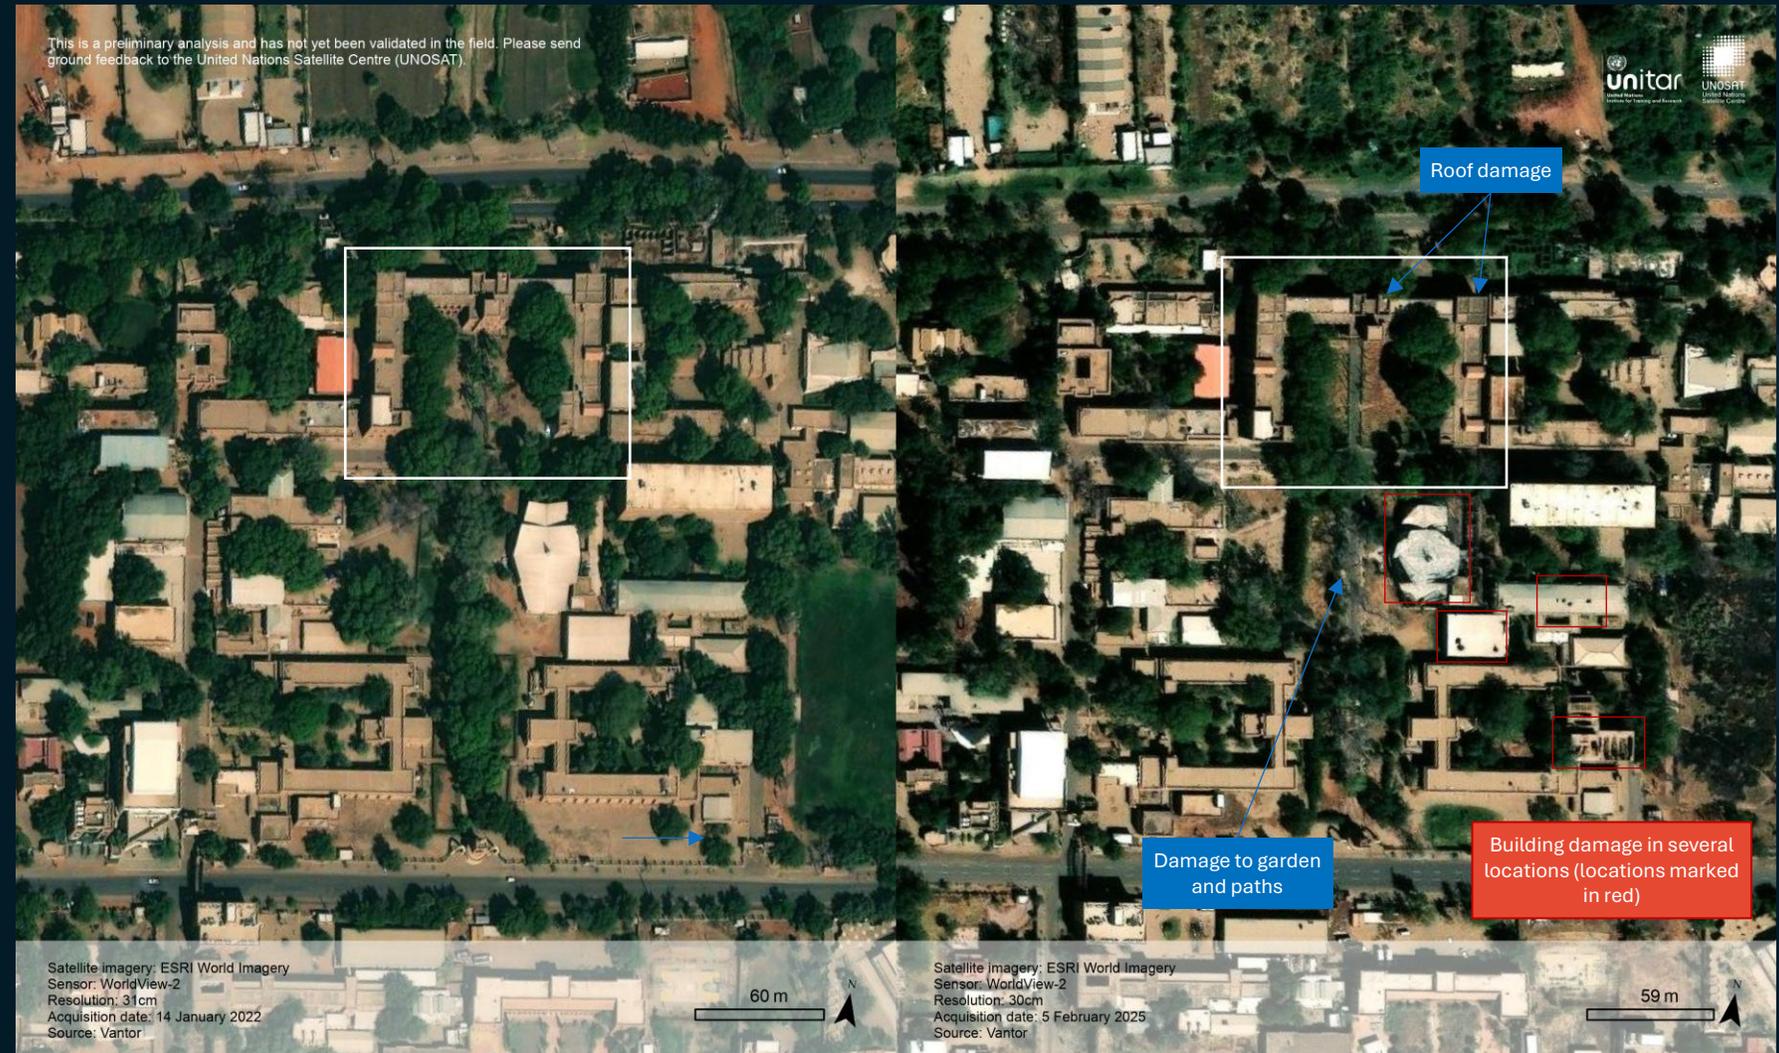
This page illustrates damage observed from a very-high resolution image captured by a WorldView-2 satellite on the 12 November 2025. It shows moderate damage to the University of Khartoum and specifically the library (white box) has sustained damage to the building roof and façade.

Several buildings on the campus have been damaged, with roof damage detected in several locations. Additionally, the gardens and grounds of the university have been damaged and destroyed in some parts.

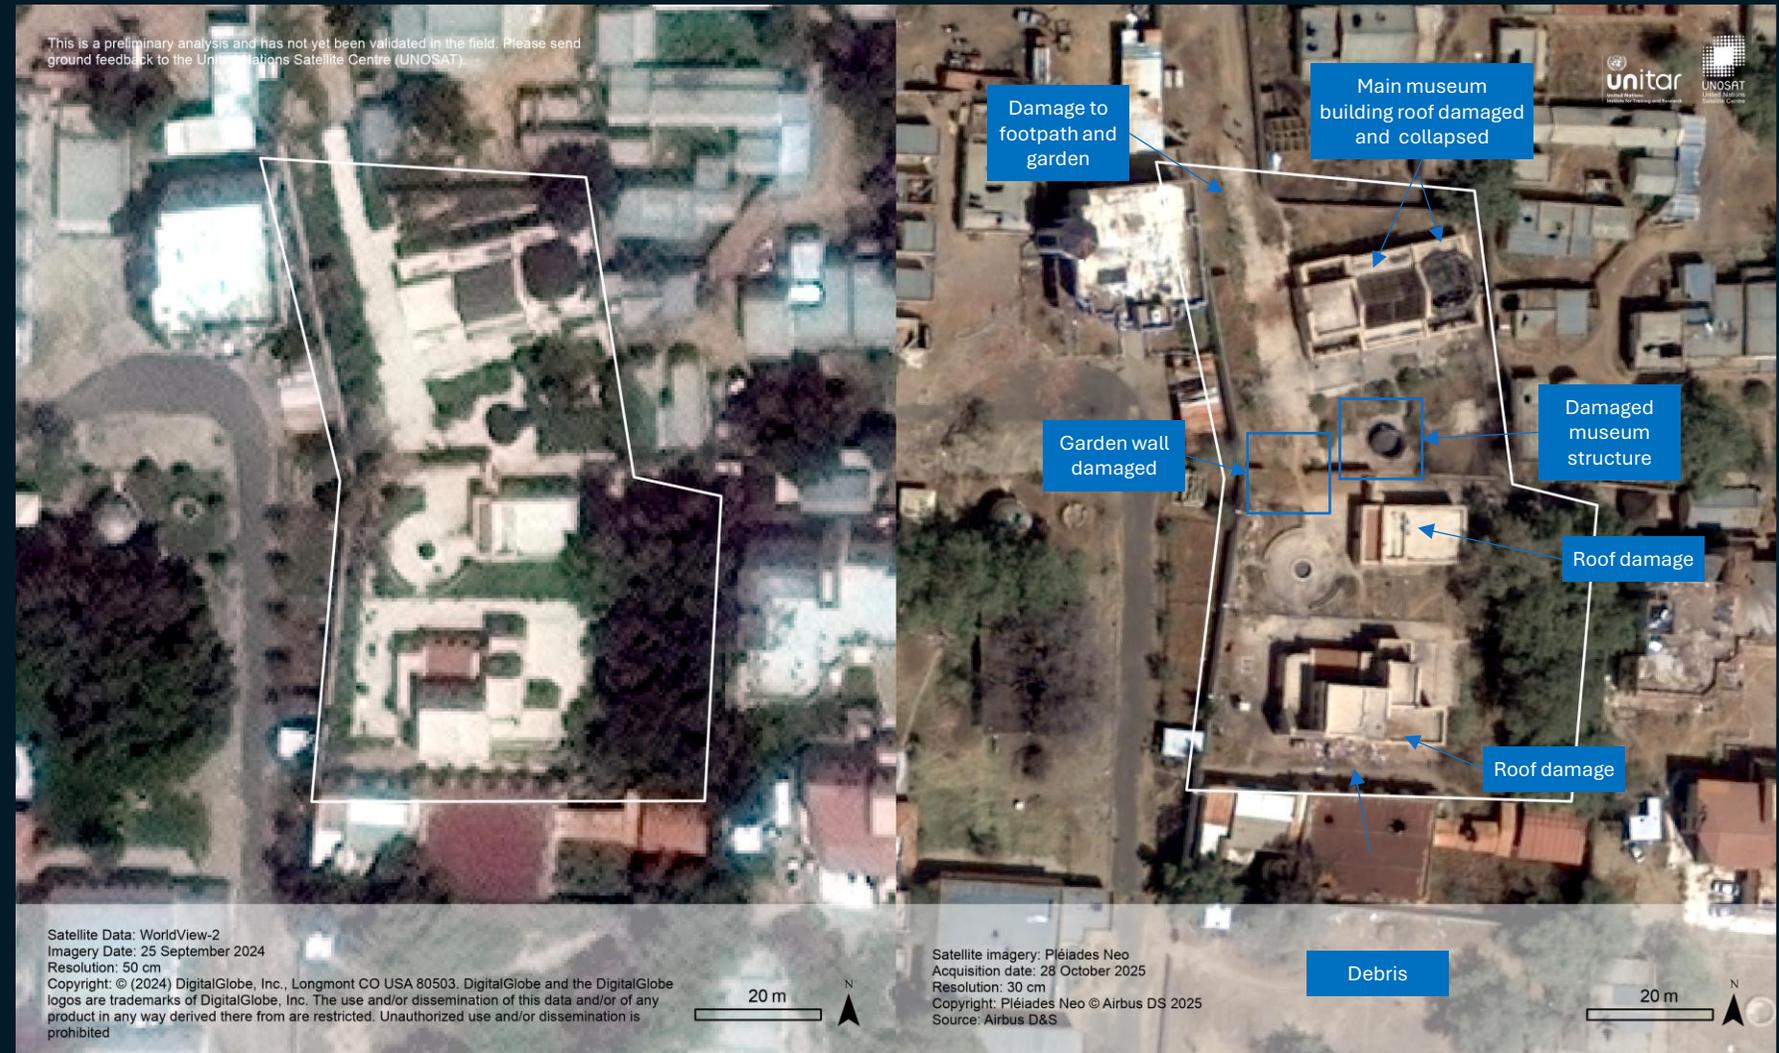
In 2024 no visible damage was detected to the site due to flooding using a very-high resolution image captured by a WorldView-2 satellite on the 25 September 2024 (left image, Charter Activation [917](#)).

However, in 2025 the museum reportedly suffered serious damage from indiscriminate shelling, including destruction of parts of the building and loss of furniture and contents ([The Art Newspaper, 2025](#)), ([Blue Shield International, 2025](#)).

The right image illustrates damage observed from a very-high resolution image captured by a Pléiades Neo satellite on the 28 October 2025. It shows moderate damage to the museum. Based on analysis of several satellite images the first damage occurred to the museum around the 18 December 2024, when the main museum building roof was damaged and collapsed.

Further damage was sustained in mid 2025 to other parts of the museum, including the garden area and south building which has visible debris surrounding it.
