Satellite-based Damage Assessment

Sectoral Analysis: Cultural Heritage

Sudan

CE20231504SDN

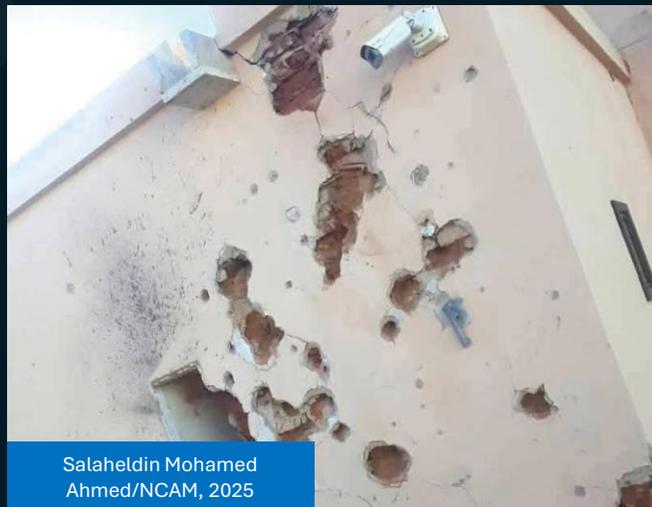
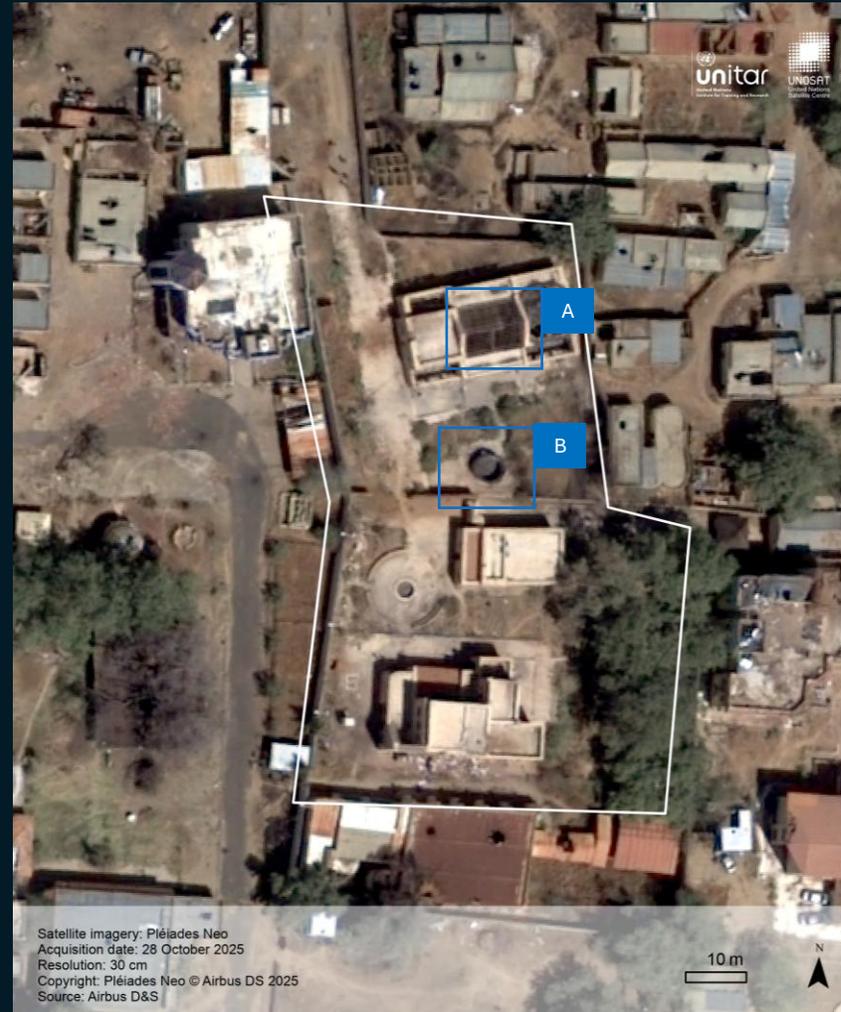
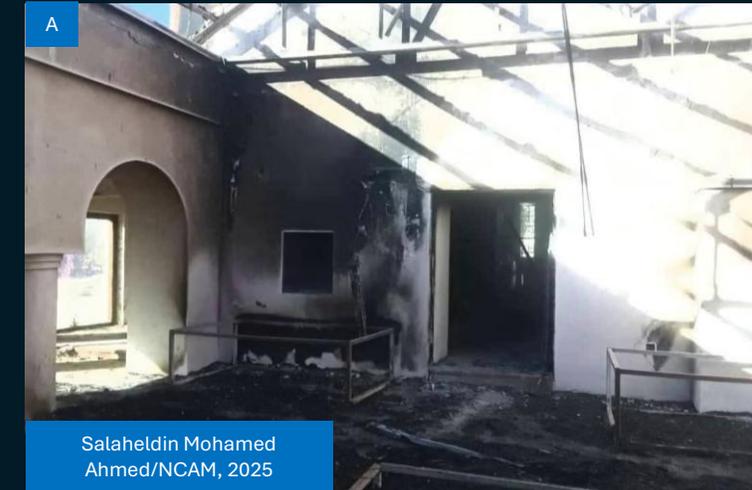
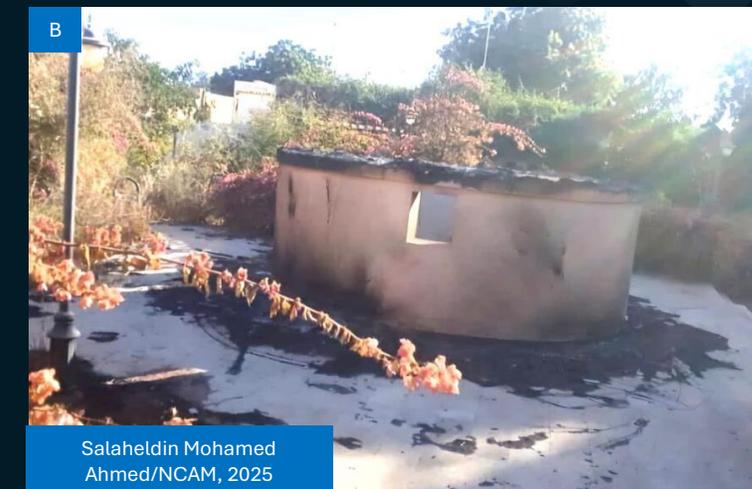
2.1 Sultan Ali Dinar Palace Museum – Ground Photos

Ground photos help to verify damage that has been identified through satellite imagery.

Photos taken by Salaheldin Mohamed Ahmed/NCAM show damage from both outside and inside the Museum. Where possible UNOSAT has marked the likely locations of the photos on the satellite image.

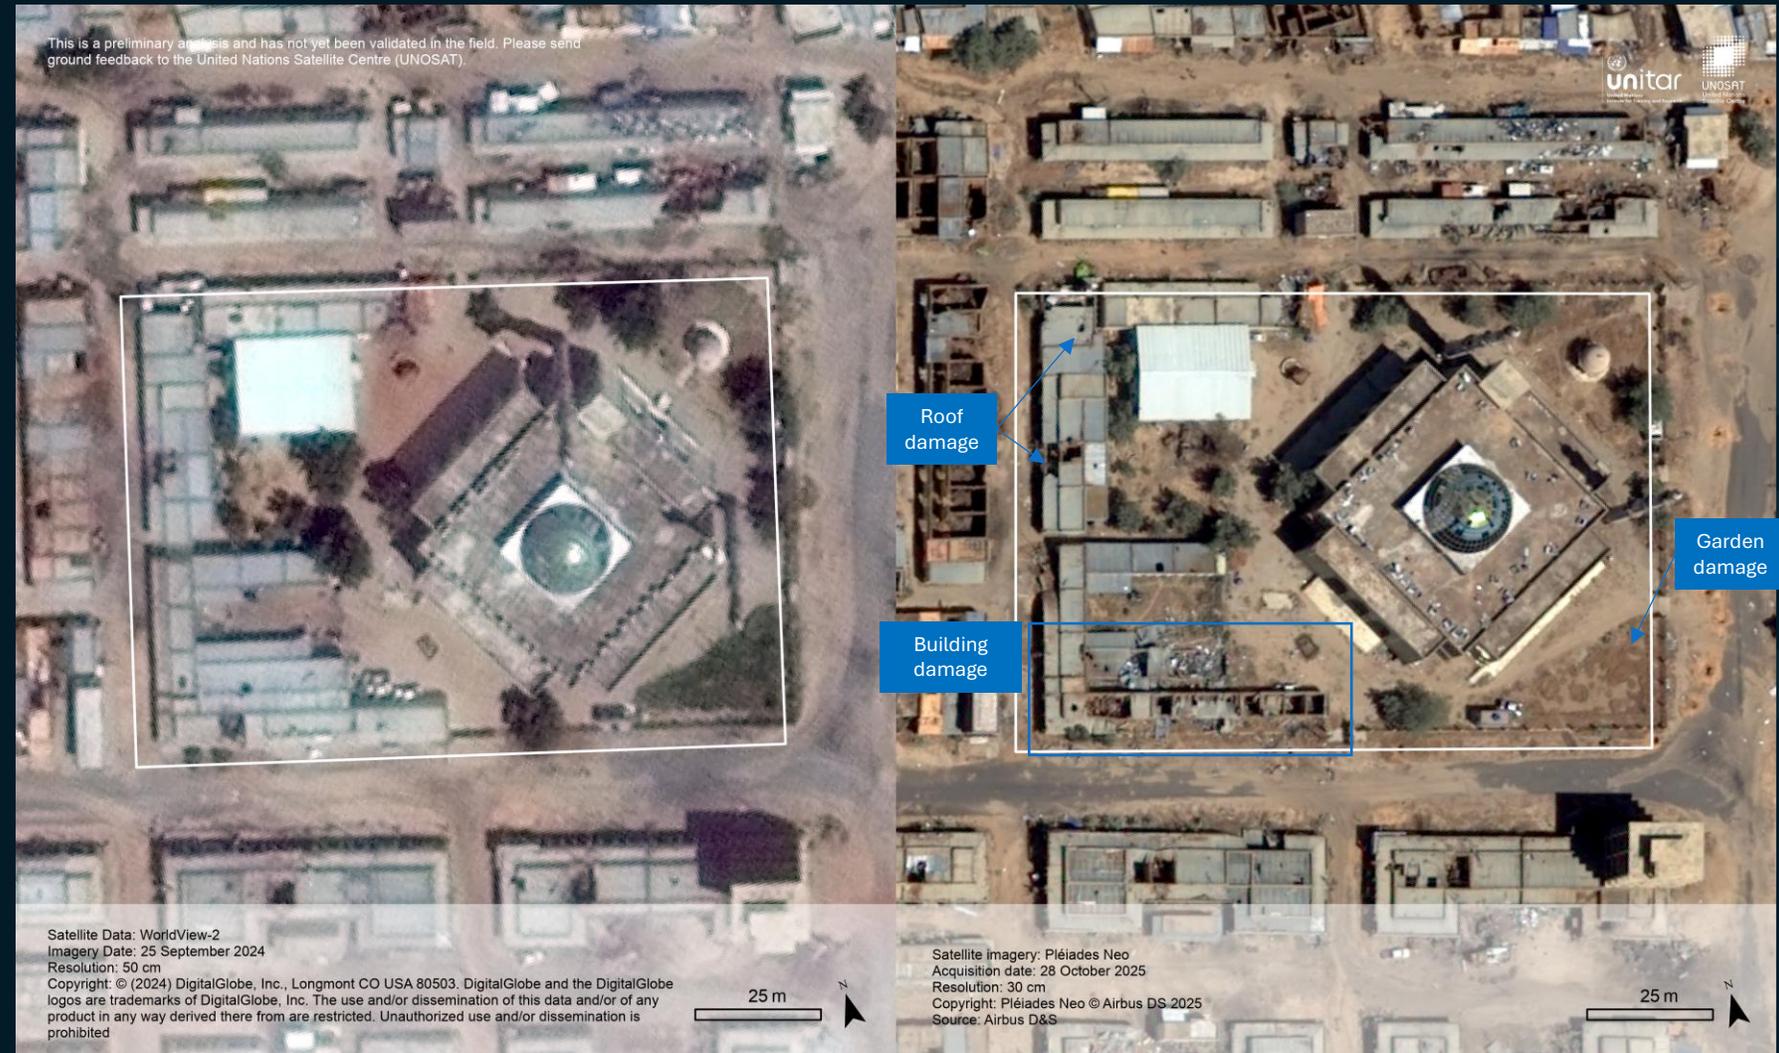
2.2 El Fasher Grand Mosque

This page illustrates damage observed from a very-high resolution image captured by a Pléiades Neo satellite on the 28 October 2025 (right).

It shows possible damage to the mosque. Several buildings in the mosque complex have sustained damage, with moderate damage to several buildings on the southern side and roof damage to buildings on the west.

There is no visible damage to the main mosque building, however possible damage may have occurred to the building façade due to impact from surrounding damage. The mosque's two minarets look to be still standing and intact.

Additionally, this site had no visible damage due to the flooding in 2024 using a very-high resolution image captured by a WorldView-2 satellite on the 25 September 2024 (left, Charter Activation [917](#)).

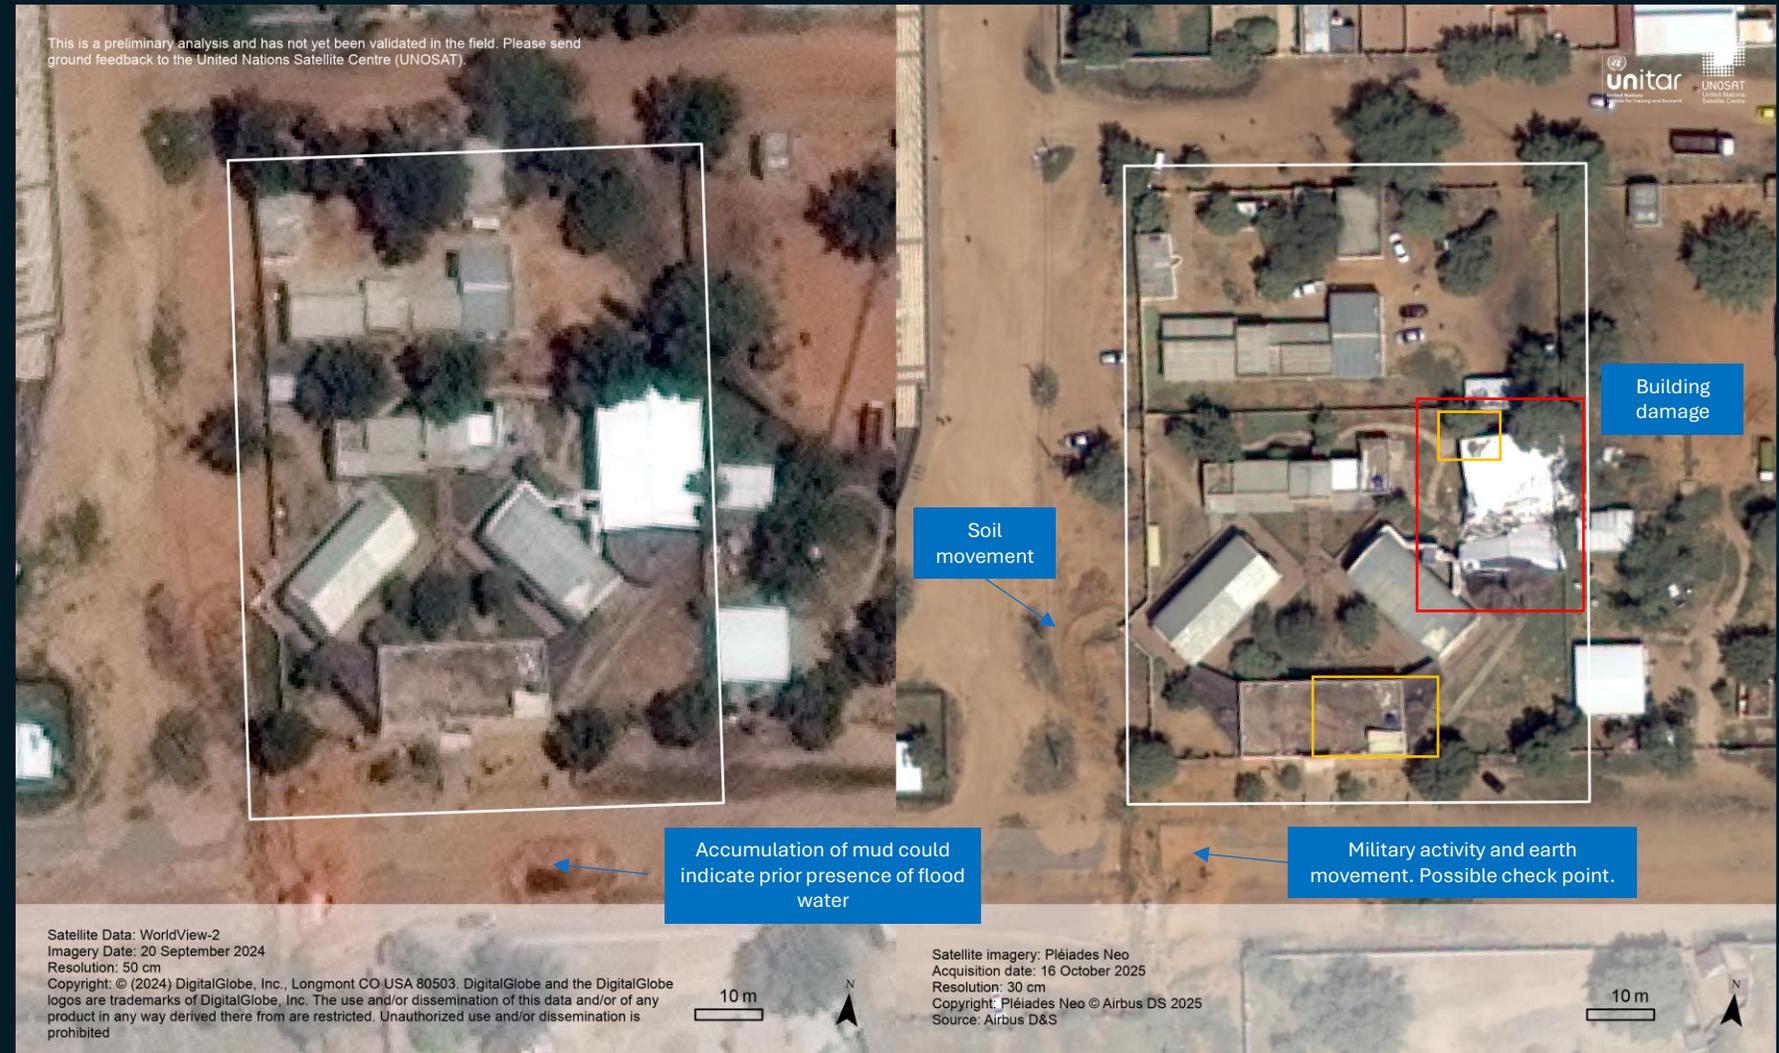
This page illustrates damage observed from a very-high resolution image captured by a Pléiades Neo satellite on the 16 October 2025 (right).

It shows moderate damage to the Sheikan Museum. Analysing several satellite images, the first damage to the site occurred in two different roof parts around November 2024. These are highlighted in orange boxes.

The second period of damage was observed between August and September 2025 and resulted in a large impact to one of the museum buildings. This is highlighted in a red box.

In addition, military activity in the form of earth movements and earth berms, leading to possible check points or roadblocks outside the museum.

This site had no visible damage due to flooding in 2024 using a very-high resolution image captured by a WorldView-2 satellite on the 20 September 2024 (left, Charter Activation [917](#)).

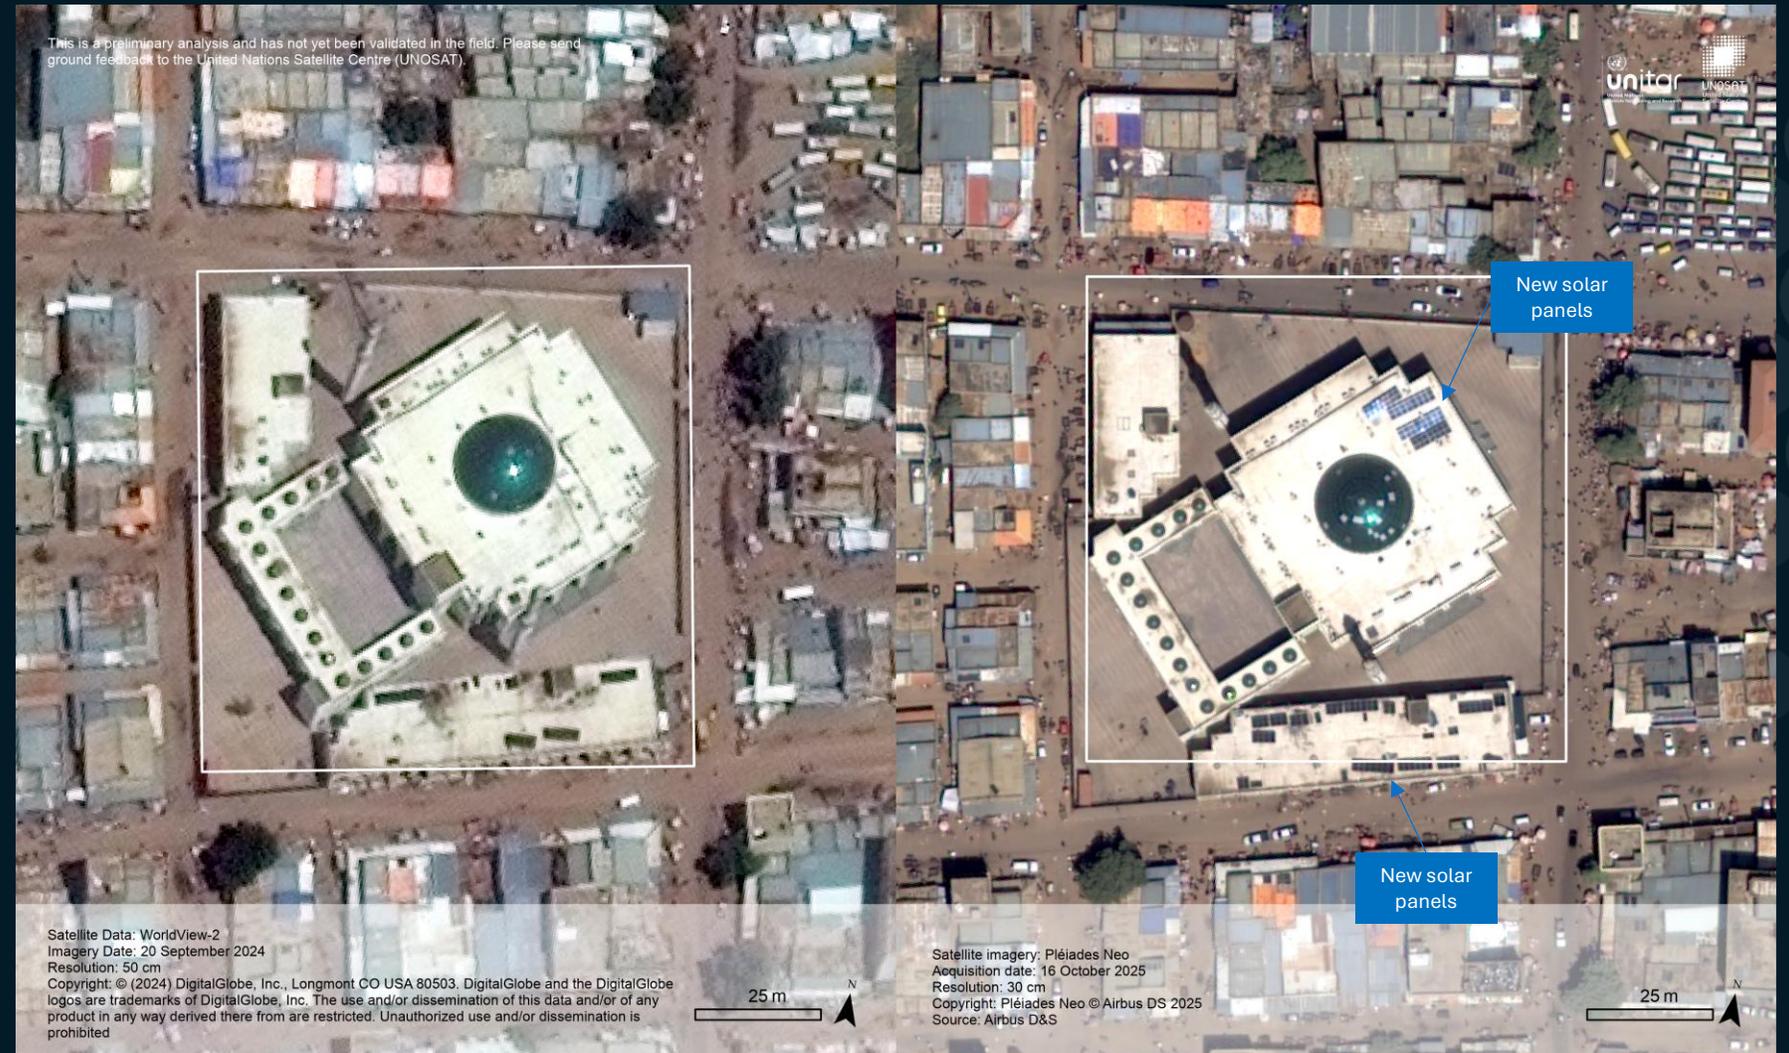
3.2 El Obeid Great Mosque

This page illustrates damage observed from a very-high resolution image captured by a Pléiades Neo satellite on the 16 October 2025 (right).

No visible damage looks to appear on the main mosque building and the mosque's two minarets look to be still standing and intact.

This site also had no visible damage due to the flooding in 2024 using a very-high resolution image captured by a WorldView-2 satellite on the 20 September 2024 (left, Charter Activation 917).

Since September 2024, new solar panels have been installed on the mosque's roof and additional solar panels have been added to the building beside.

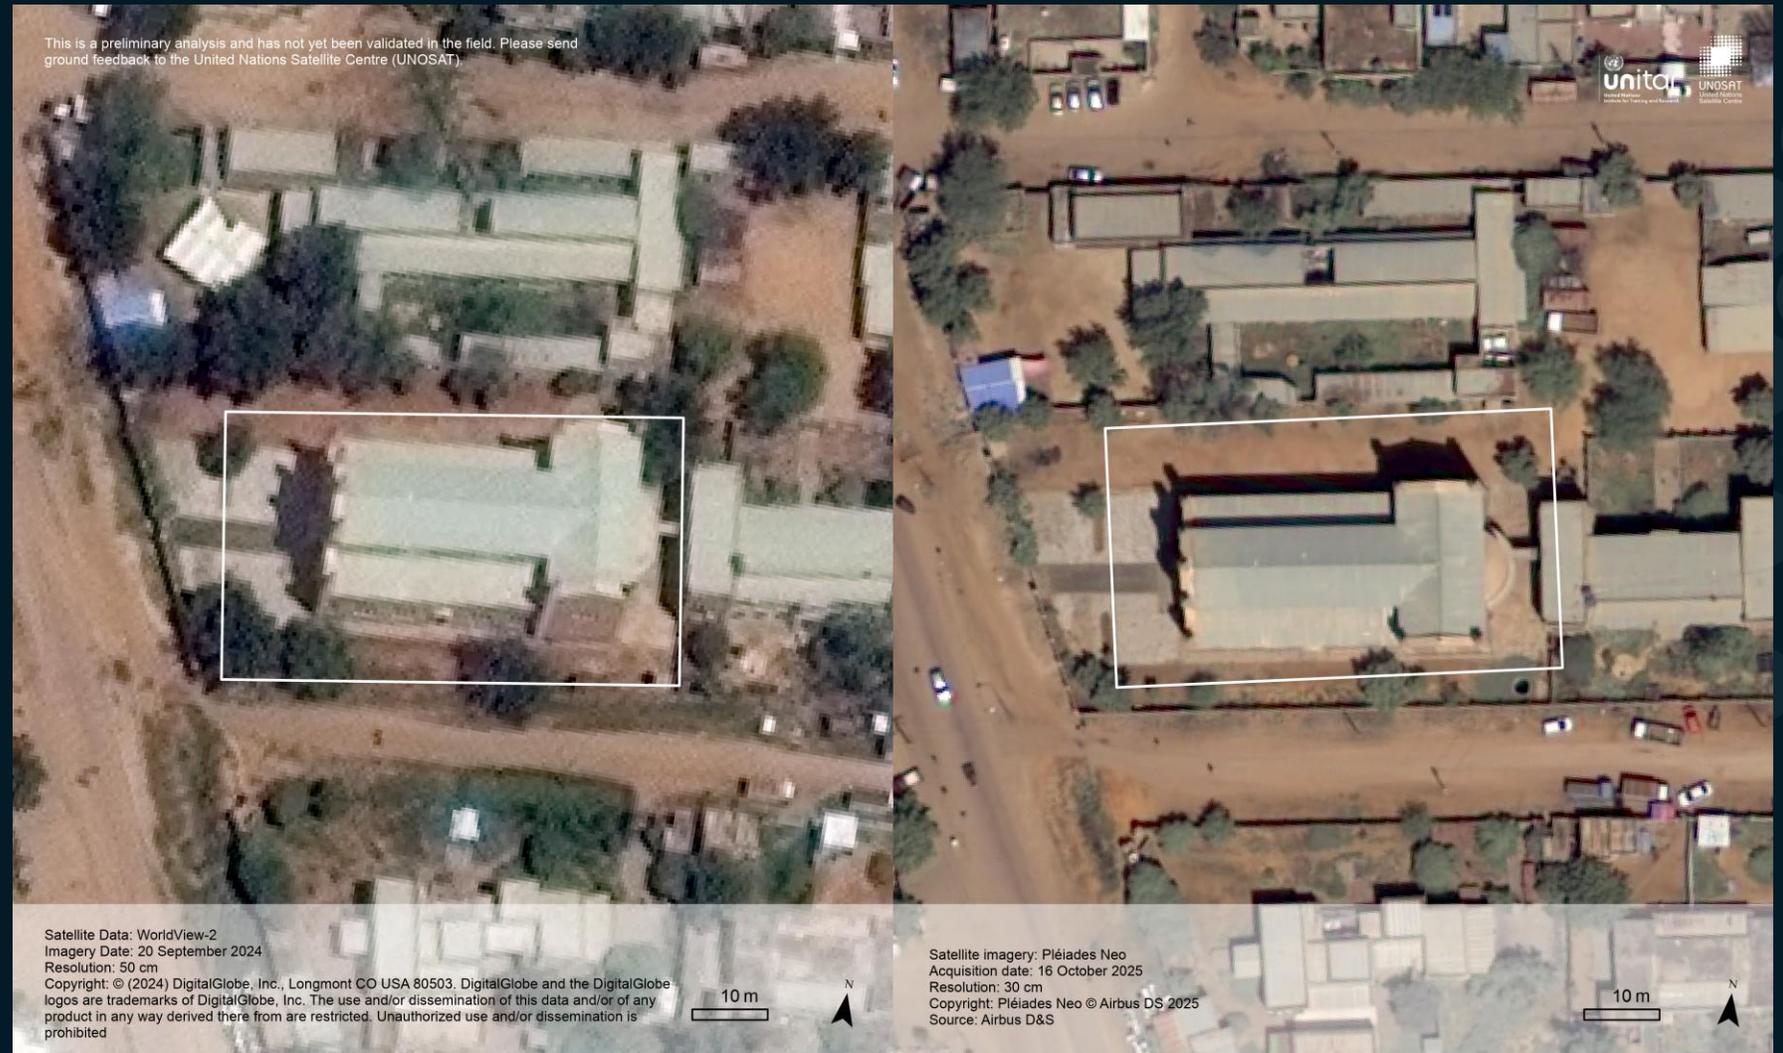
It has been reported that on 27 April 2023, the Cathedral experienced damages due to clashes within close proximity. Damages reported included bullets hitting in front of the main gate and damaged glass on the Cathedral ([Agenzia Fides, 2023](#)).

This site had no visible damage due to flooding in 2024 using a very-high resolution image captured by a WorldView-2 satellite on the 20 September 2024 (left, Charter Activation [917](#)).

Through satellite-derived analysis, from a very-high resolution image captured by a Pléiades Neo satellite on the 16 October 2025 (right), shows no visible damage. Damage to gates/ walls and broken glass are very difficult to see on satellite imagery.

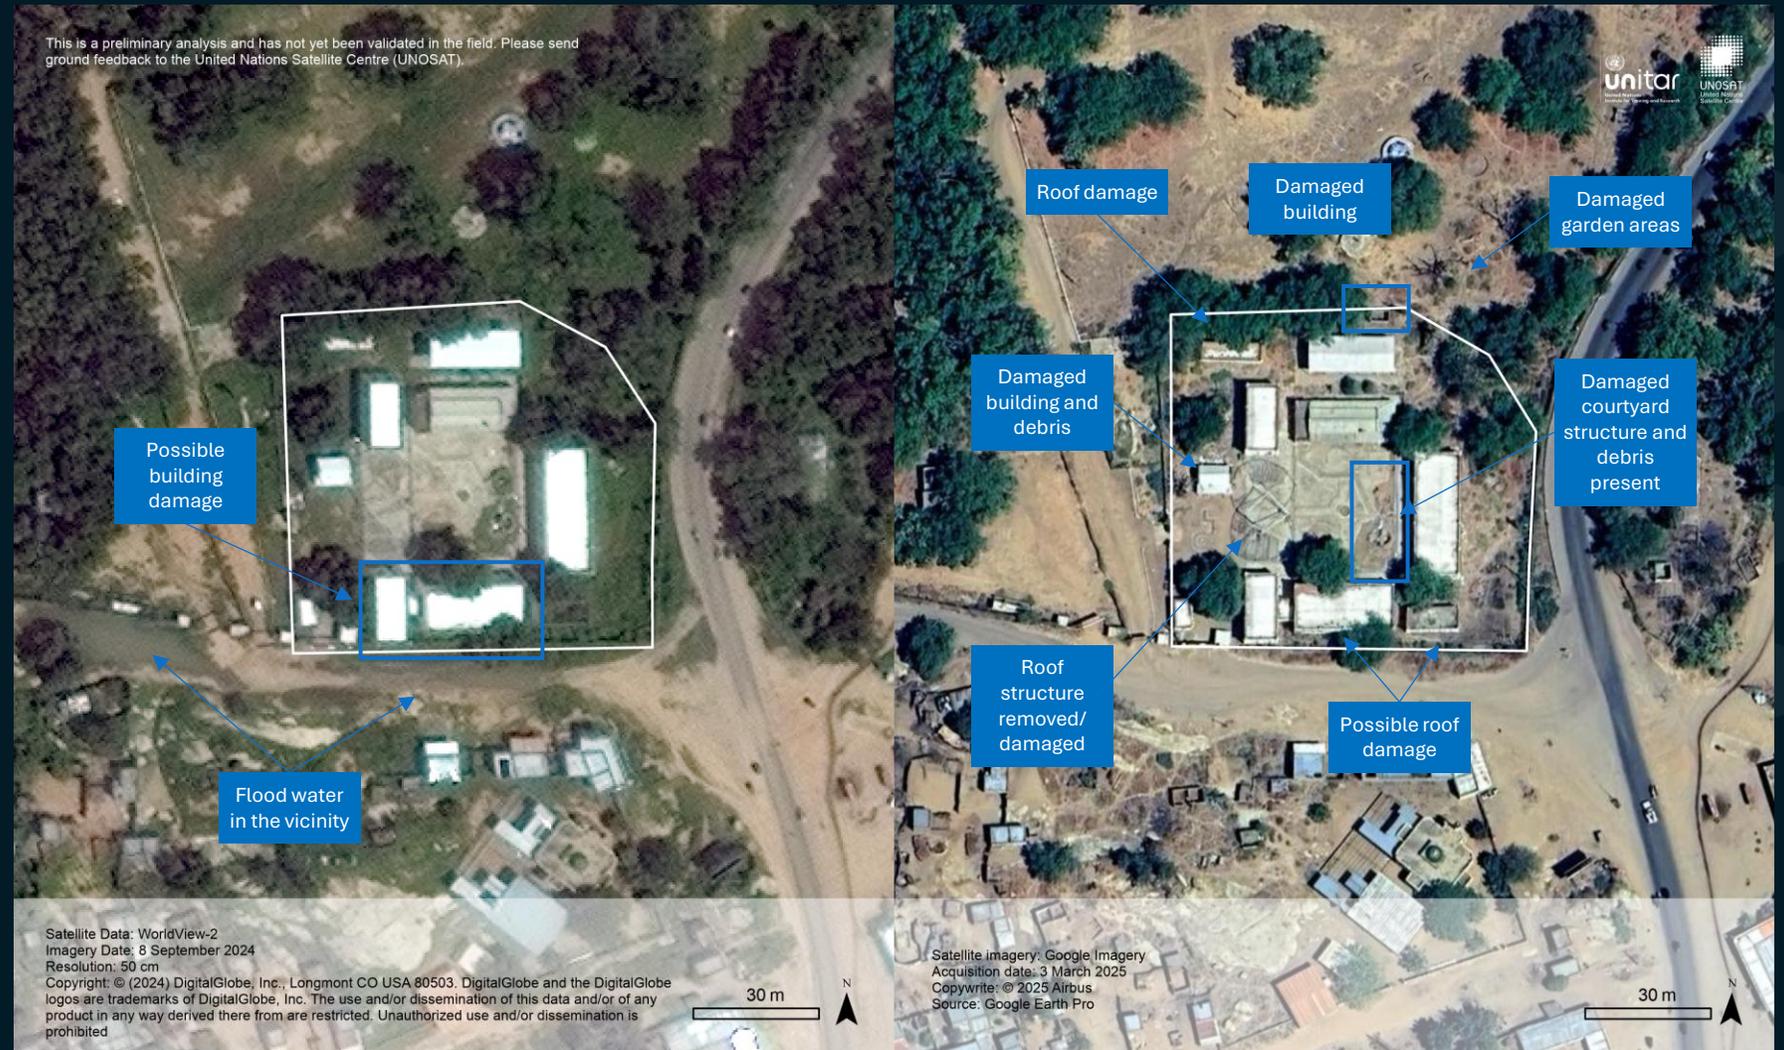
A later assessment observed from a very-high resolution image captured by a WorldView-2 satellite on the 6 November 2025, shows moderate damage to the museum. A large circular structure of roofing areas has been removed. In addition, other museum buildings have experienced damage. The museum courtyard has been damaged and vegetation and trees surrounding the museum have been destroyed.

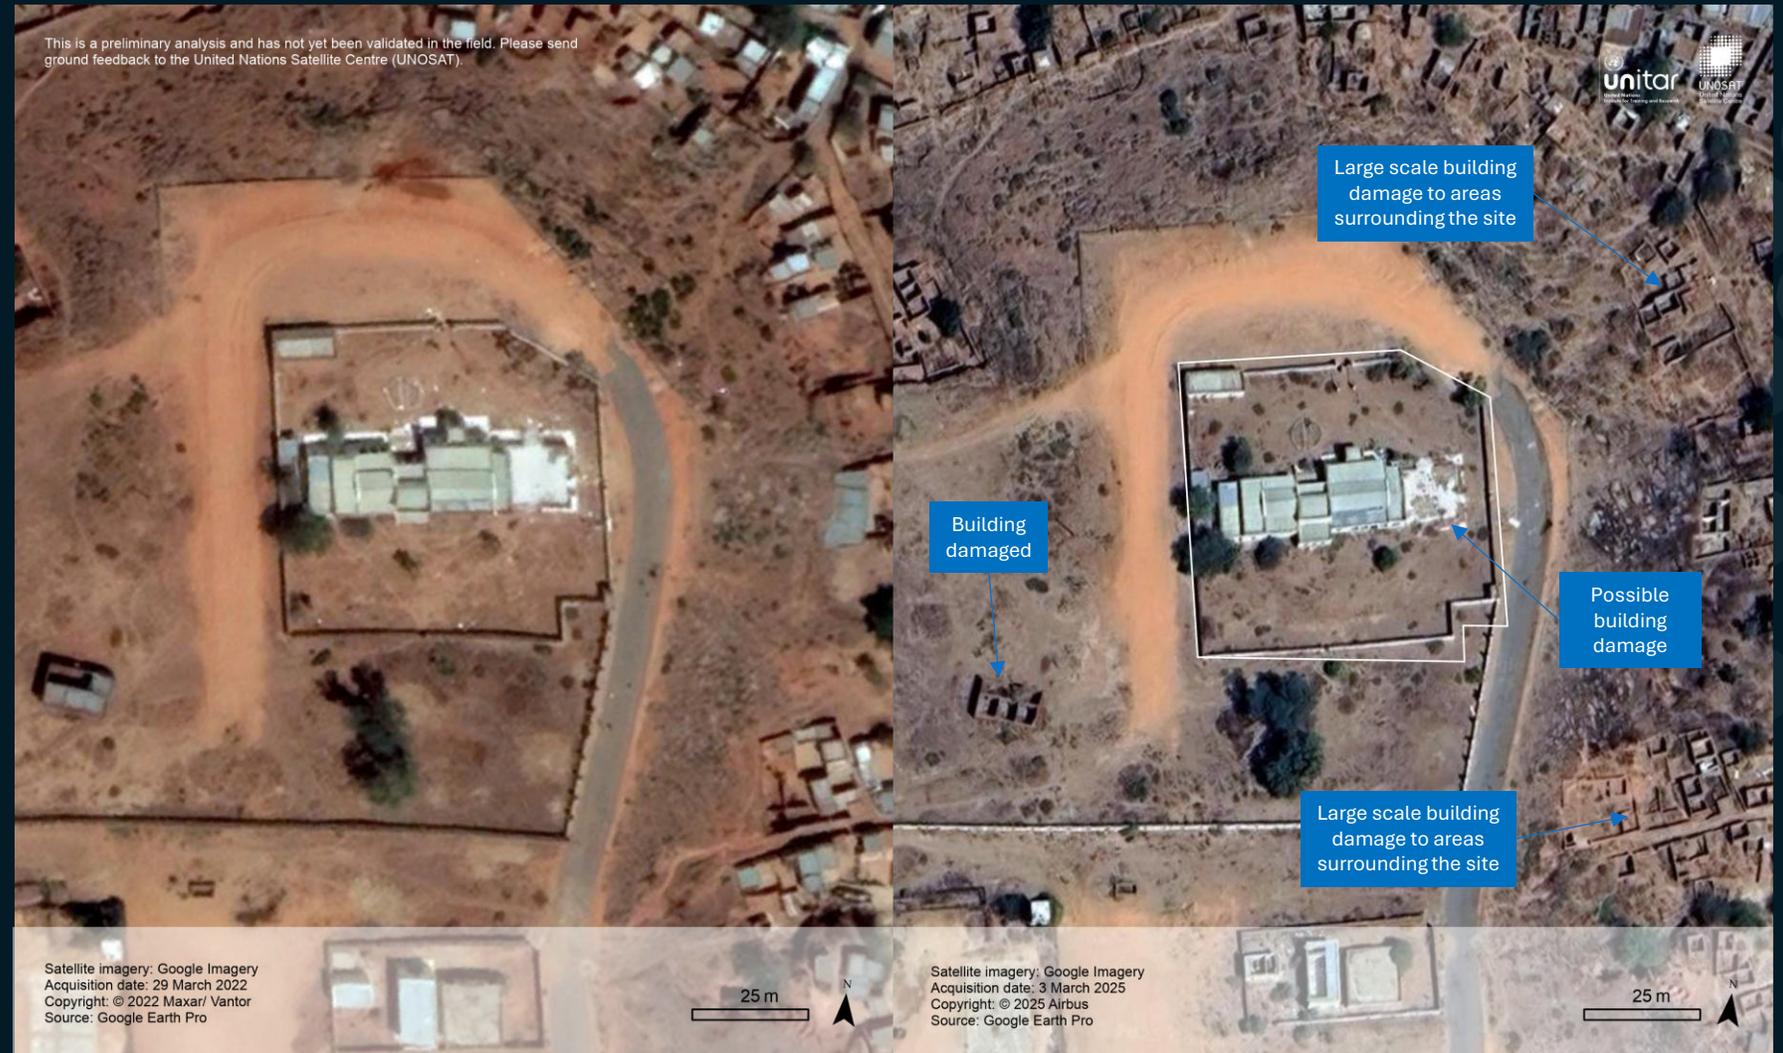
This page illustrates damage observed from a very-high resolution image captured by a WorldView-2 satellite on the 31 October 2025. It shows possible damage to a roof of one of the museum buildings. Additionally, the large residential area surrounding the museum (on the Eastern side) has been destroyed, with several buildings missing roofs and looking to be burned.

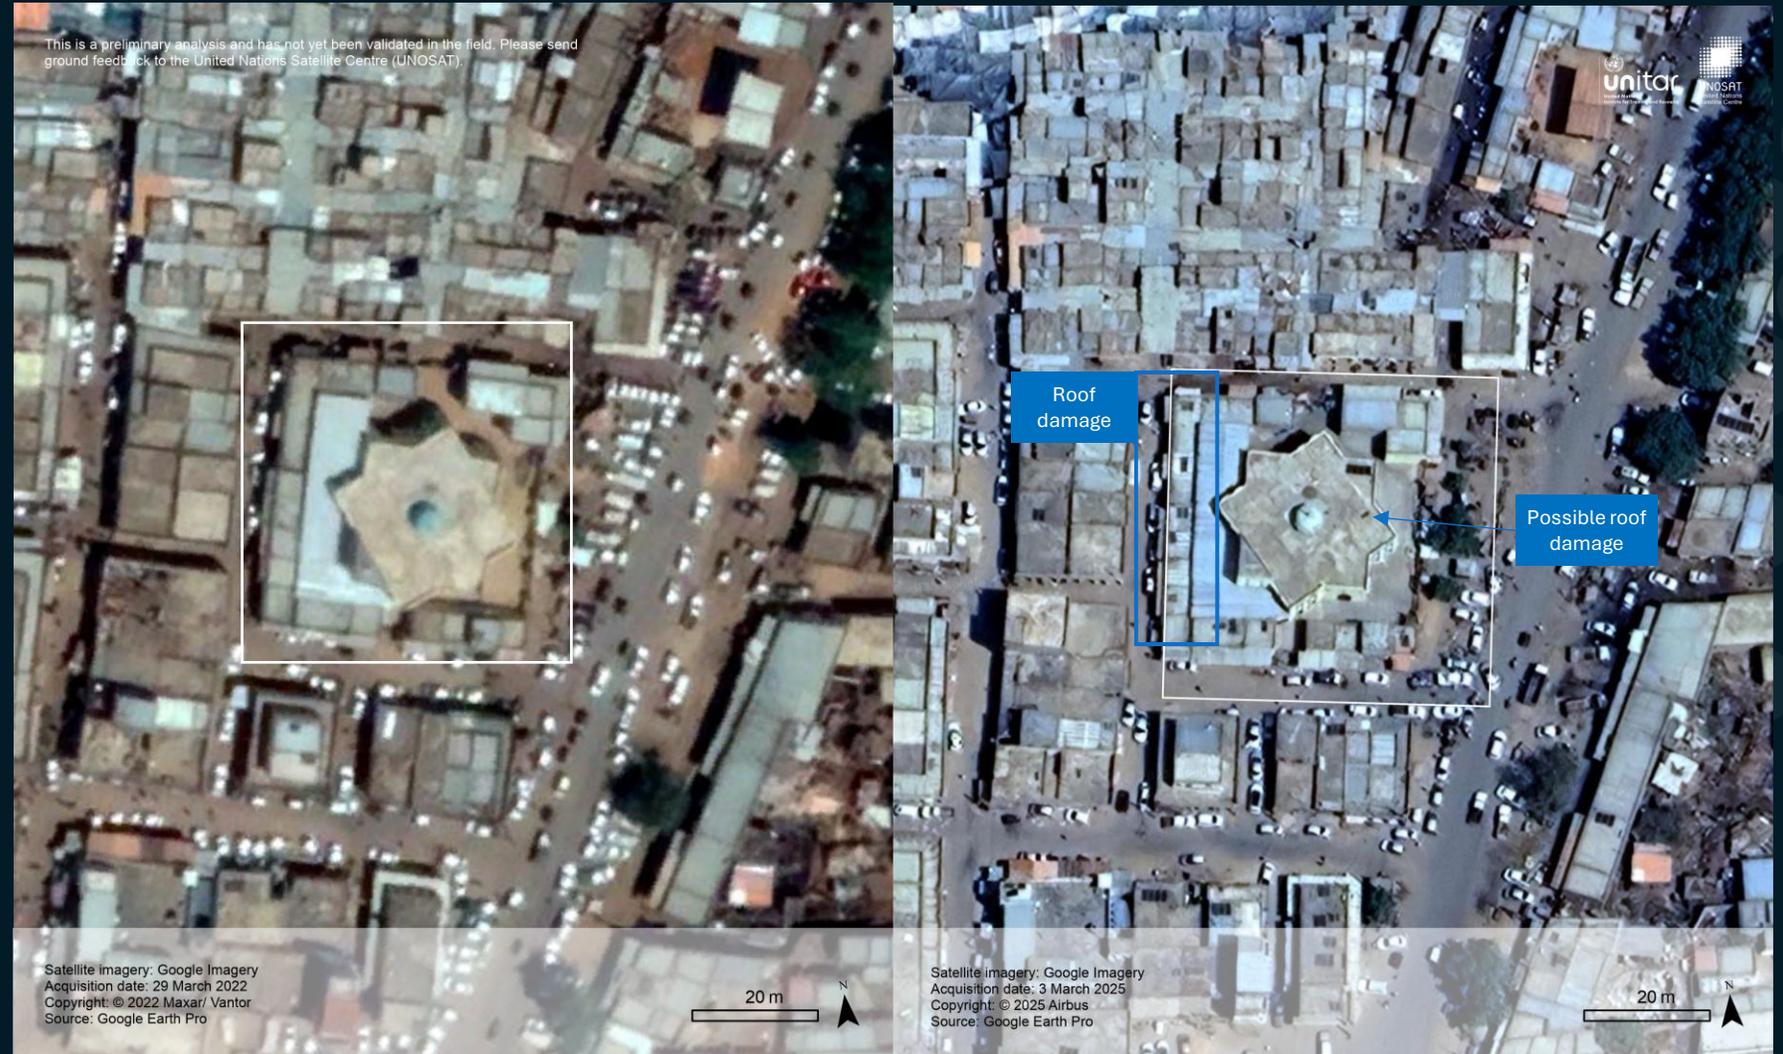
There is possible roof damage to the mosque and the buildings surrounding the mosque to the west look to have sustained roof damage in several locations.

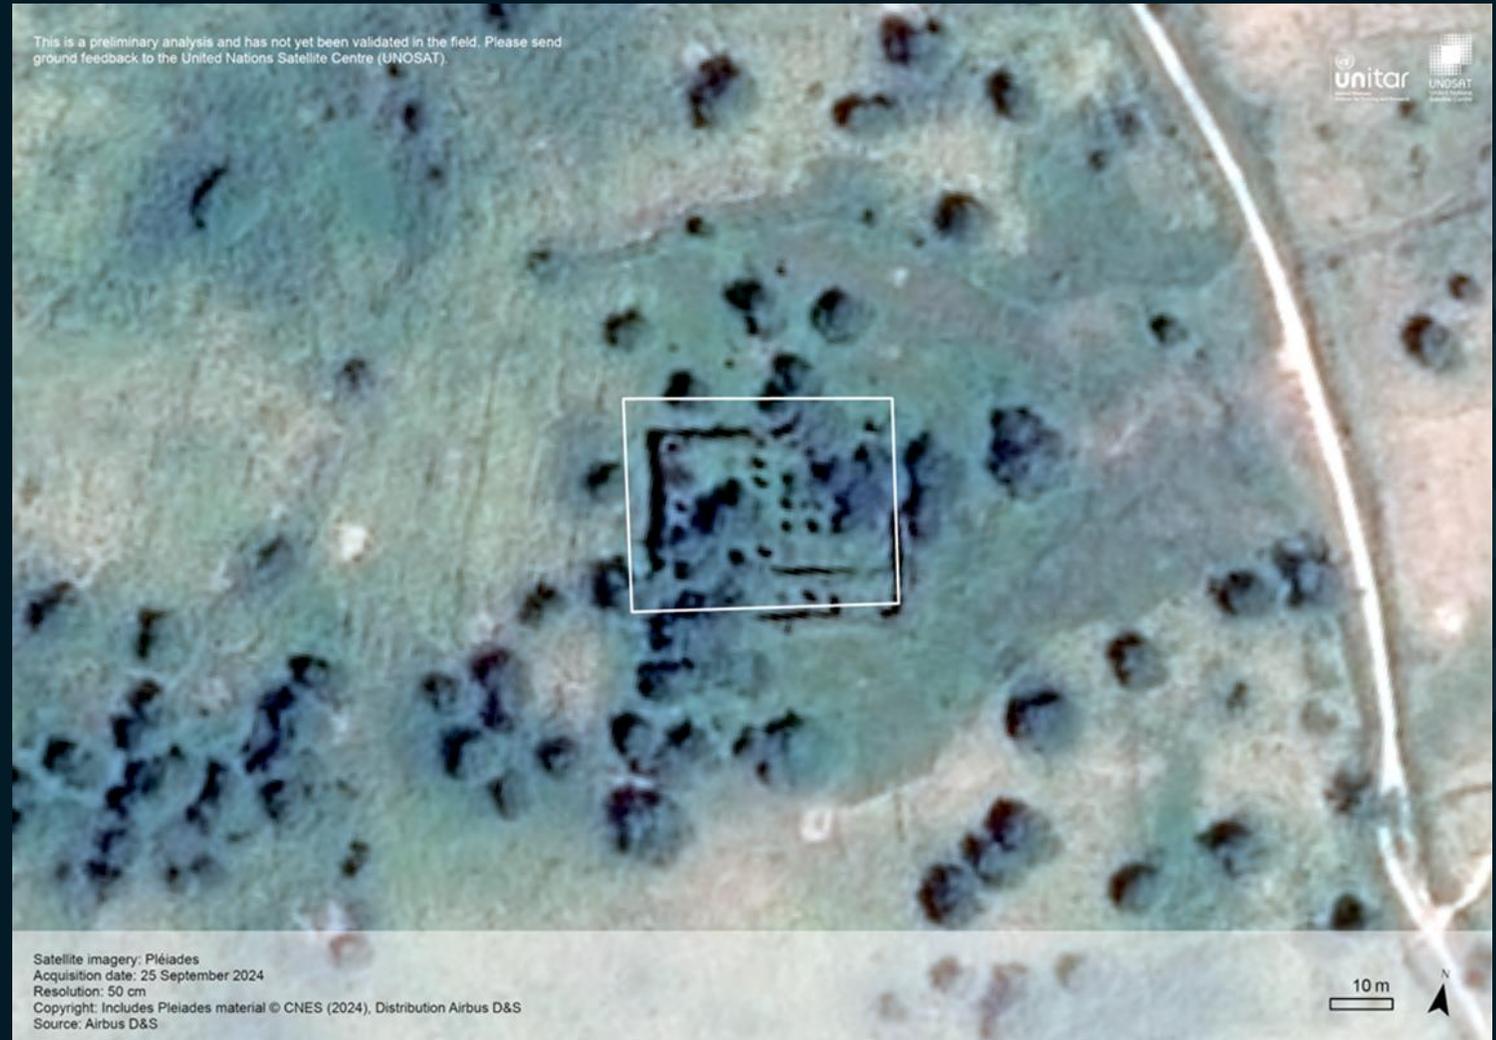
1. Shoba Mosque – Palace of Sultan Mohammed Teirab

This page describes damage observed from a very-high resolution satellite image captured by a WorldView-3 satellite on the 6 October 2025.

This site was also analysed under the UNOSAT Emergency Mapping Service in September 2024 (FL20240826SDN, Charter Activation [917](#)), using a very-high resolution image captured by a Pléiades satellite on the 25 September 2024.

During both assessments no visible damage has been detected on the site.

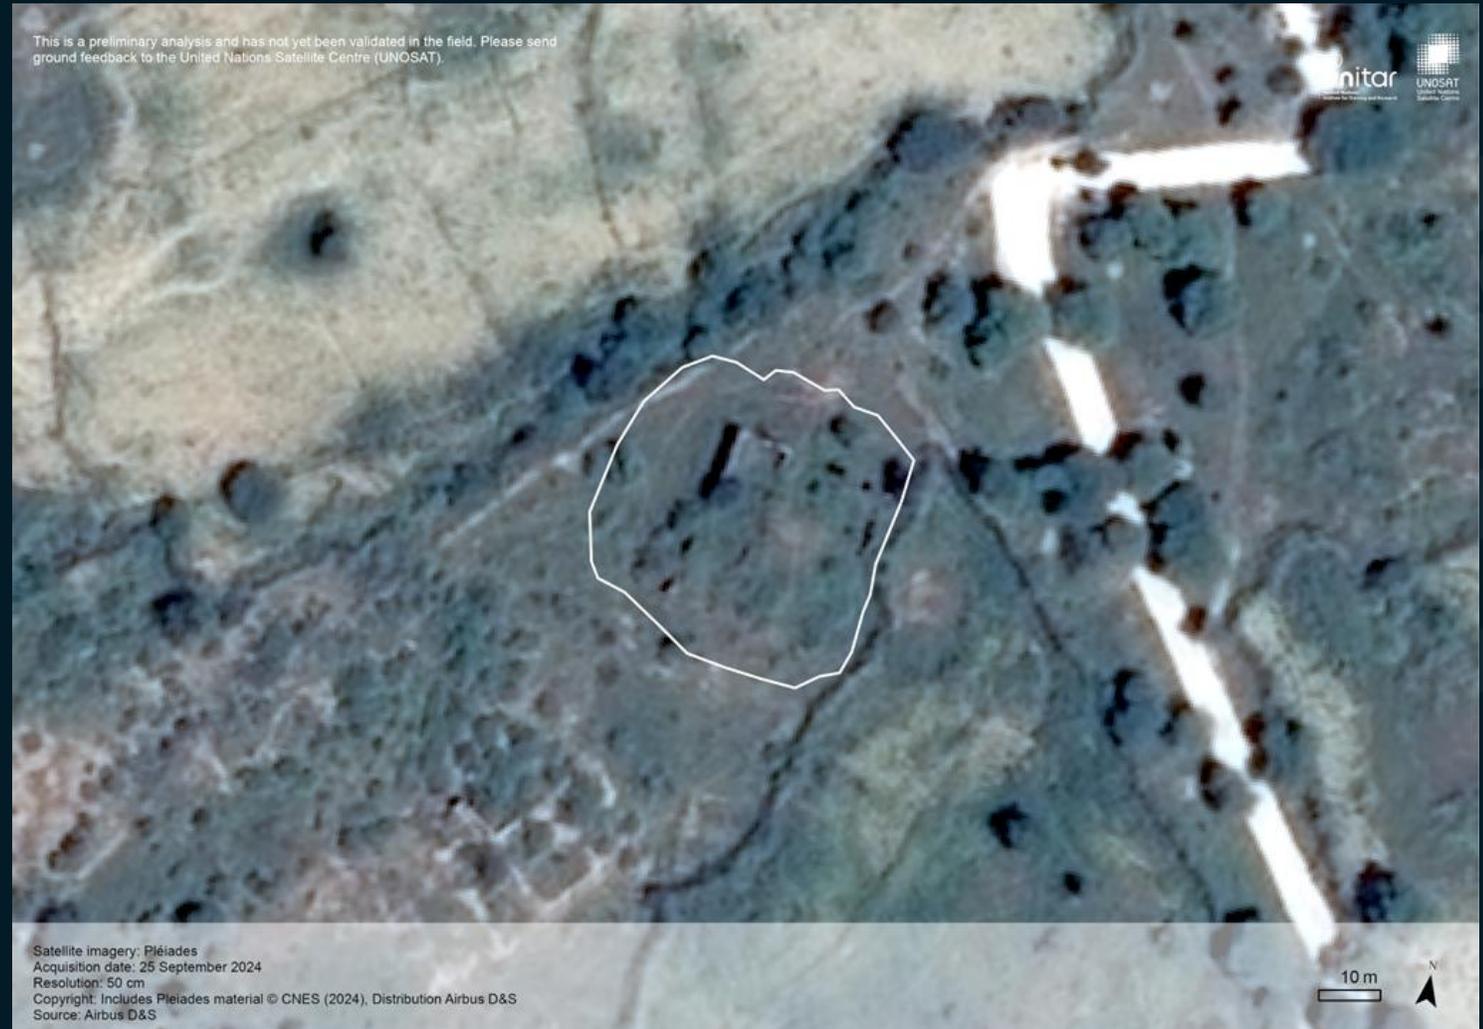
2. Shoba Lower Palace – Palace of Sultan Mohammed Teirab

This page describes damage observed from a very-high resolution satellite image captured by a WorldView-3 satellite on the 6 October 2025.

This site was also analysed under the UNOSAT Emergency Mapping Service in September 2024 (FL20240826SDN, Charter Activation [917](#)), using a very-high resolution image captured by a Pléiades satellite on the 25 September 2024.

During both assessments no visible damage has been detected on the site.

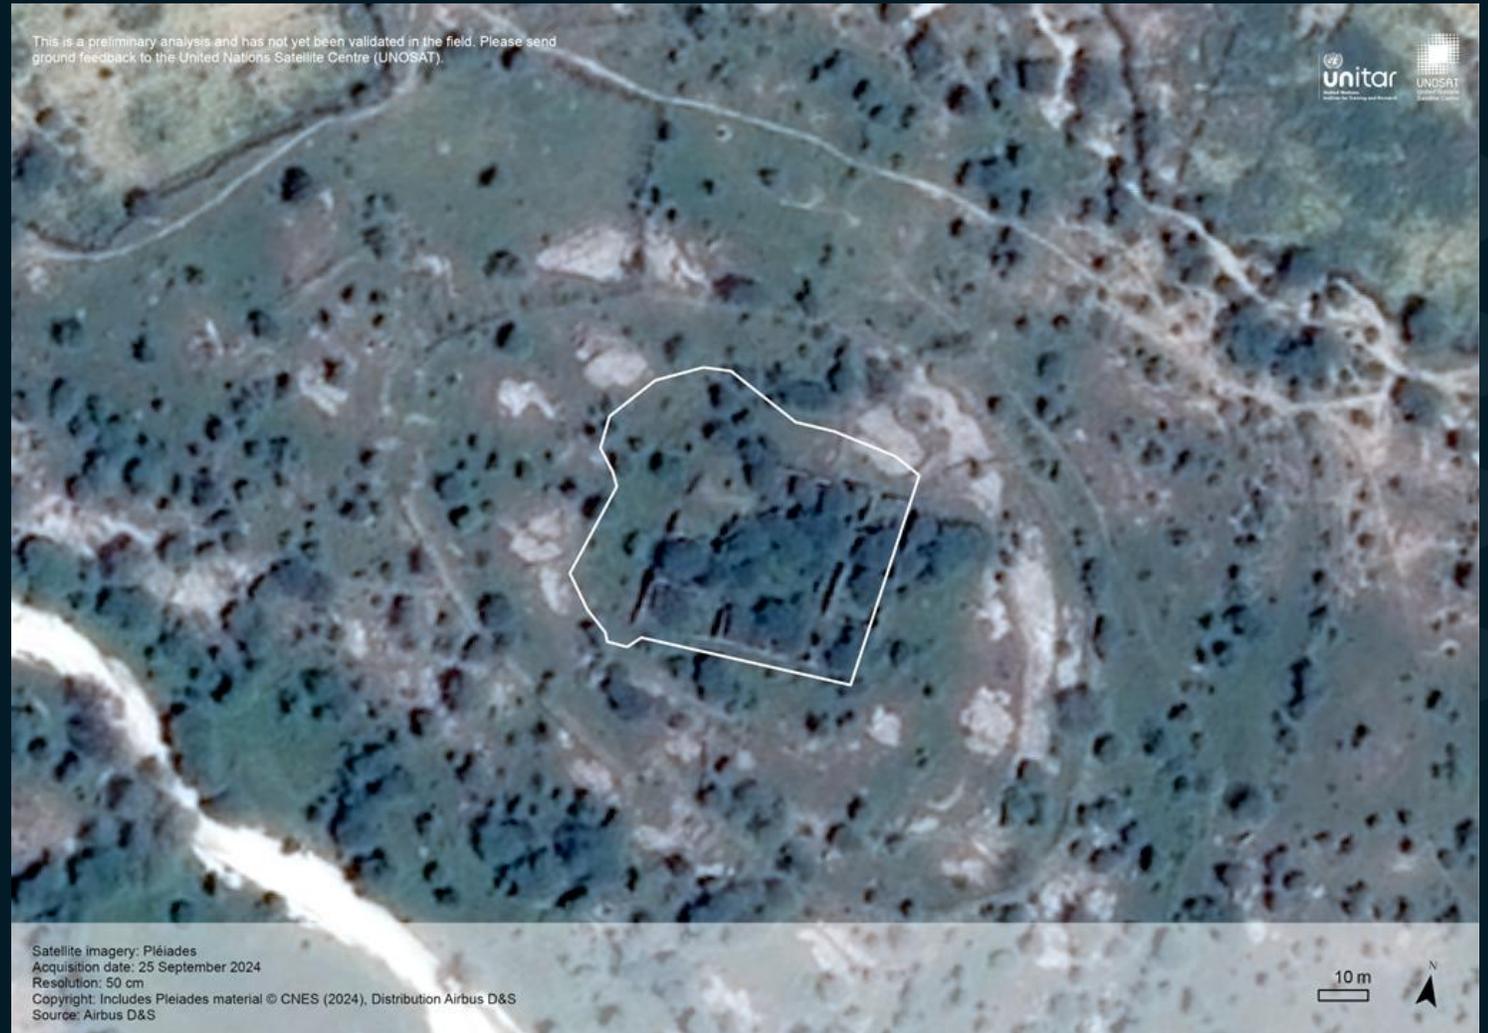
3. Shoba Palace – Palace of Sultan Mohammed Teirab

This page describes damage observed from a very-high resolution satellite image captured by a WorldView-3 satellite on the 6 October 2025.

This site was also analysed under the UNOSAT Emergency Mapping Service in September 2024 (FL20240826SDN, Charter Activation [917](#)), using a very-high resolution image captured by a Pléiades satellite on the 25 September 2024.

During both assessments no visible damage has been detected on the site.

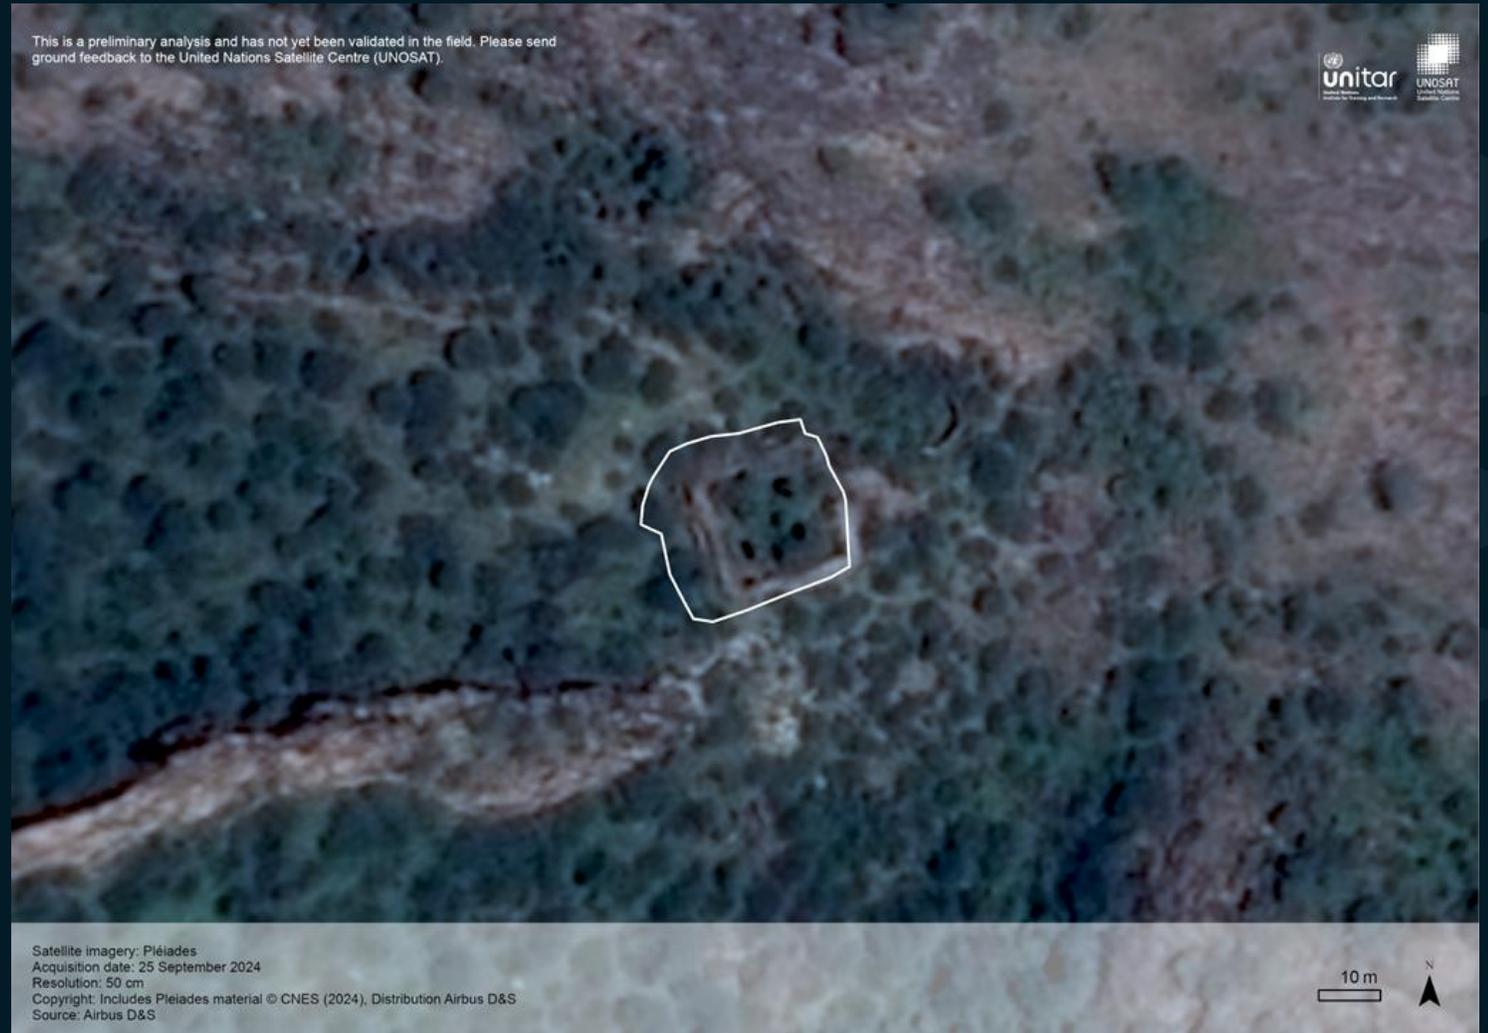
4. Ayn Farrah Mosque

This page describes damage observed from a very-high resolution satellite image captured by a GeoEye-1 satellite on the 11 July 2025.

This site was also analysed under the UNOSAT Emergency Mapping Service in September 2024 (FL20240826SDN, Charter Activation [917](#)), using a very-high resolution image captured by a Pléiades satellite on the 25 September 2024.

During both assessments no visible damage has been detected on the site.
