Satellite-based Damage Assessment

Sectoral Analysis: Cultural Heritage

Sudan

CE20231504SDN

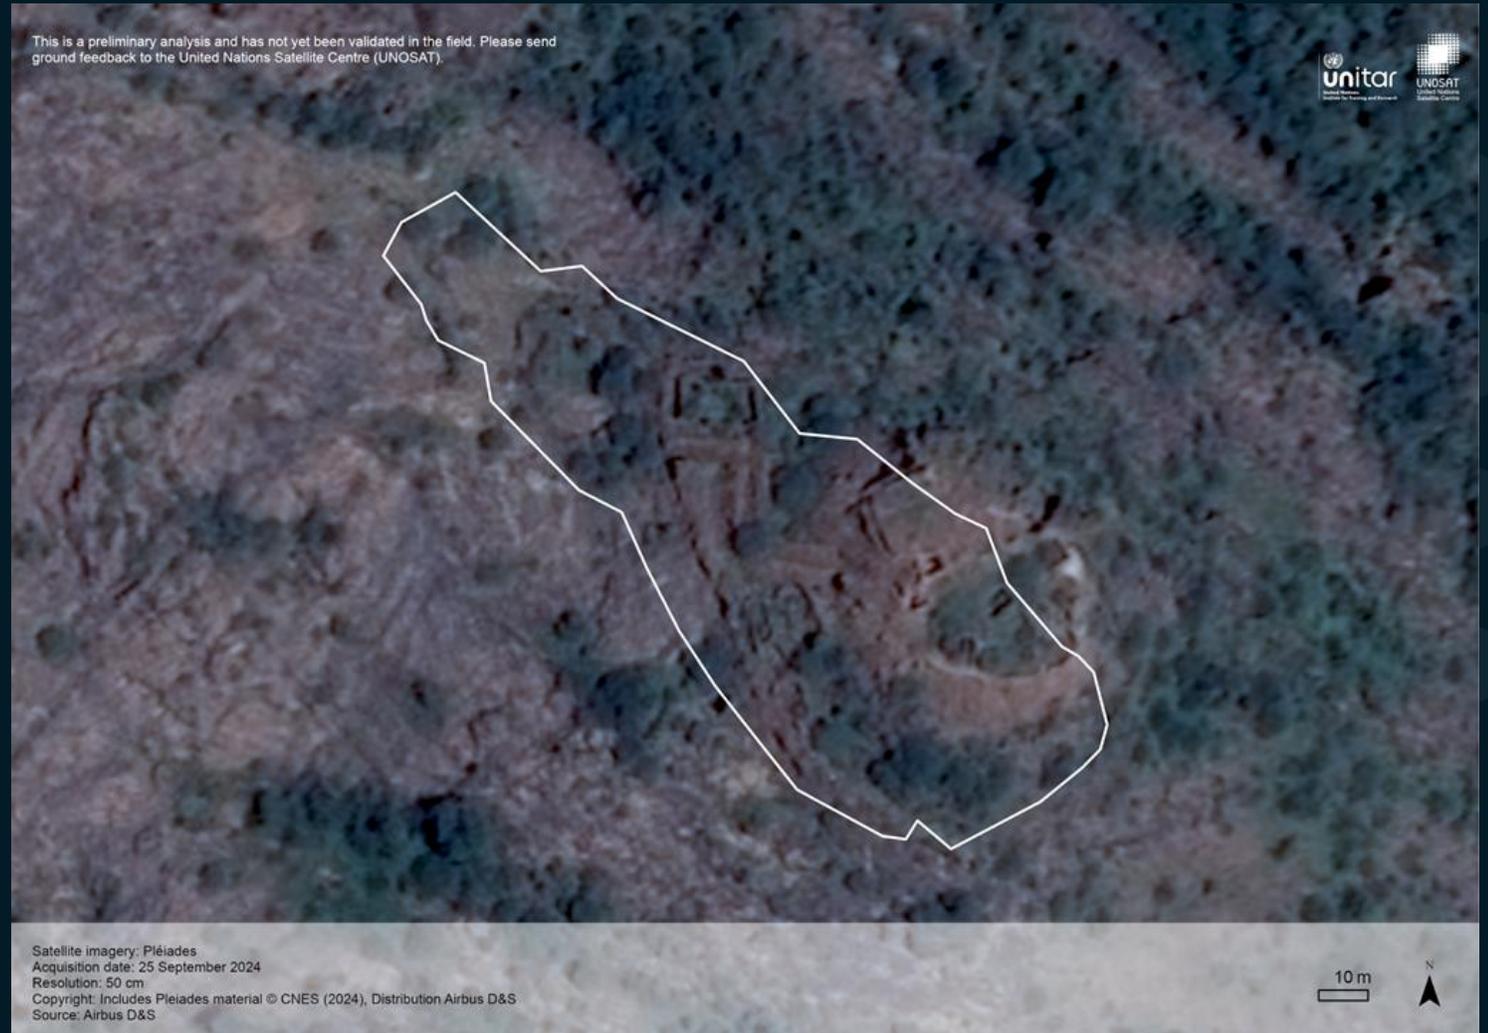
5. Ayn Farrah Palace

This page describes damage observed from a very-high resolution satellite image captured by a GeoEye-1 satellite on the 11 July 2025.

This site was also analysed under the UNOSAT Emergency Mapping Service in September 2024 (FL20240826SDN, Charter Activation [917](#)), using a very-high resolution image captured by a Pléiades satellite on the 25 September 2024.

During both assessments no visible damage has been detected on the site.

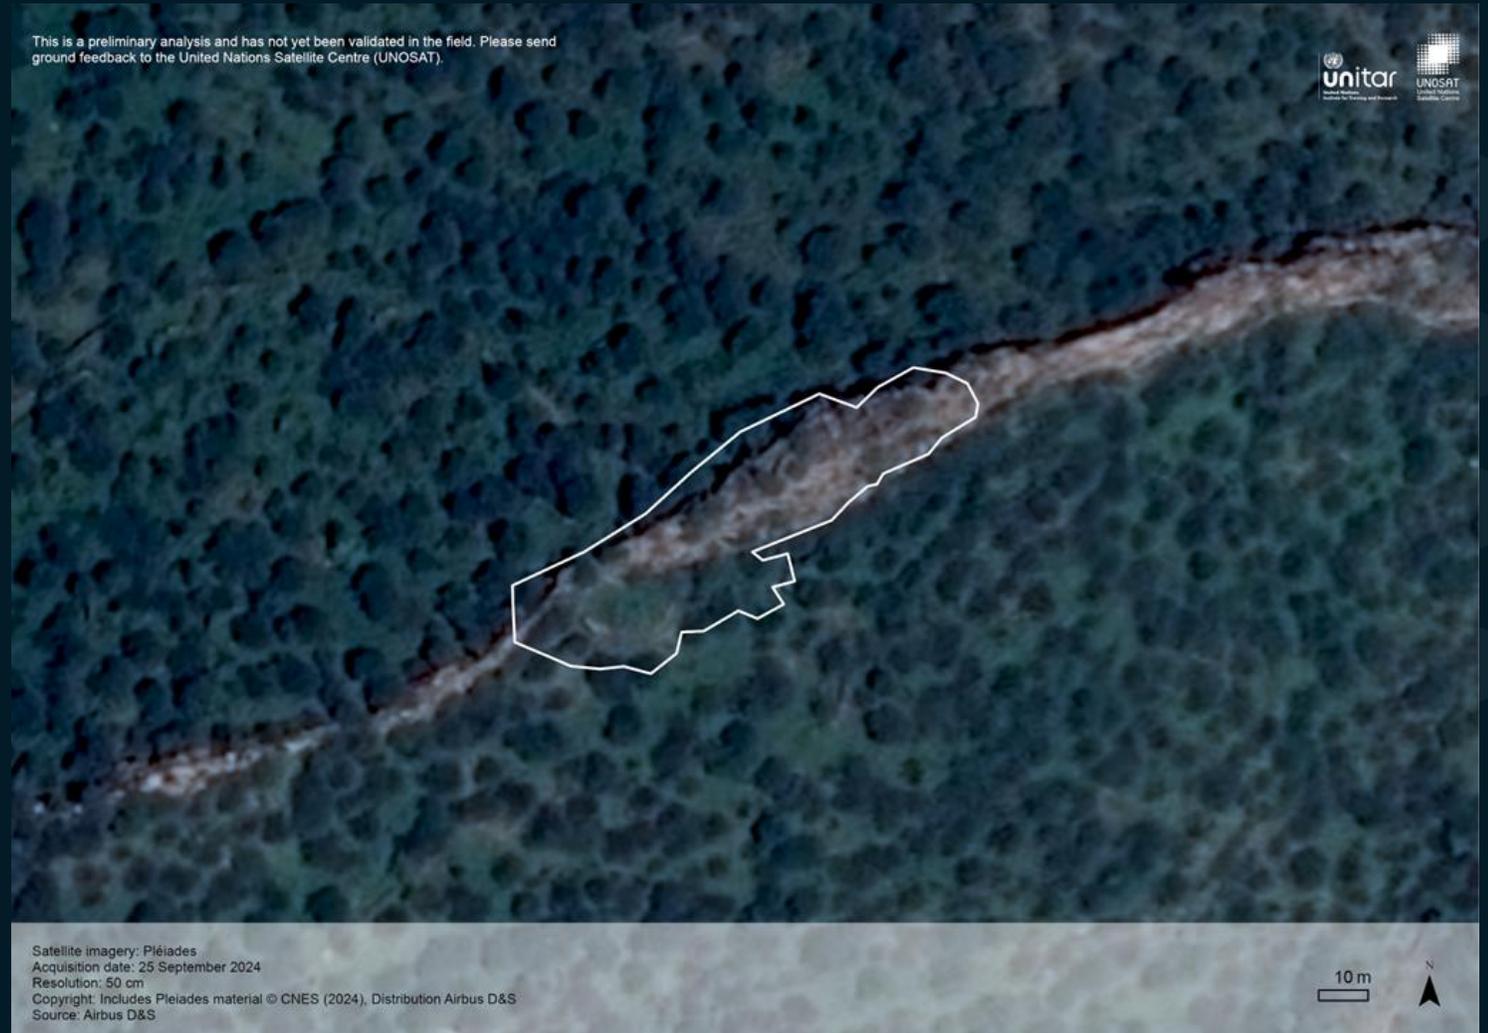
6. Ayn Farrah Lower House

This page describes damage observed from a very-high resolution satellite image captured by a GeoEye-1 satellite on the 11 July 2025.

This site was also analysed under the UNOSAT Emergency Mapping Service in September 2024 (FL20240826SDN, Charter Activation [917](#)), using a very-high resolution image captured by a Pléiades satellite on the 25 September 2024.

During both assessments no visible damage has been detected on the site.

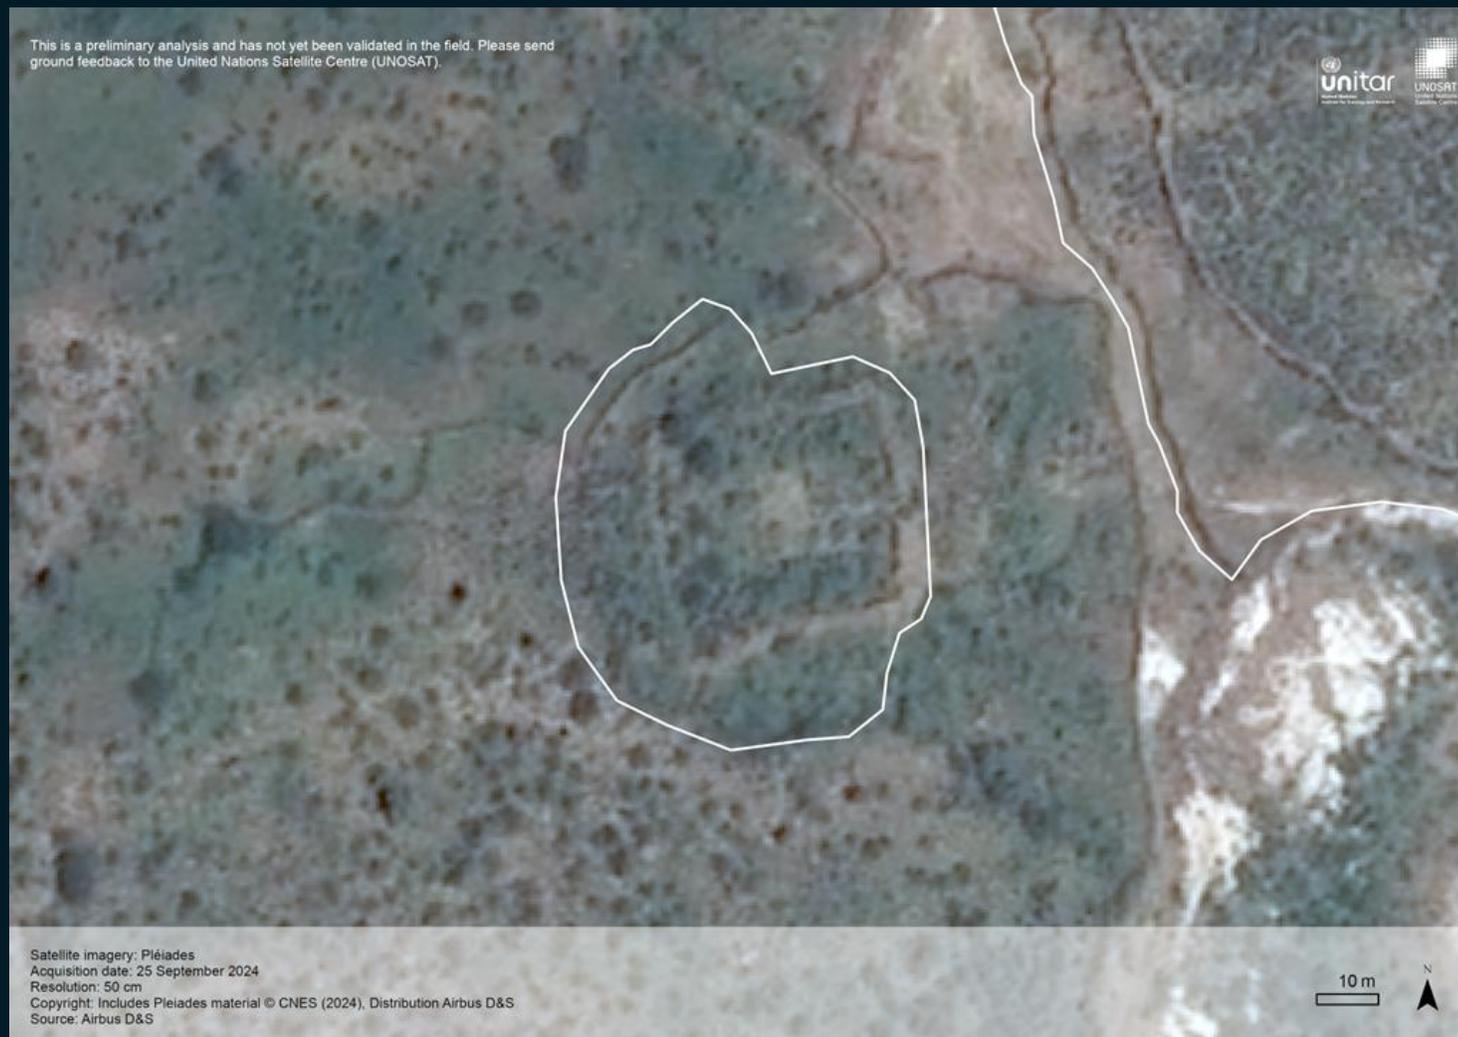
7. Uri Mosque

This site was analysed under the UNOSAT Emergency Mapping Service in September 2024 (FL20240826SDN, Charter Activation [917](#)), using a very-high resolution image captured by a Pléiades satellite on the 25 September 2024.

This analysis indicated no visible damage was detected on the site.

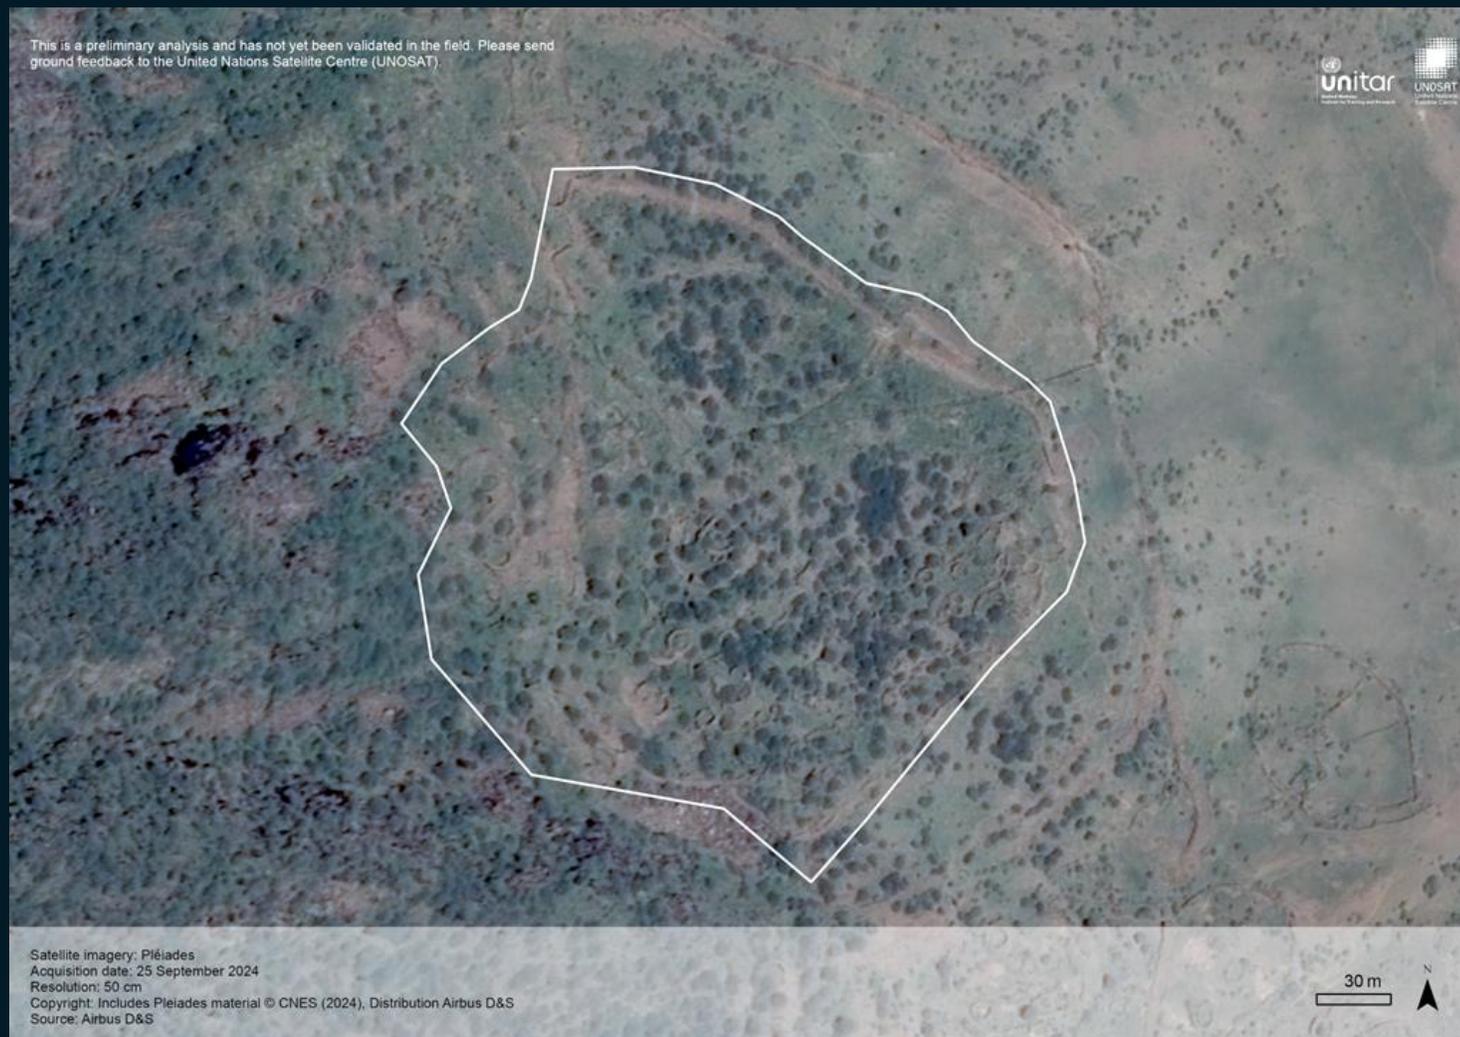
8. Uri Upper Palace

This site was analysed under the UNOSAT Emergency Mapping Service in September 2024 (FL20240826SDN, Charter Activation [917](#)), using a very-high resolution image captured by a Pléiades satellite on the 25 September 2024.

This analysis indicated no visible damage was detected on the site.

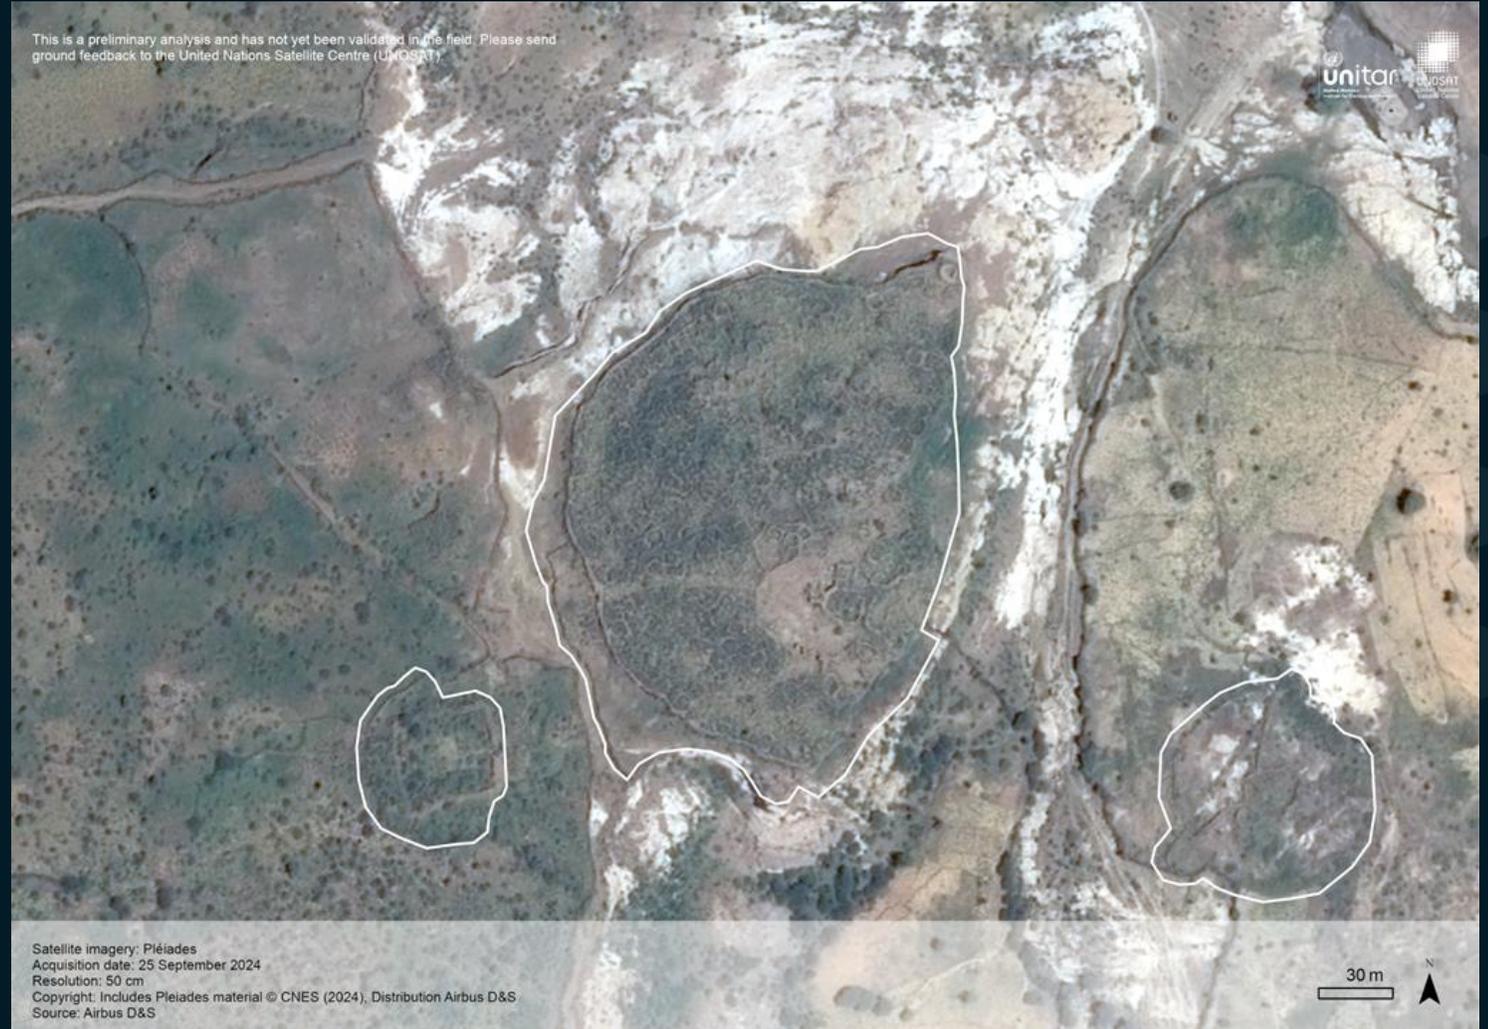
9. Uri Lower Palace

This site was analysed under the UNOSAT Emergency Mapping Service in September 2024 (FL20240826SDN, Charter Activation [917](#)), using a very-high resolution image captured by a Pléiades satellite on the 25 September 2024.

The analysis indicated no visible damage was detected on the site.

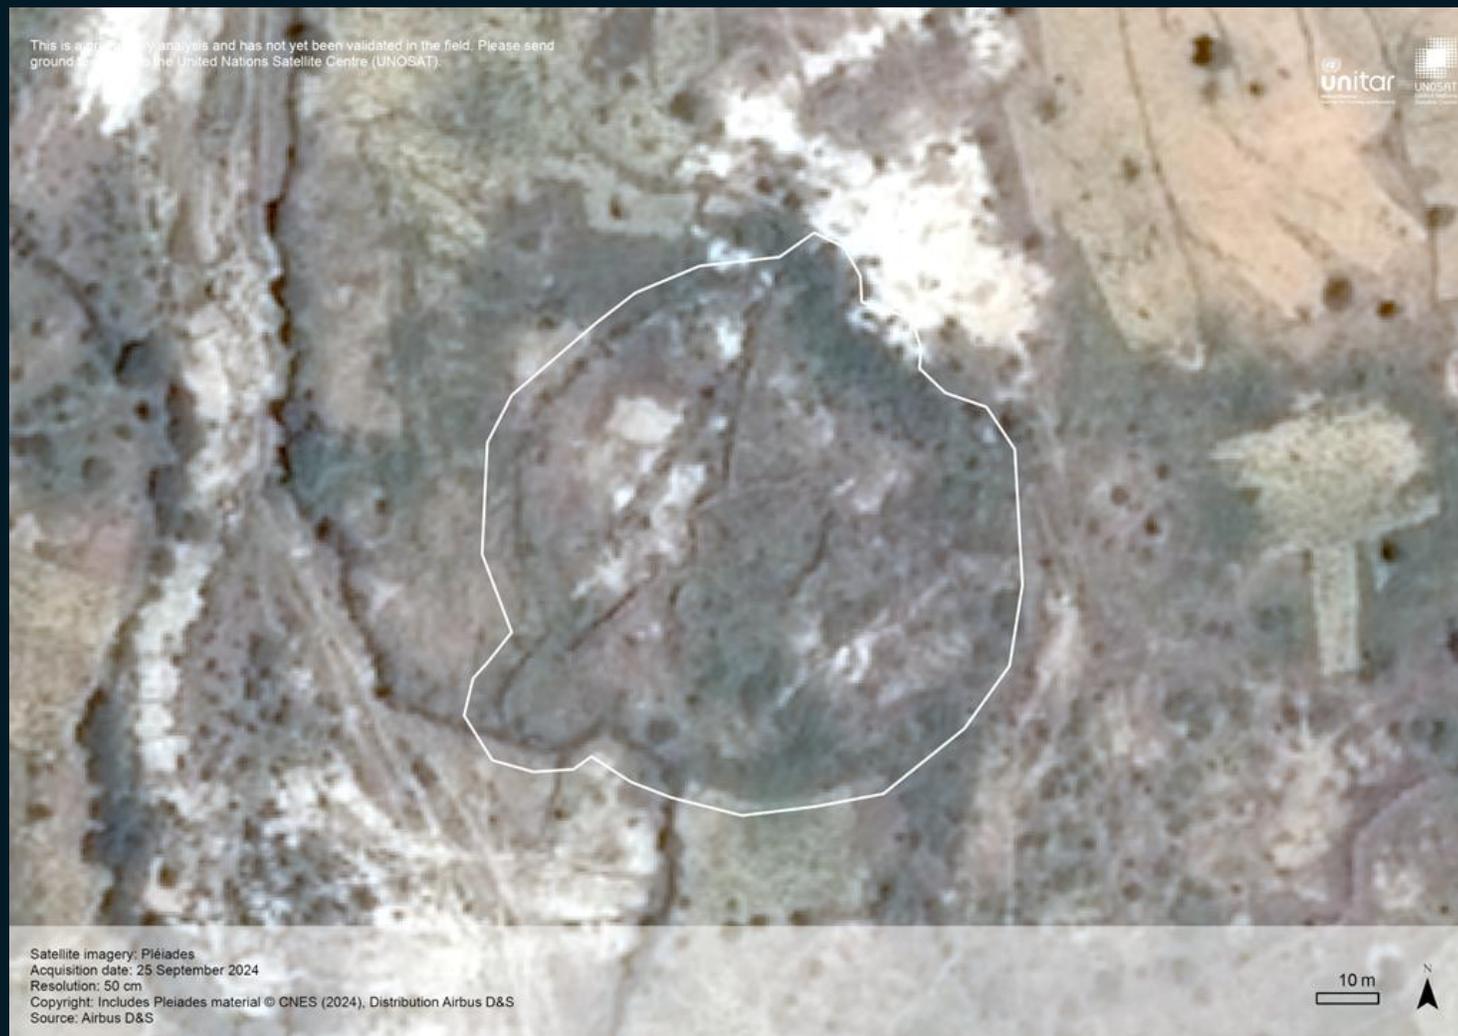
10. Uri Dali House

This site was analysed under the UNOSAT Emergency Mapping Service in September 2024 (FL20240826SDN, Charter Activation [917](#)), using a very-high resolution image captured by a Pléiades satellite on the 25 September 2024.

The analysis indicated no visible damage was detected on the site.

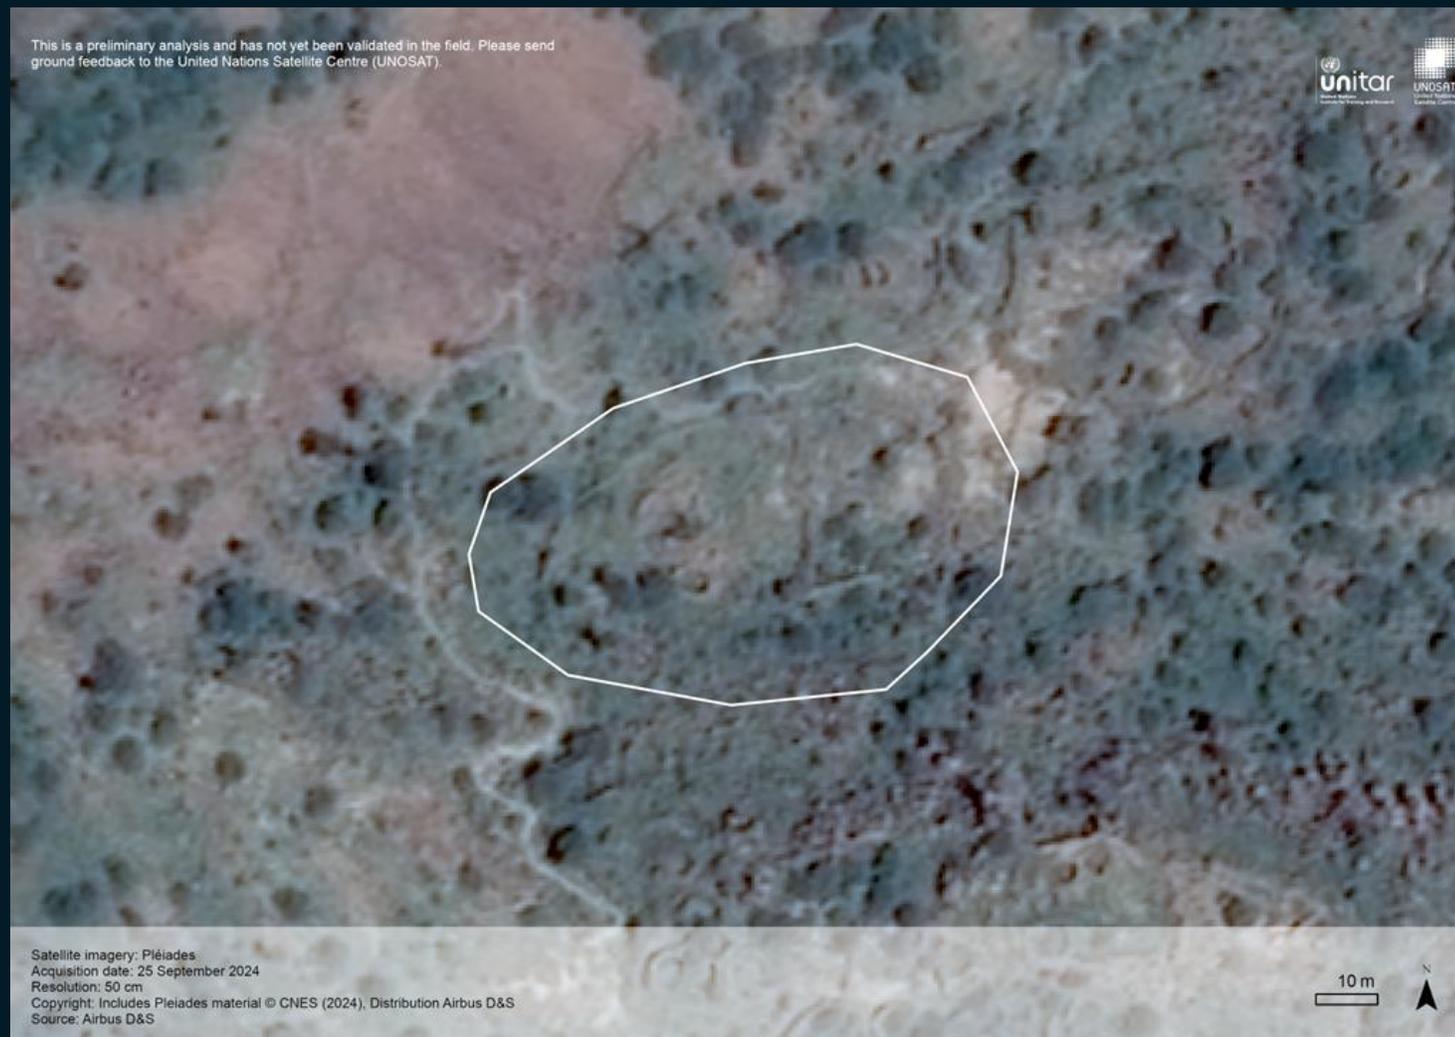
11. Meiram's House - Uri

This site was analysed under the UNOSAT Emergency Mapping Service in September 2024 (FL20240826SDN, Charter Activation [917](#)), using a very-high resolution image captured by a Pléiades satellite on the 25 September 2024.

The analysis indicated no visible damage was detected on the site.

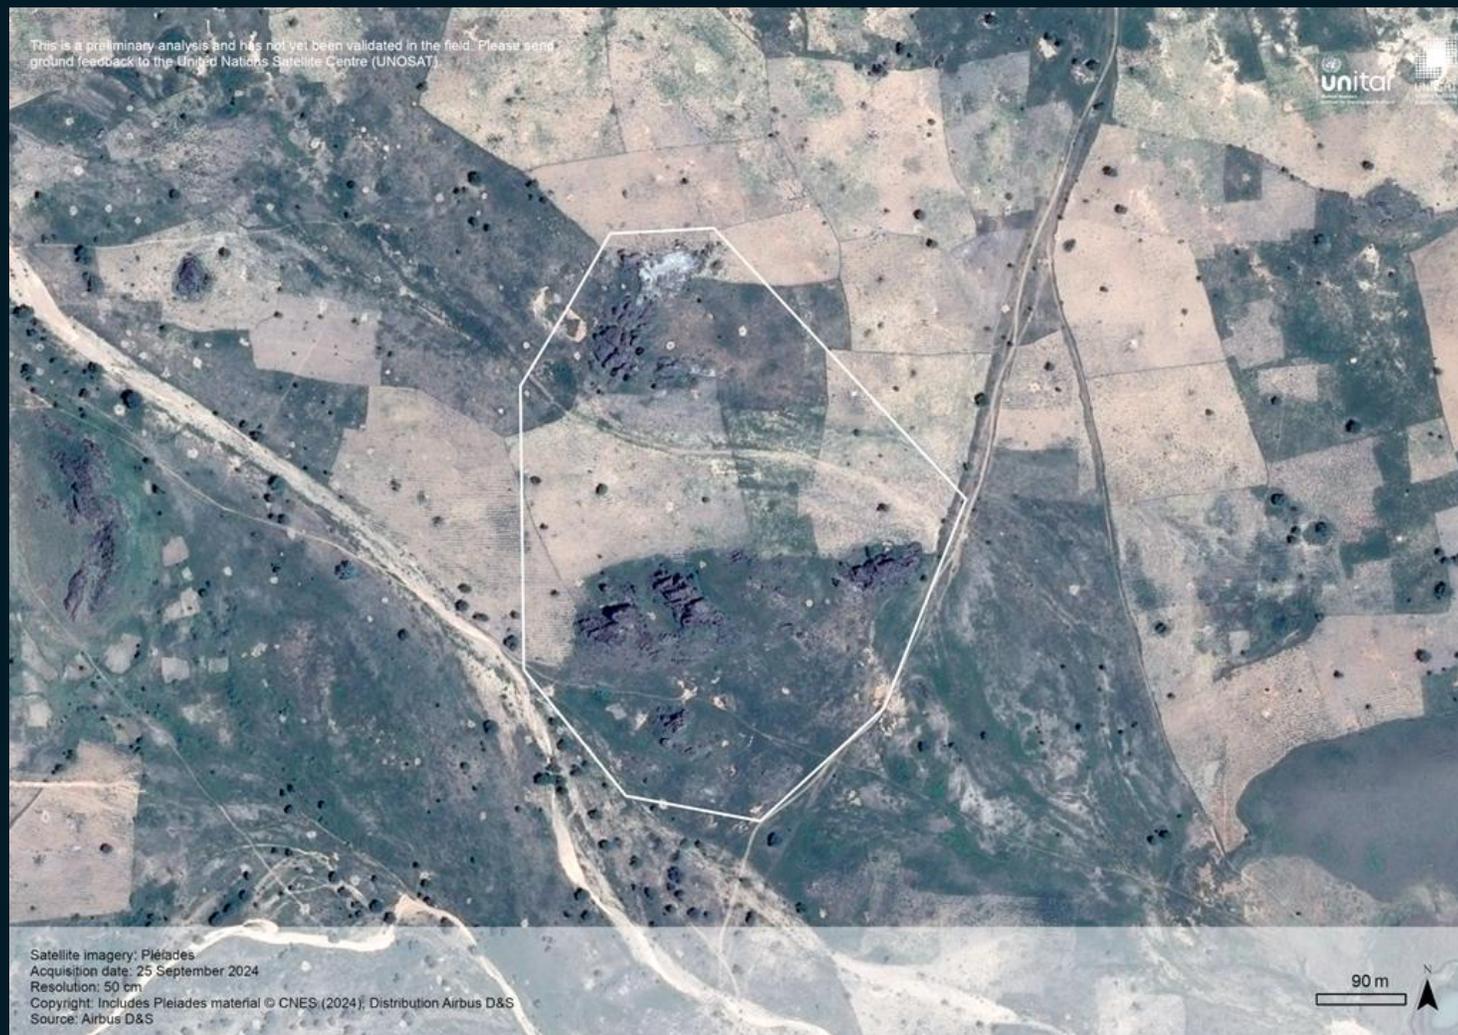
12. Jebel Bonq Bunq - Musical Rocks

This site was also analysed under the UNOSAT Emergency Mapping Service in September 2024 (FL20240826SDN, Charter Activation [917](#)), using a very-high resolution image captured by a Pléiades satellite on the 25 September 2024.

During both assessments no visible damage has been detected on the site.

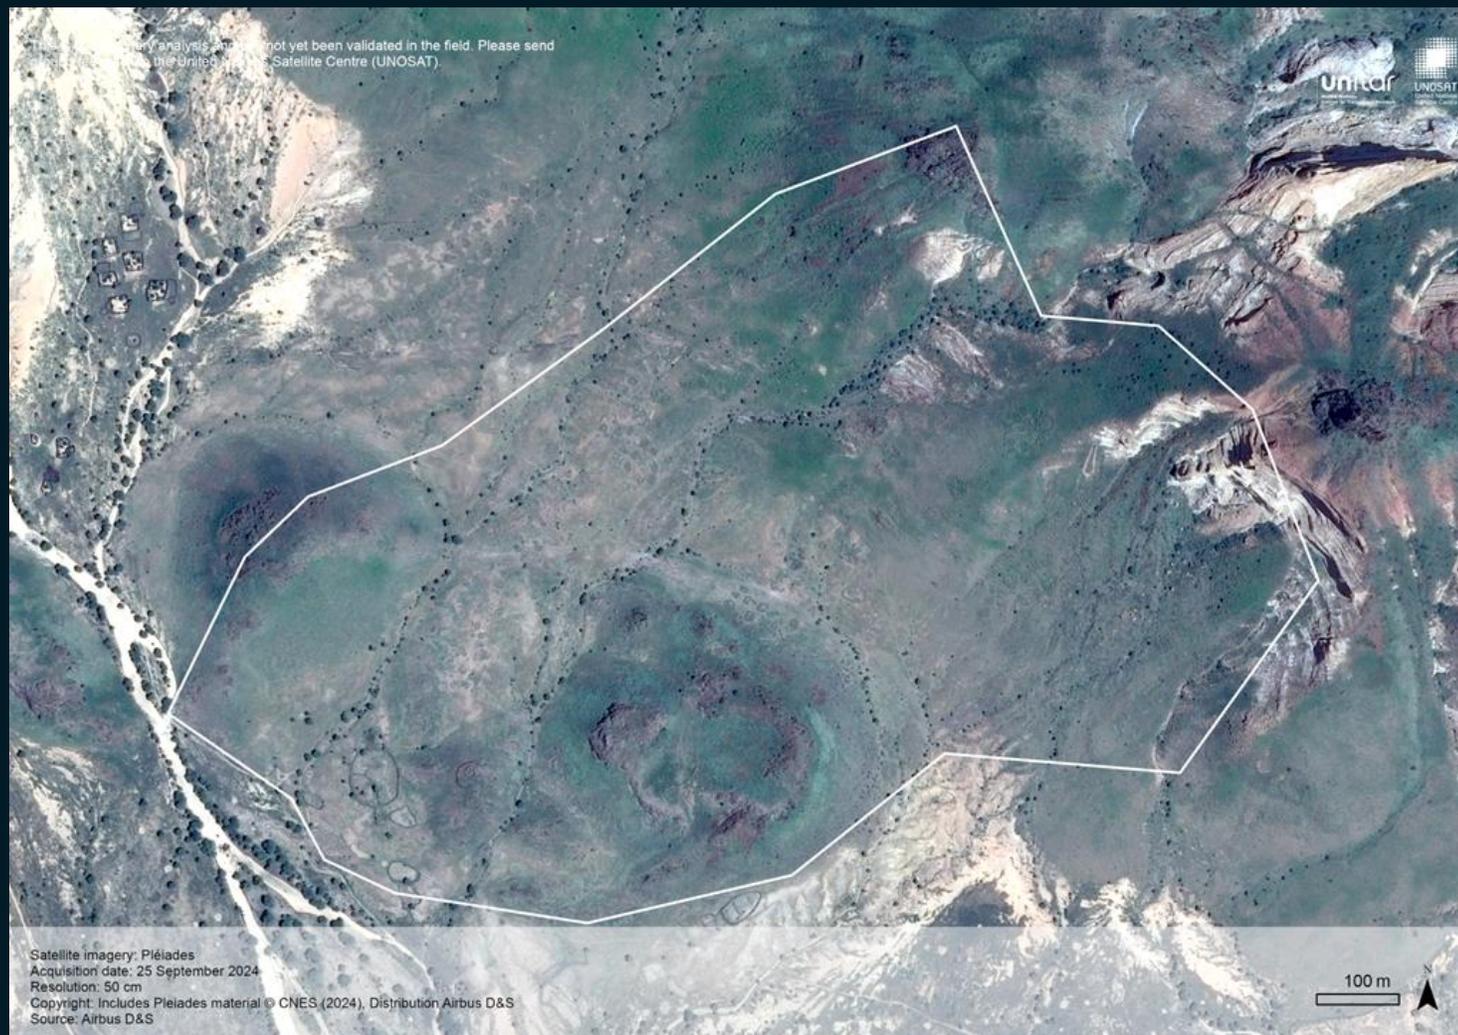
13. Jebel Abri - Rock Art

This site was also analysed under the UNOSAT Emergency Mapping Service in September 2024 (FL20240826SDN, Charter Activation [917](#)), using a very-high resolution image captured by a Pléiades satellite on the 25 September 2024.

During both assessments no visible damage has been detected on the site.

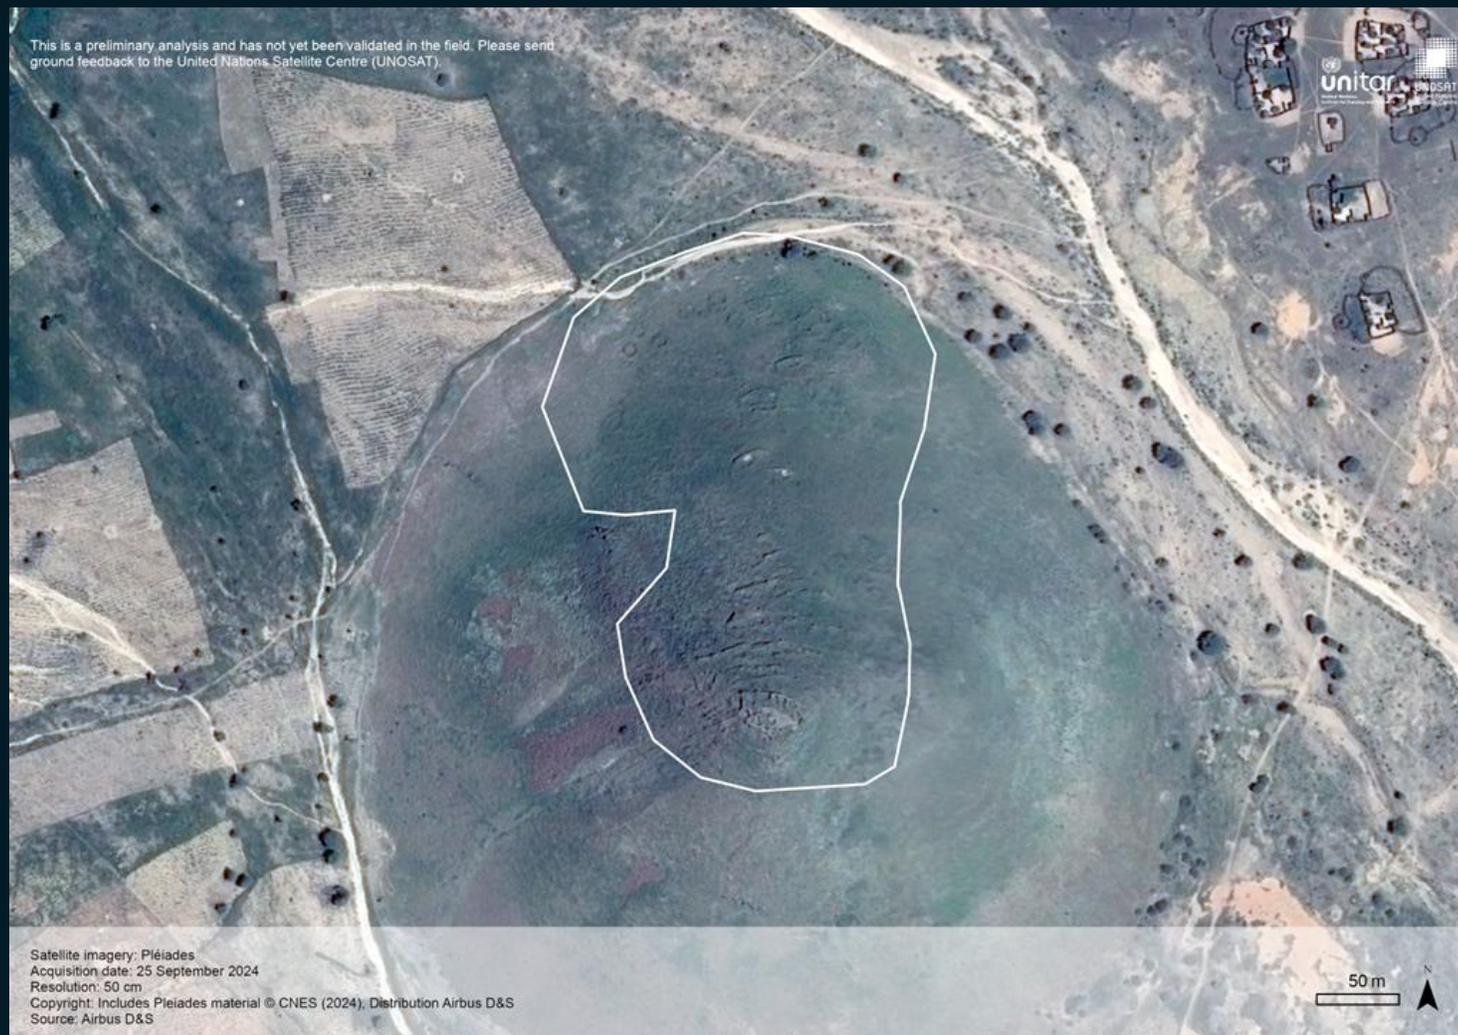
14. Jebel Souqoro - Palace of Nyamadu

This site was also analysed under the UNOSAT Emergency Mapping Service in September 2024 (FL20240826SDN, Charter Activation [917](#)), using a very-high resolution image captured by a Pléiades satellite on the 25 September 2024.

During both assessments no visible damage has been detected on the site.

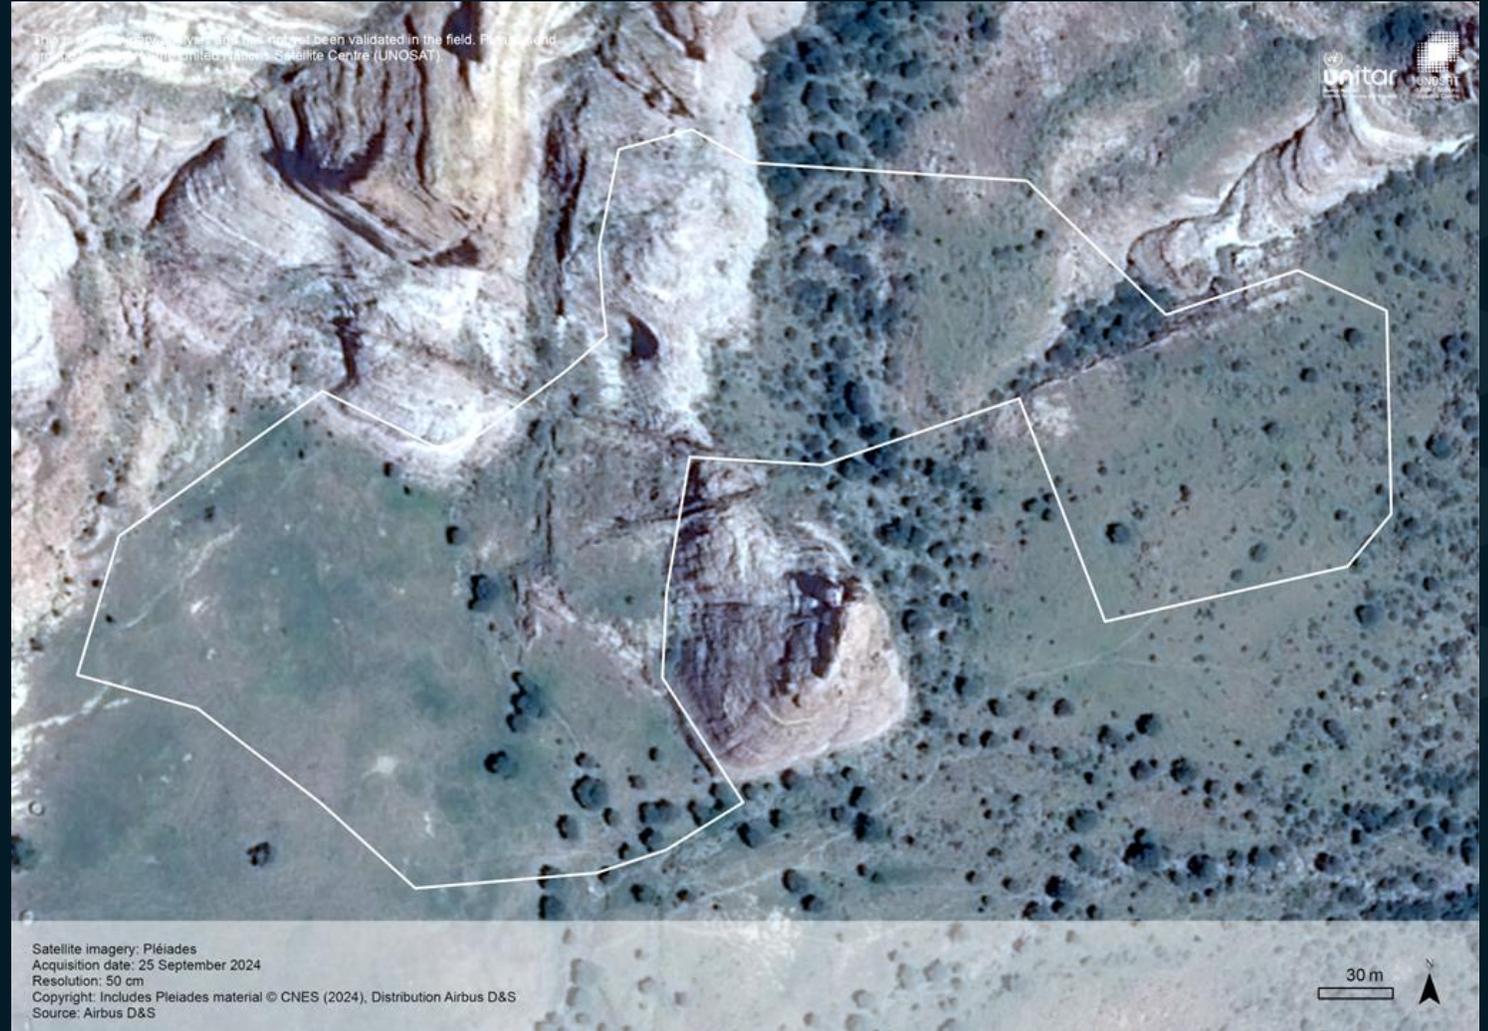
15. Mao Houses

This site was also analysed under the UNOSAT Emergency Mapping Service in September 2024 (FL20240826SDN, Charter Activation [917](#)), using a very-high resolution image captured by a Pléiades satellite on the 25 September 2024.

During both assessments no visible damage has been detected on the site.

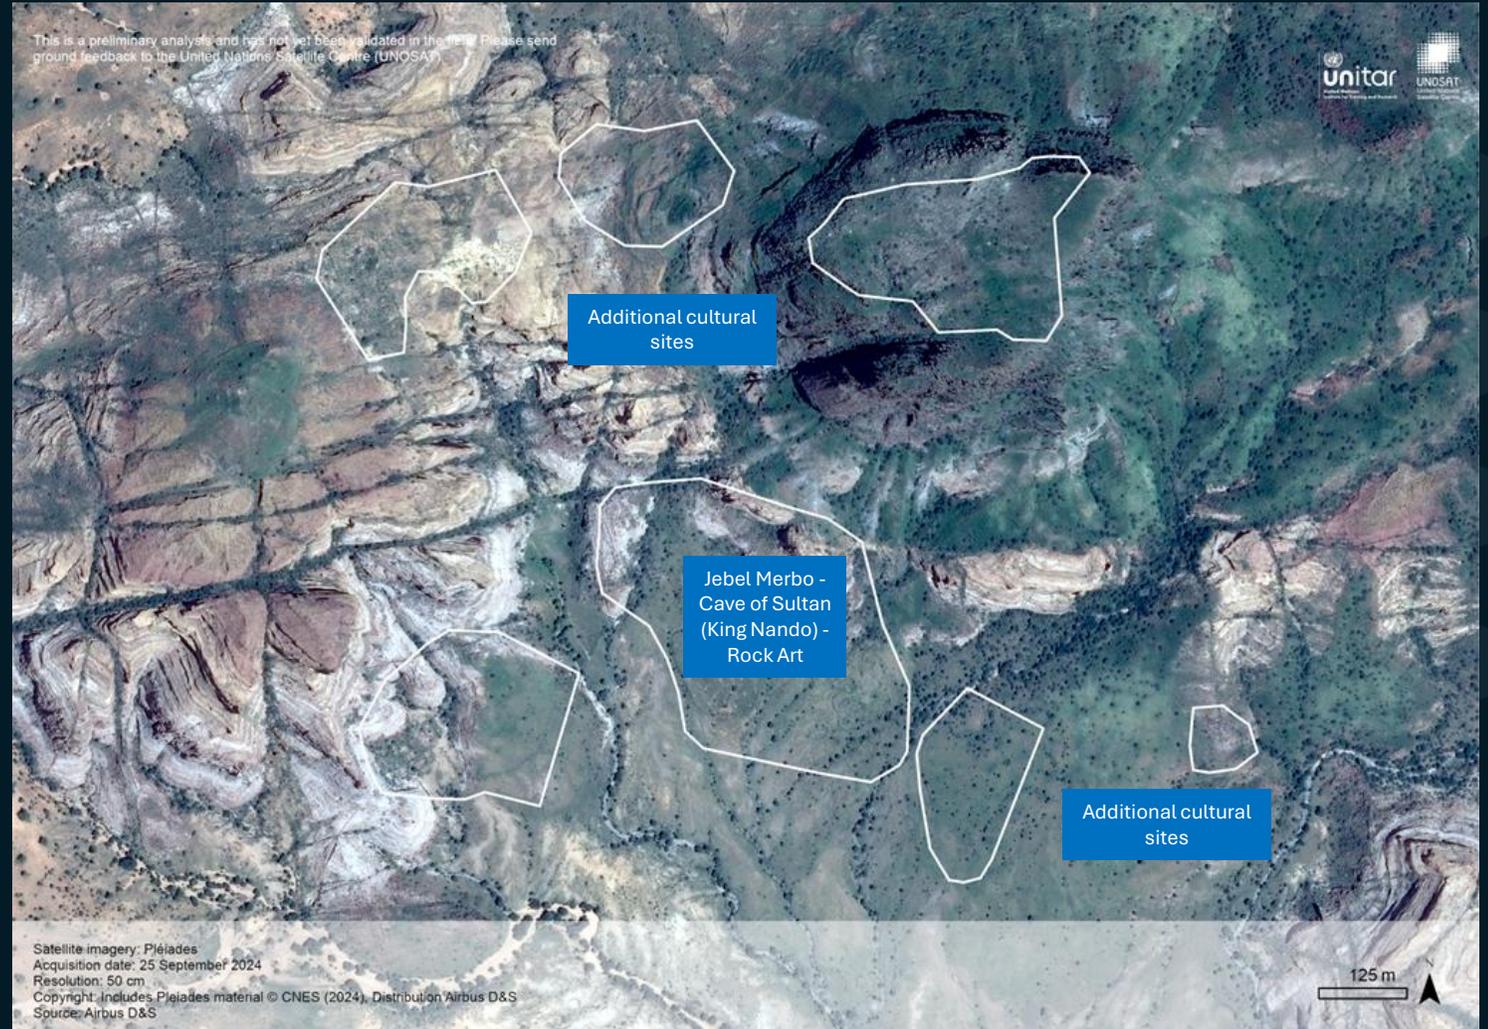
16. Jebel Merbo - Cave of Sultan Nyamadu (King Nando) - Rock Art

This site was also analysed under the UNOSAT Emergency Mapping Service in September 2024 (FL20240826SDN, Charter Activation [917](#)), using a very-high resolution image captured by a Pléiades satellite on the 25 September 2024.

During both assessments no visible damage has been detected on the site or the surrounding areas.

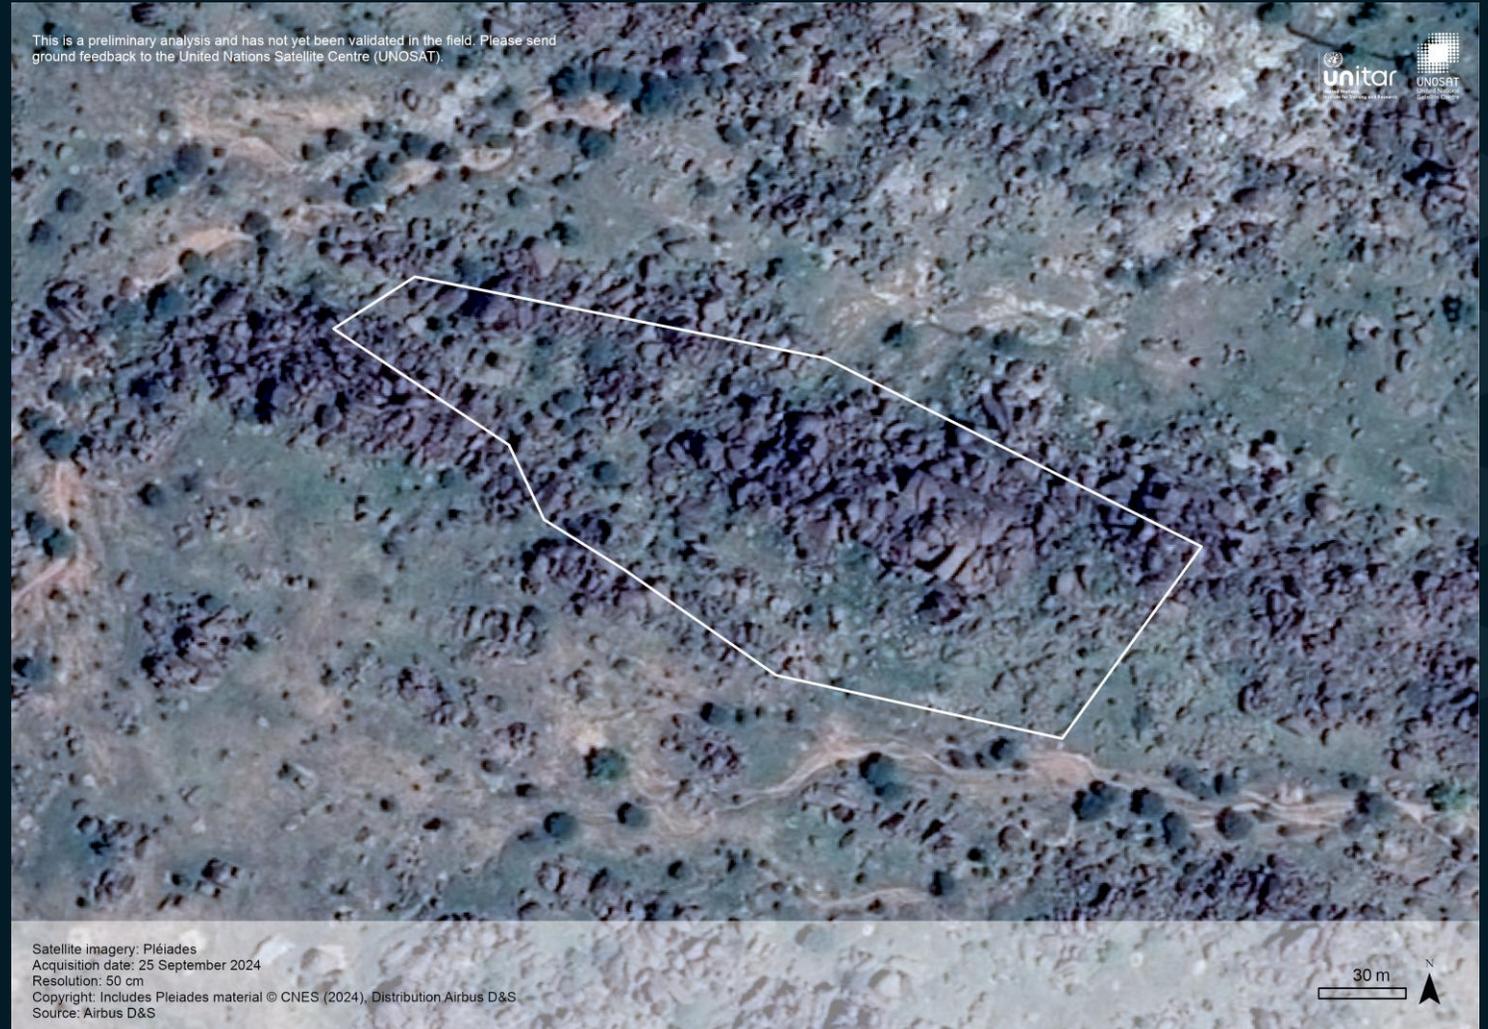
This page describes damage observed from a very-high resolution satellite image captured by a WorldView-3 satellite on the 1 June 2025.

This site was also analysed under the UNOSAT Emergency Mapping Service in September 2024 (FL20240826SDN, Charter Activation [917](#)), using a very-high resolution image captured by a Pléiades satellite on the 25 September 2024.

During both assessments no visible damage has been detected on the site.

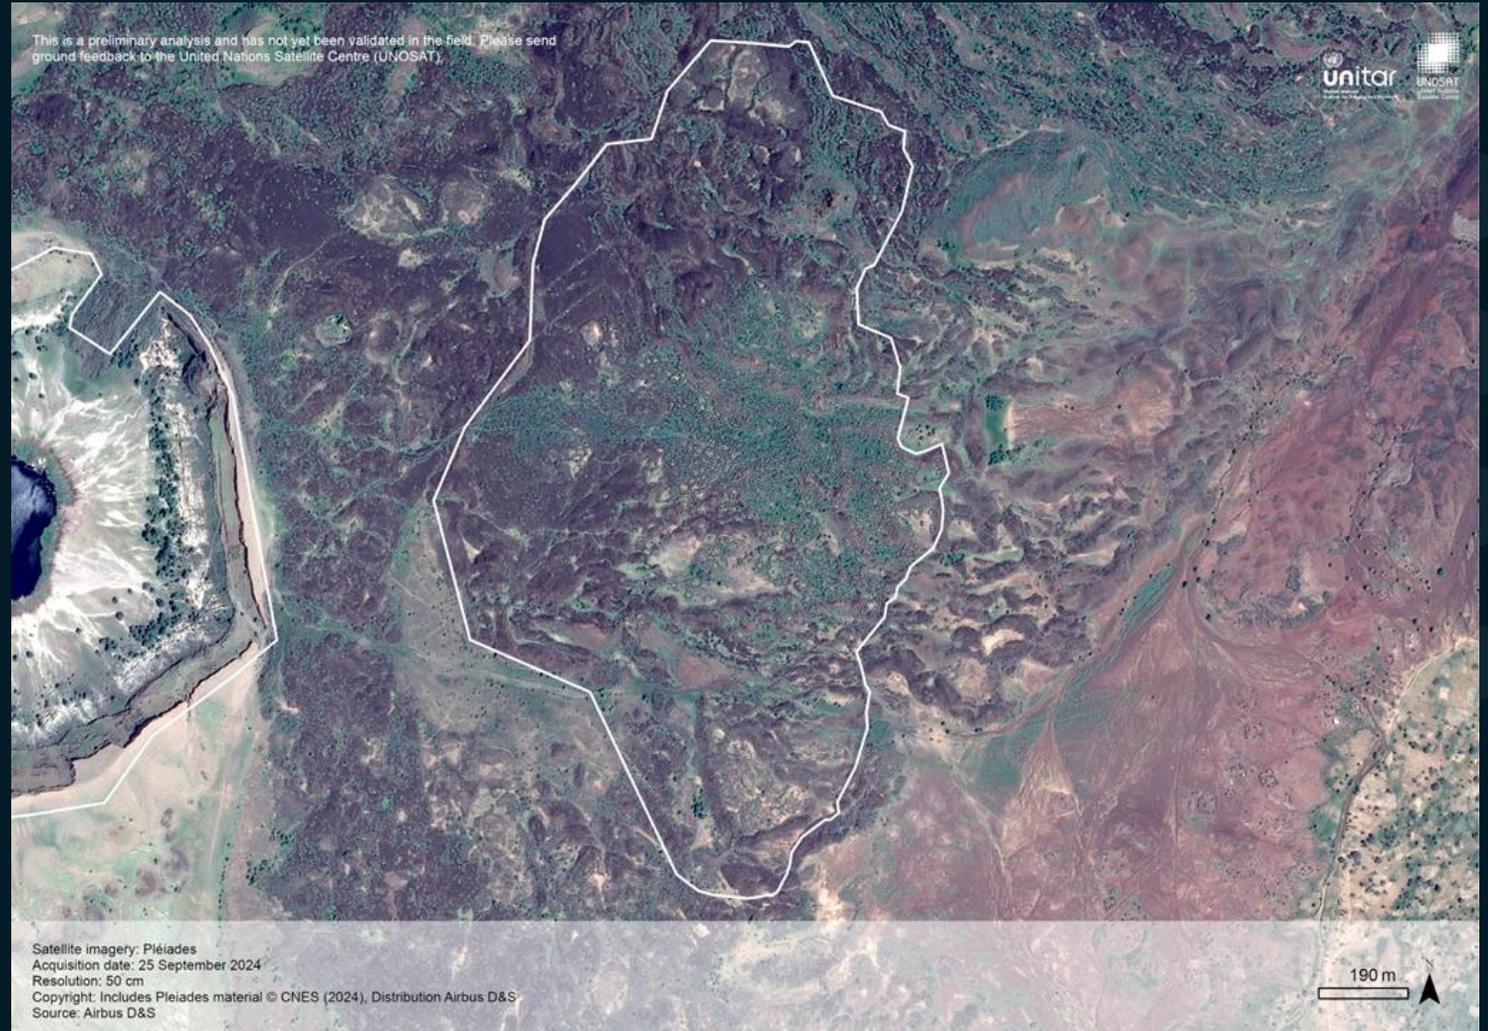
This page describes damage observed from a very-high resolution satellite image captured by a WorldView-2 satellite on the 3 November 2025.

This site was also analysed under the UNOSAT Emergency Mapping Service in September 2024 (FL20240826SDN, Charter Activation [917](#)), using a very-high resolution image captured by a Pléiades satellite on the 25 September 2024.

During both assessments no visible damage has been detected on the site.
