Satellite-based Damage Assessment

Sectoral Analysis: Cultural Heritage

Sudan

CE20231504SDN

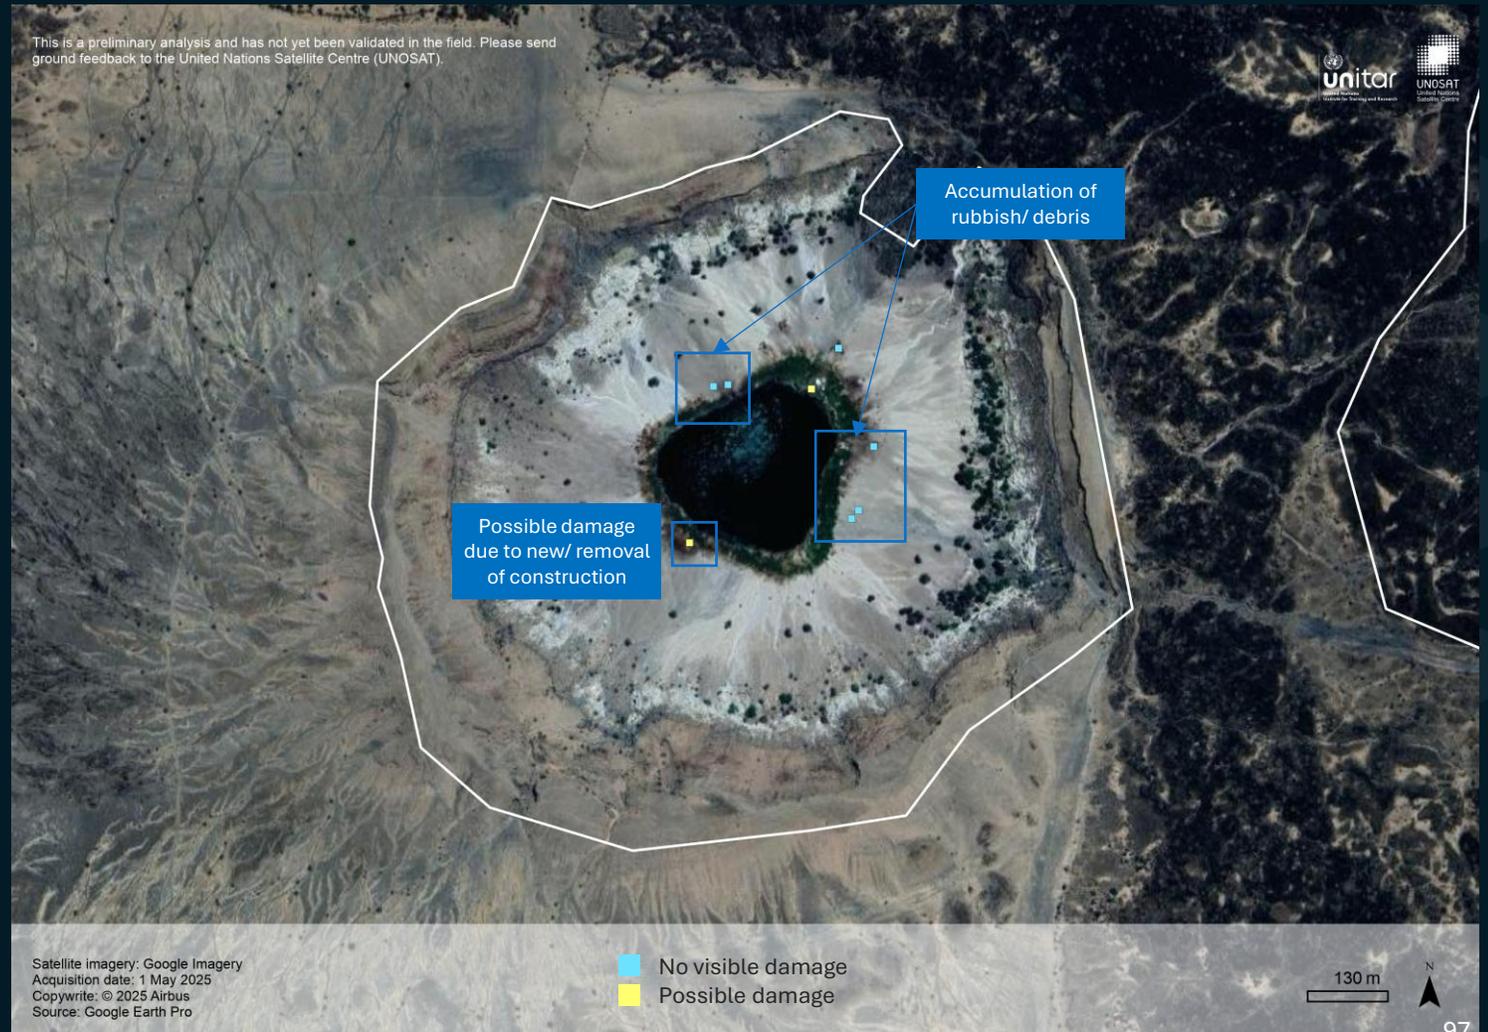
19. Malha - Lake and Salt works

POSSIBLE
DAMAGE

This page describes damage observed from a very-high resolution satellite image captured by a WorldView-2 satellite on the 3 November 2025.

Analysis shows possible damage around the lake shore, due to possible new construction and removal of structures.

Other points of no visible damage indicate the accumulation of rubbish / debris on the lake shore.

This site was also analysed under the UNOSAT Emergency Mapping Service in September 2024 (FL20240826SDN, Charter Activation [917](#)), using a very-high resolution image captured by a Pléiades satellite on the 25 September 2024 and no visible damage was present.

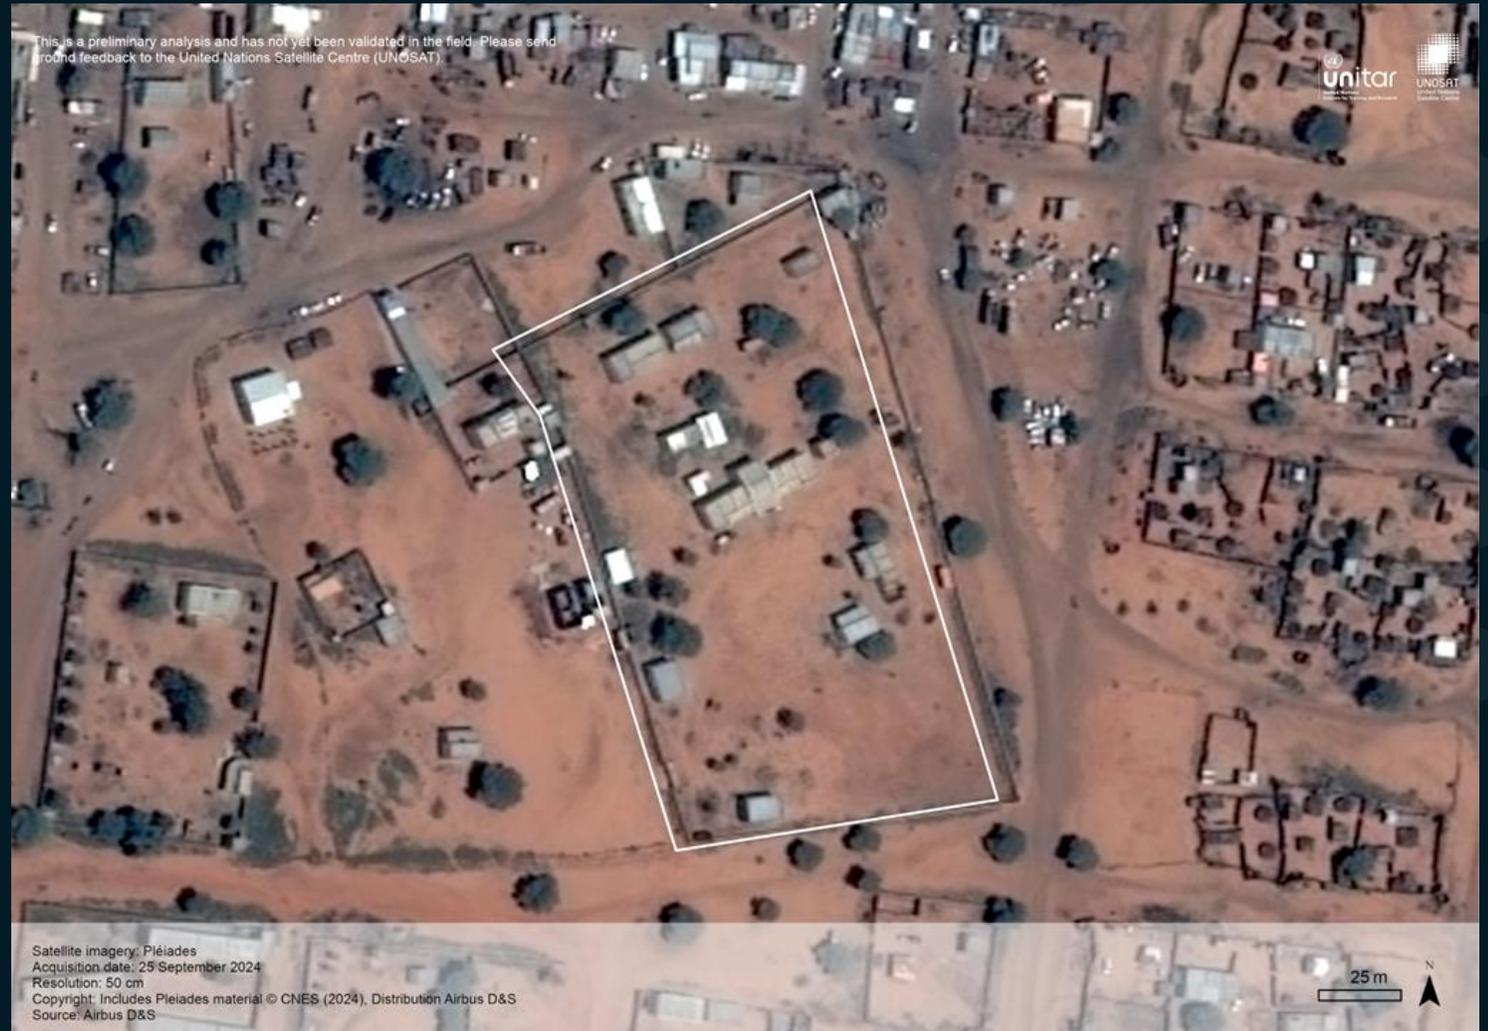
20. Malha Khairganqa Prison of Ali Dinar

NO VISIBLE
DAMAGE

This page describes damage observed from a very-high resolution satellite image captured by a WorldView-2 satellite on the 3 November 2025.

During both assessments no visible damage was detected on the site.

However, the town of El Malha (where the prison is situated) has sustained large scale damage to several buildings within the vicinity of the Malha Khairganqa Prison. In addition, military activity and presence can be seen within the town. Including a large earth berm surrounding the town.

Reports describe fighting and clashes within the town in early 2025, with reports that the RSF had seized control of El Malha on 20 March 2025 ([Sudan Tribune, 2025](#)). These reports and observations seen on satellite imagery put the site at a high concern.

Even though satellite imagery reports no visible damage at the site; interior damage, theft or looting cannot be detected through satellite imagery analysis.
